Willow Creek III HOA

Level 2 Reserve Analysis

Report Period – 01/01/14 – 12/31/14

Date of Property Observation - October 23, 2013
Project Manager - G. Michael Kelsen, RS, PRA
Main Contact Person - Mr. Ron Valiga, Community Manager

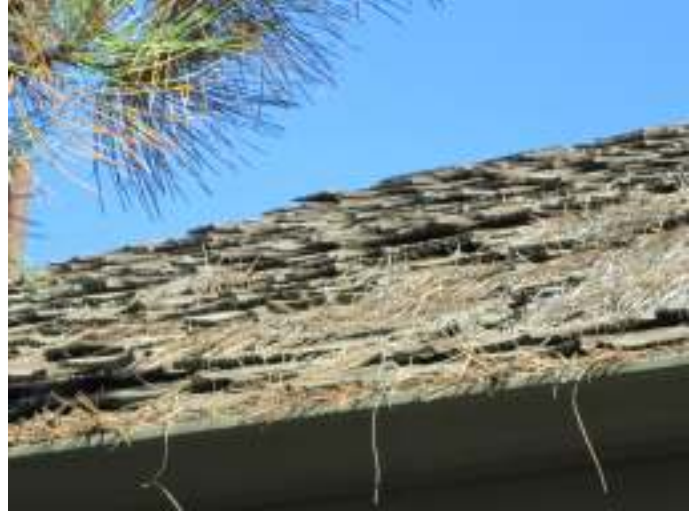
Comp #: 107 Building Roofs - Replace

Wood shake is exhibiting some warped and cupped shingles, which is an indicating factor that the roof is nearing the end of it's life expectancy. Most associations install a 50 year dimensional shingle as the best aesthetic match to a shake roof. Despite the rating, a replacement cycle of about 50% the manufacturers warranty should be anticipated for composition shingle in this climate. Weather elements such as hail, wind, and temperature fluctuations will cause a shorter life for this product. Reserve funding includes complete tear off and replacement.

Best Cost: \$8,800
\$400/square; Estimate to replace

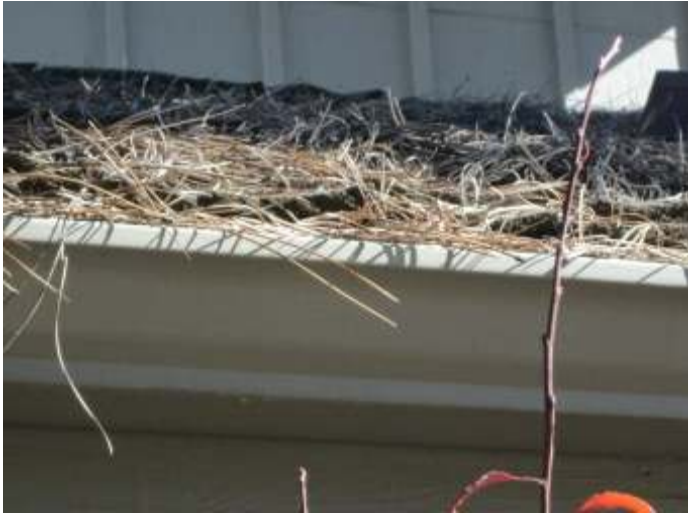
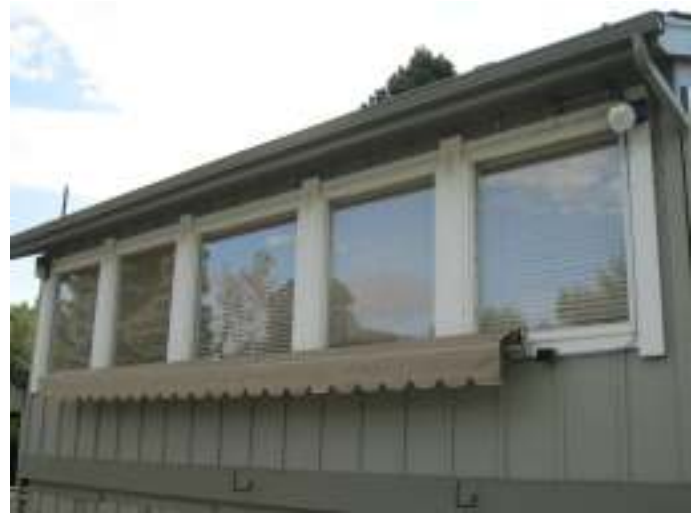
Comp #: 120 Gutters/Downspouts - Replace

Lines in front of the clubhouse are clogged with pine needles. It is important to keep the lines free from any debris to ensure proper drainage and to prevent any advanced deterioration of the metal materials. The average life expectancy for rain gutters and downspouts typically ranges between 20 - 25 years, depending on the level of maintenance and past cleanings. Typically, lines are replaced at the same time as roof materials. When replacement is required, we suggest upgrading the size of the lines to 5" or 6" to improve drainage.

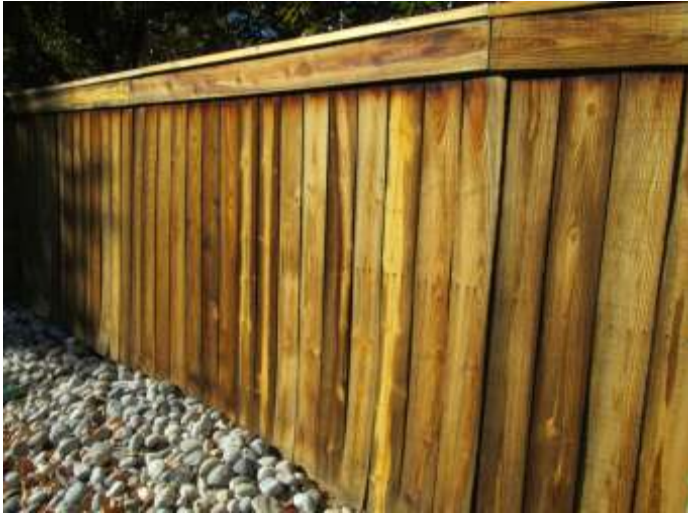
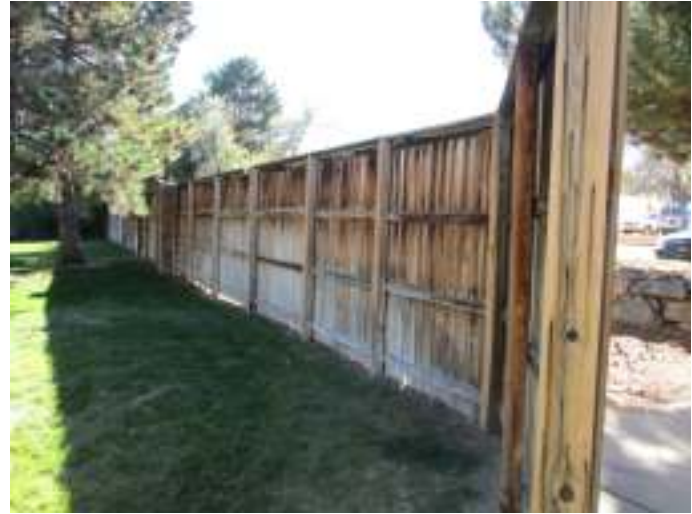
Comp #: 209 Wood Fencing - Restain

The only fence that was stained was the entry area. The fences have never been stained or painted to protect the materials against warping and splitting. As long as the fence remains unprotected (not sealed), Reserve funding is not required for this component. If association decides to restain in the future, then Reserve funding can be added in future Reserve Study updates.

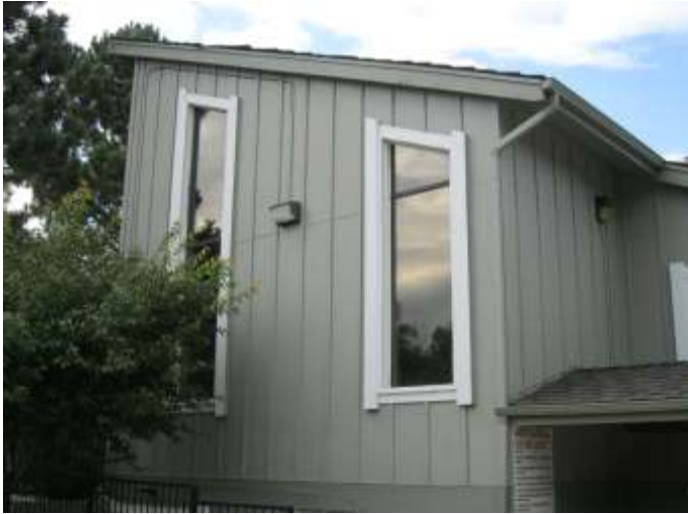
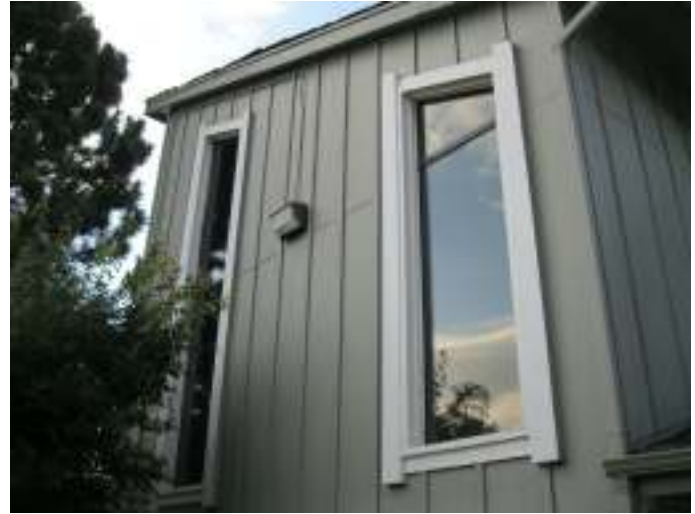
Comp #: 301 Clubhouse Siding - Replace

Siding materials are in good condition for age of building with no signs of significant warping or deterioration. It appears as though this building has been well maintained in the past and the results are positive. Typically, this material has a life expectancy of 25 - 30 years. However, due to following proper paint cycles, we have extended the life by a couple years. When replacement is required, some associations are deciding to upgrade to a material (cement fiber) that has a longer life expectancy (50+ years), and requires less frequent painting cycles.

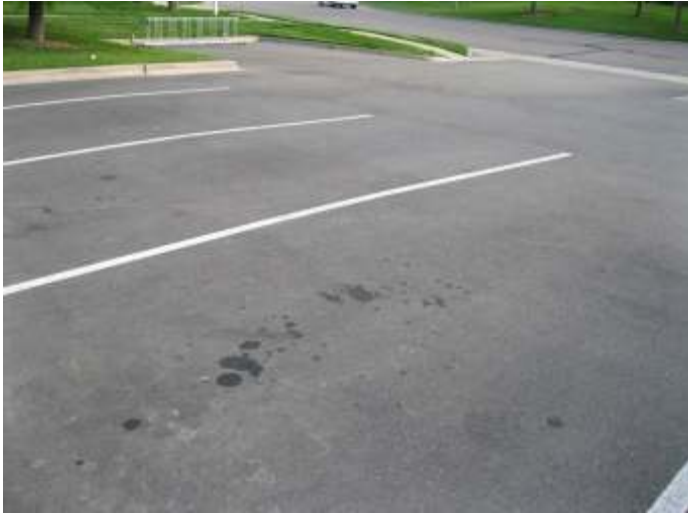
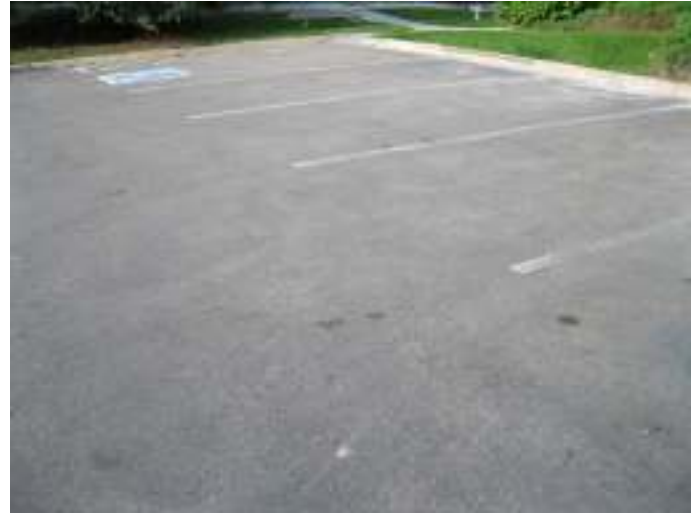
Comp #: 402 Asphalt - Seal Coat/crack fill

Clubhouse parking area has extensive signs of recent crack fill, some repairs and has recently been seal coated.

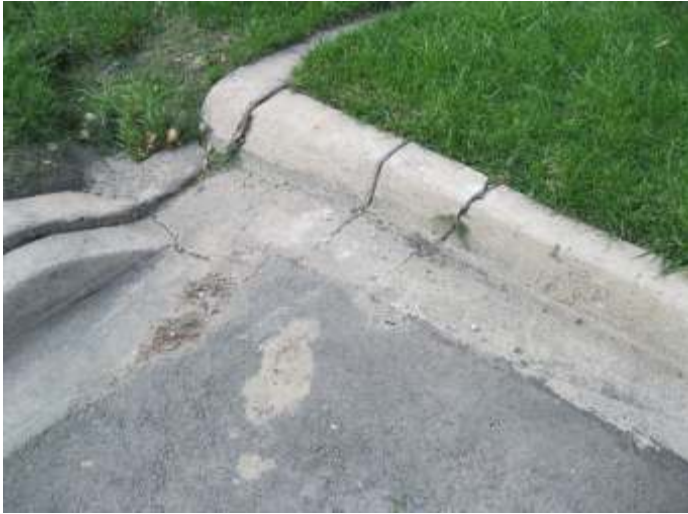
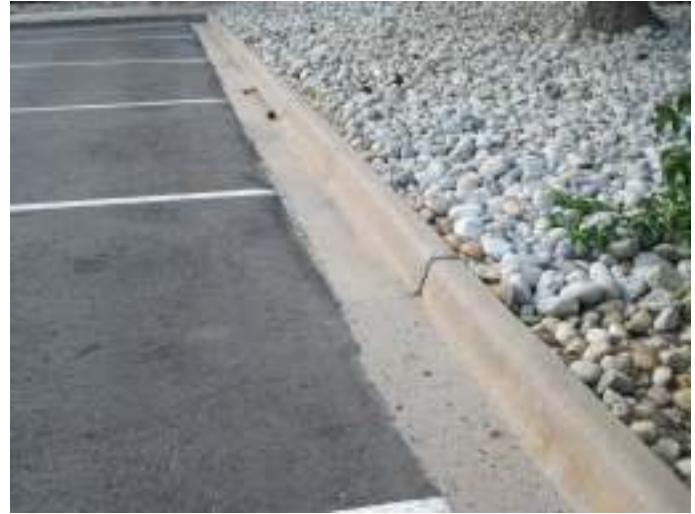
Comp #: 406 Curb and Gutters - Repair

Location: Clubhouse parking lot

Estimate to repair 10% of area every 3 years

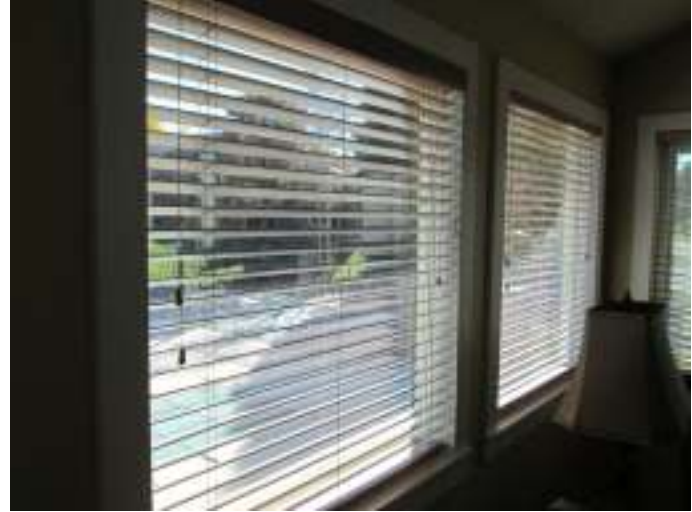
Comp #: 506 Doors/Windows - Replace

2009 - \$800 (replace doors at clubhouse), 2009 - \$830.75 (doors), 2011 - \$2500 (windows). Based on the expense history, it does not appear that all windows and doors were replaced. Therefore, due to varying ages, we have revised the philosophy to include an allowance for partial replacement of windows (about 1/3rd) every 10 years. One of the middle windows on the pool side of the building was broken.

Allowance for partial replacement

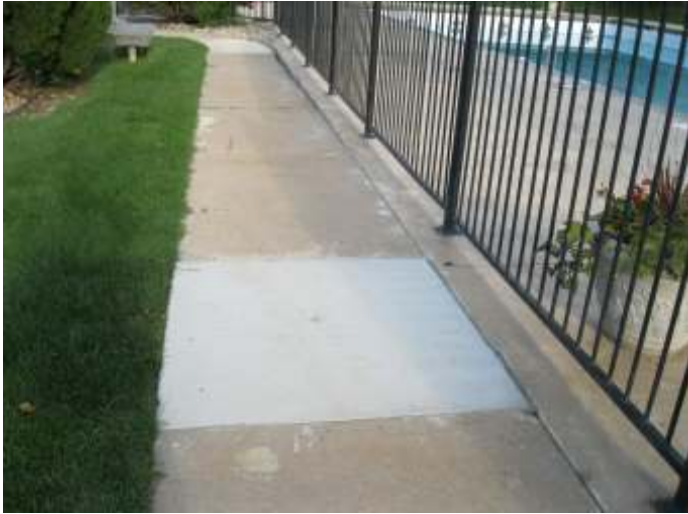
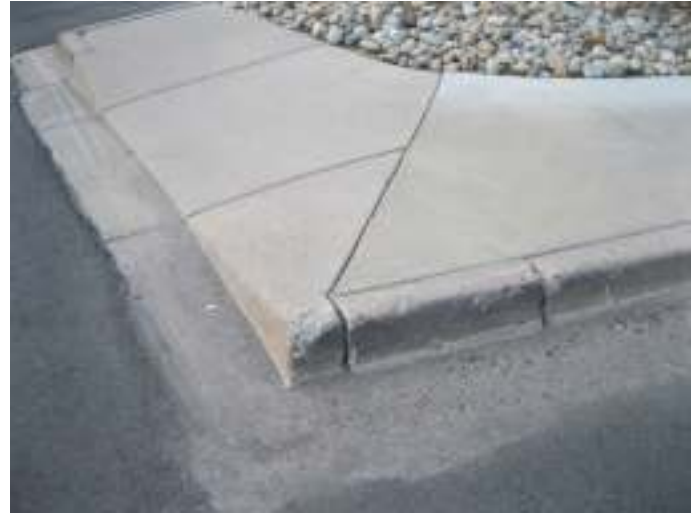
Comp #: 601 Concrete Sidewalks/Decks - Repair

The concrete stoops have settled on several units (units observed 8124, 8152 and 8158. Townhome sidewalk numbers include concrete garage aprons. Unit 8183 has a drain installed in sidewalk located at front door. Unit 8285 has a 2" buckle in concrete at front door. Unit's 8178, 8052, 7986, 7990 and 7994 have a 1" buckle in concrete that could pose a tripping hazard. While it is unlikely that all concrete surfaces will fail and need to be replaced at the same time, frequent repairs and replacement to a percentage of the area (5% or 3600 GSF), should be anticipated every 3 years.

Allowance to repair 5% of area every 3 years

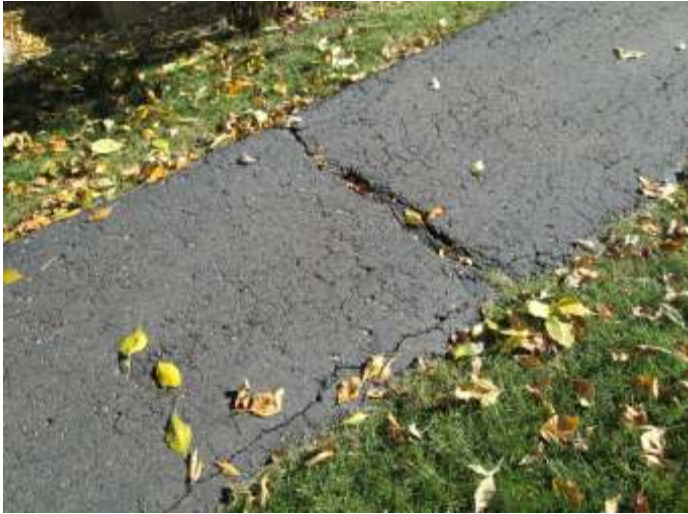
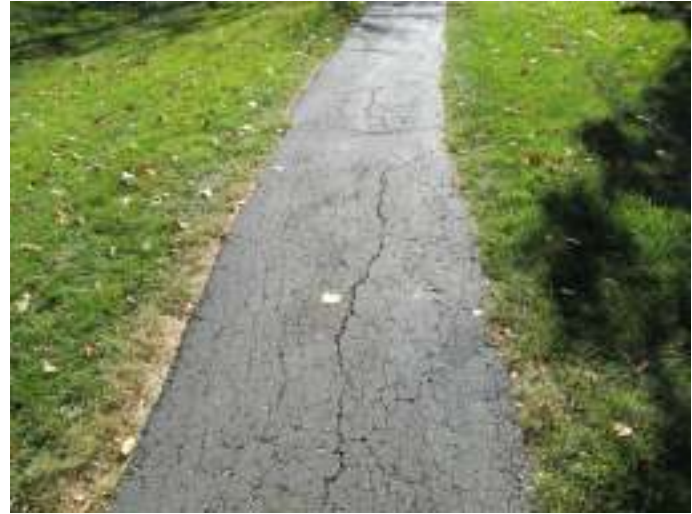
Comp #: 603 Asphalt Paths - Resurface

All done in 2005 with a 2" cap overlay. Cost \$19,975. Since installation, oil costs have increased substantially. Therefore, the costs need to be increased to compensate for today's costs. Paths are not typically seal coated due to accessibility issues. Noted cracking throughout the entire pathway. Therefore, plan on resurfacing paths every 15 - 20 years under normal conditions.

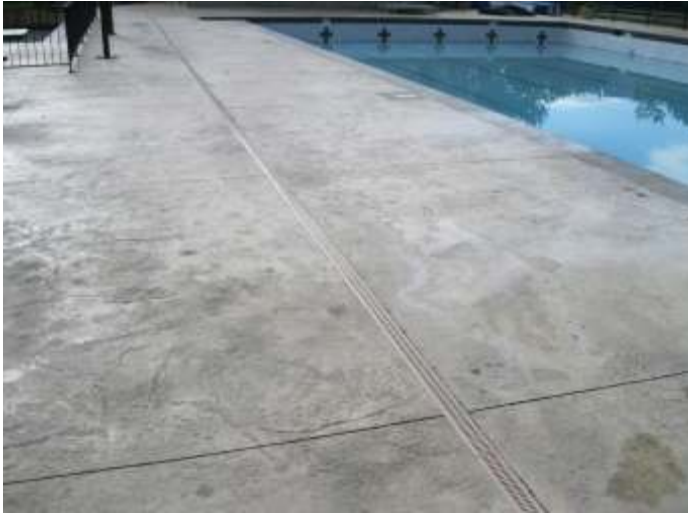
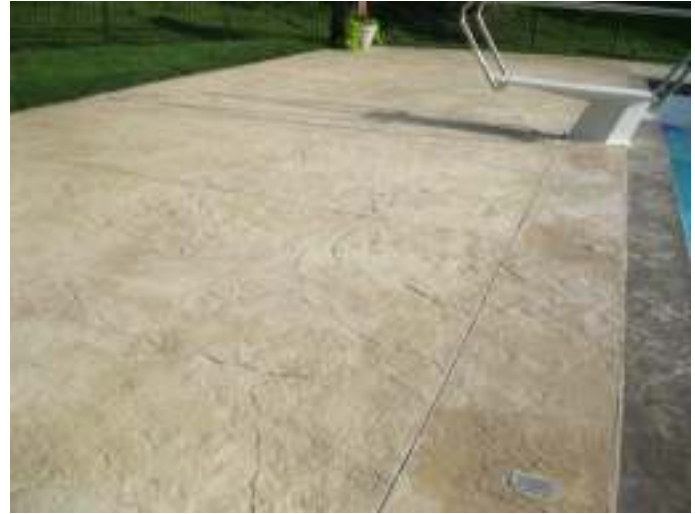
Comp #: 608 Pool Deck - Replace

Pool deck was recently replaced at the same time as the entire pool renovation project.

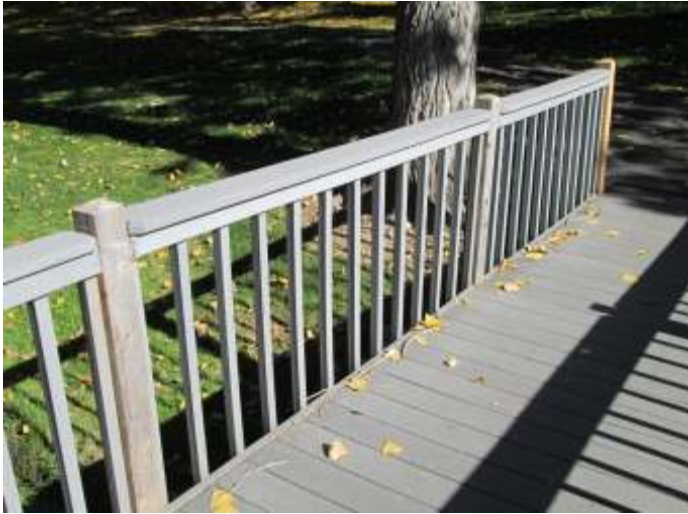
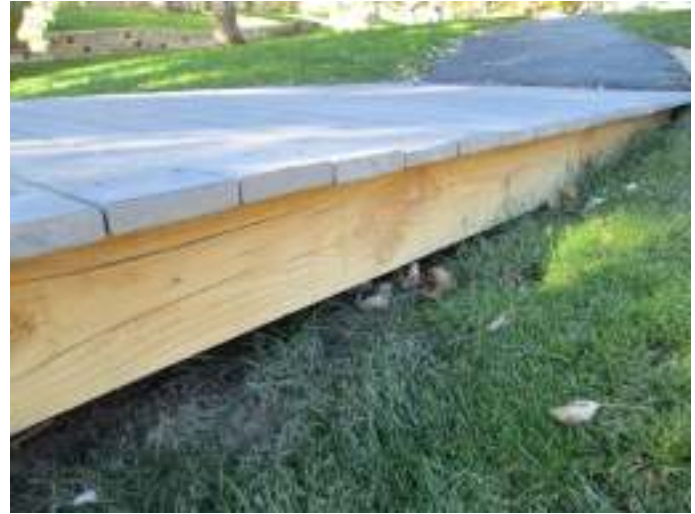
Comp #: 609 Composite Bridges - Replace

The bridge adjacent to unit #8132 was installed without pressure treated support joists. The exposure to the soil and moisture will cause this material to rot prematurely and will need to be replaced. The pickets on the first bridge in the greenbelt is broken and the rail is unstable. We suggest repairing this as an operating expense.

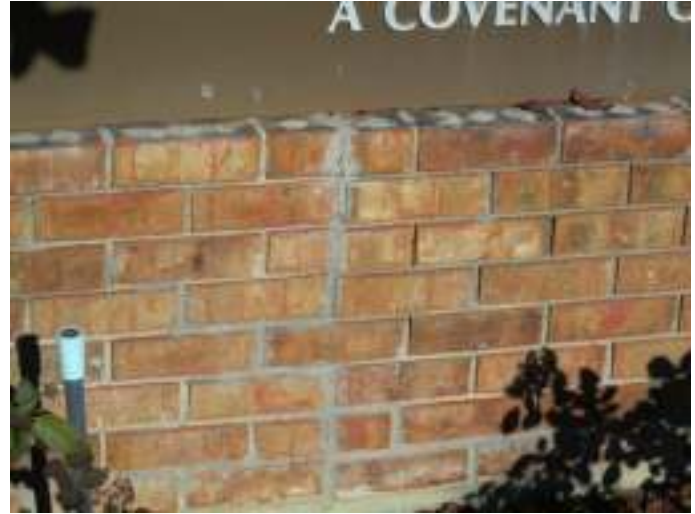
Comp #: 801 Monument - Rebuild

The crack that was noted in the brick wall below the signage has been filled. Monument is structurally stable and in good condition with no deterioration noted.

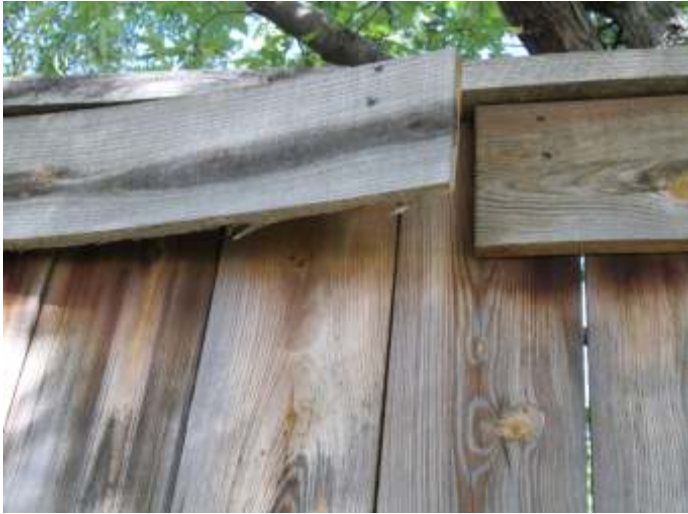
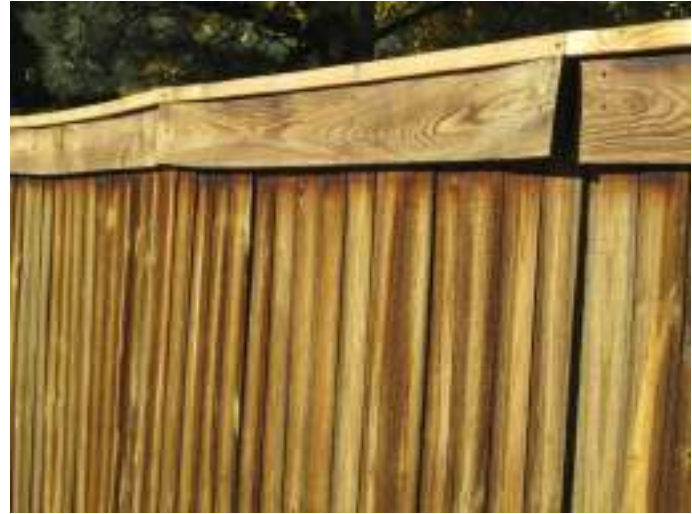
Comp #: 1001 Wood Fencing - Replace

Privacy fencing is weathered and in need of stain. Many areas were noted where the top cap on the fencing was warping and lifting at the seams.

Best Cost: **\$75,875**
\$25/LF; Estimate to replace

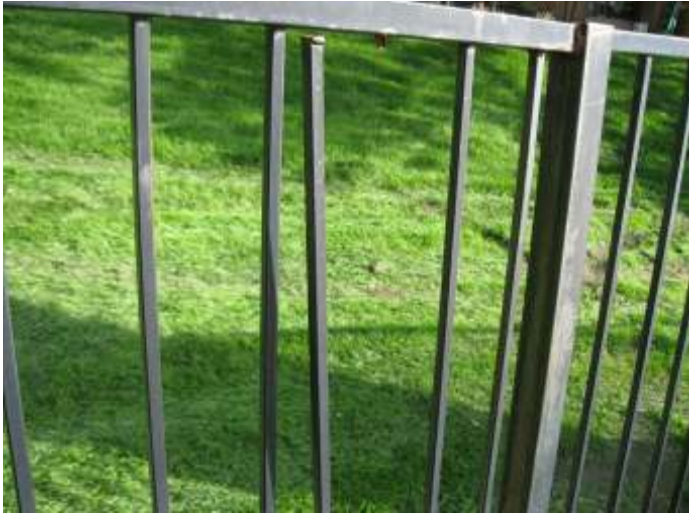
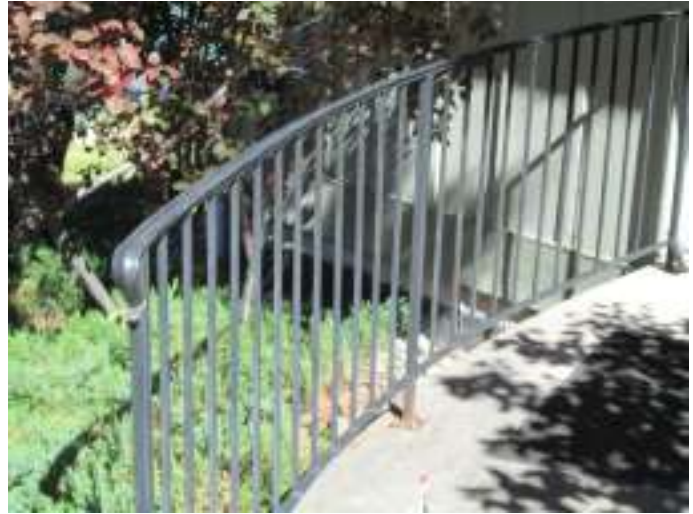
Comp #: 1002 Ironwork Fencing - Replace

Broken pickets and rusting was noted. Based on the observed conditions, we recommend replacing the fence, or performing major repairs. However, with the condition of the several pickets broken, we would assume other pickets will break soon. Therefore, it is our opinion that it would be most cost effective to replace the fence in the near future.

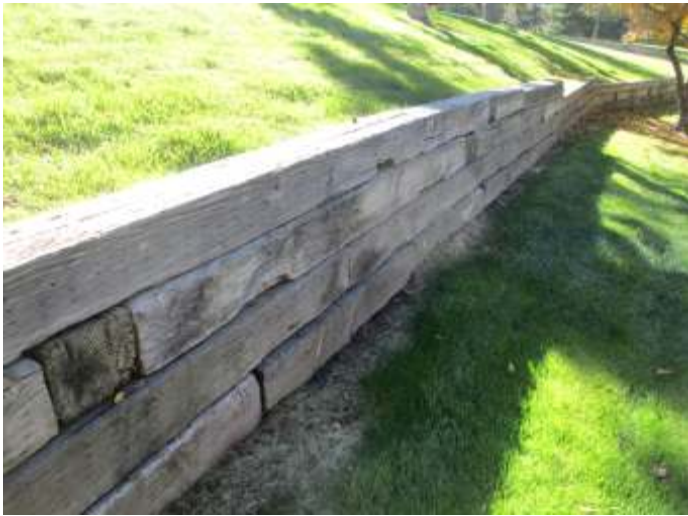
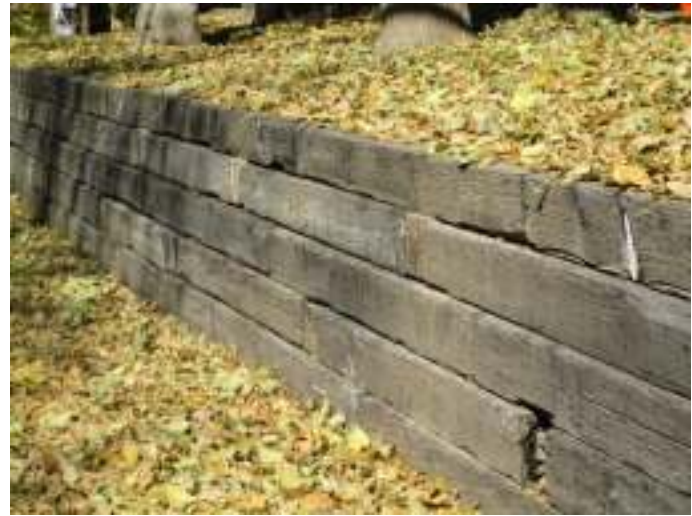
Comp #: 1007 Timber Walls - Repair

Some leaning was noted, as well as rot on the top timbers. Estimate to repair and replace 25% of the area (2600 GSF) every 6 years.

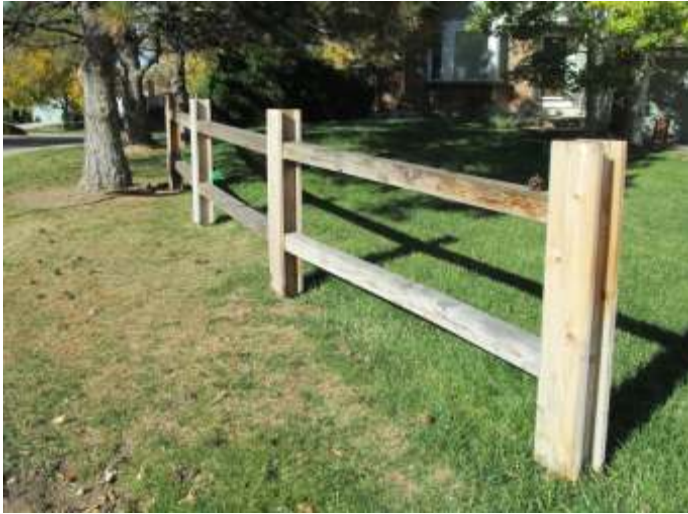
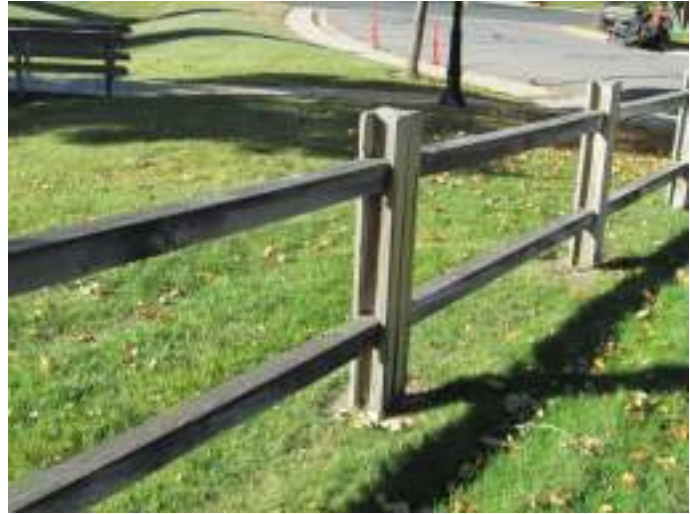
Comp #: 1009 Split Rail Fencing - Replace

Some rails and posts have been recently replaced. As a result, we adjusted the remaining life of the rail.

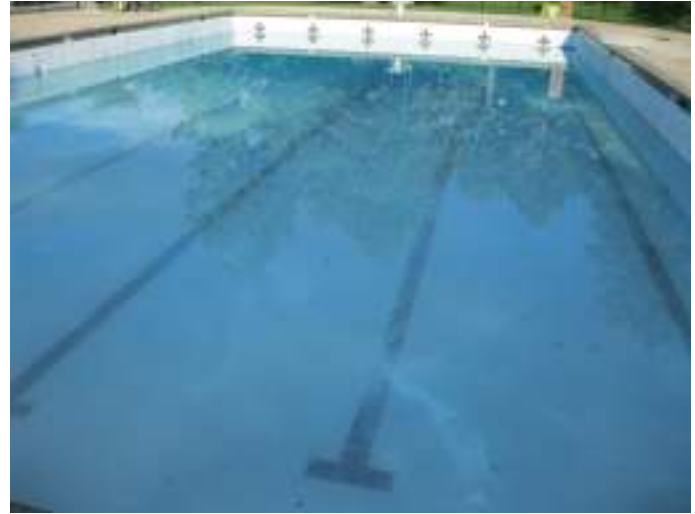
Comp #: 1101 Pool - Resurface

resurfaced in 2005 with the Diamond Brite plaster material. According to several maintenance companies, this coating should last 2-3 times longer than white marble plaster because aggregate is much more durable than marble dust. There has not been any reports of having to replace the pool due to using this type of surface. This type of material typically costs 50% more than the typical surface of marble dust.

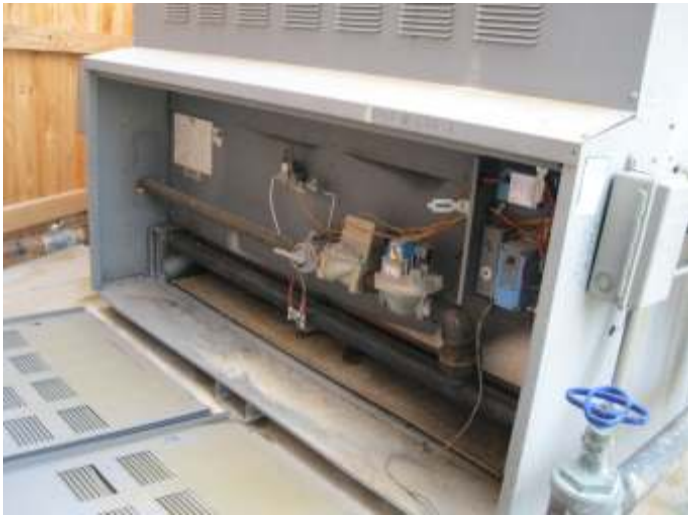
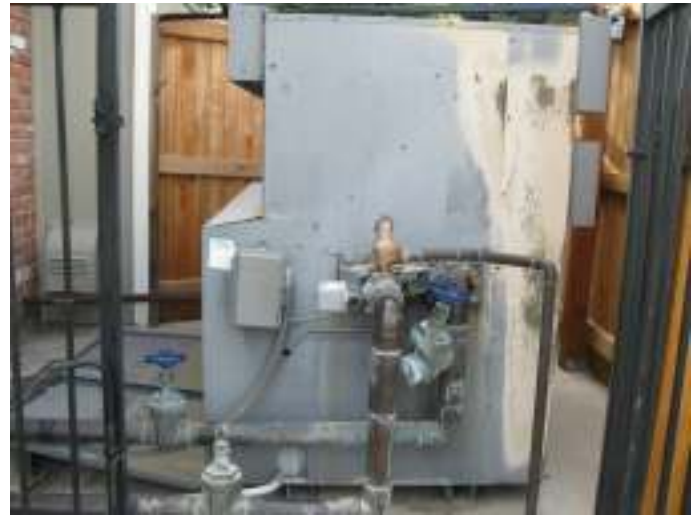
Comp #: 1104 Pool Boiler - Replace

Unit exhibited some rust and minor corrosion on the bottom plate. This is typical for boilers that are installed outside and is about halfway through it's life expectancy. It also looks like unit has caught on fire at some point in the past.

Estimate to replace with similar type and size

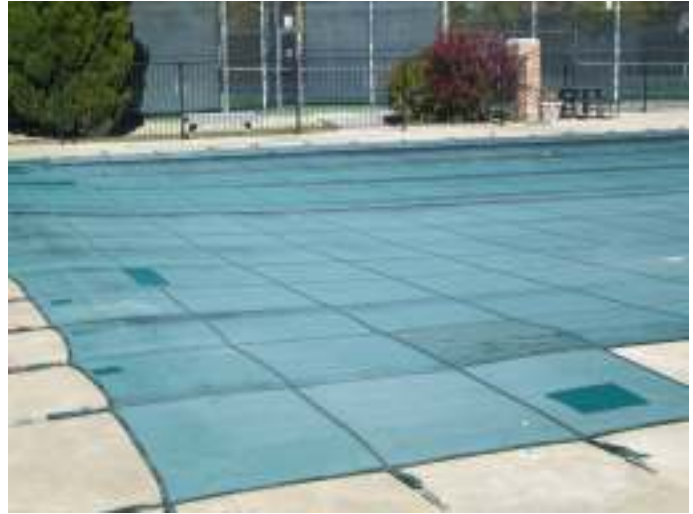
Comp #: 1112 Pool Cover - Replace

Material is very thin and does not currently serve as a safety cover. If someone were to walk on the cover, the material would not hold the weight of an average person. Also, the thin material is not protecting the plaster from exposure to sunlight during winter months when the water level is lowered. Based on observed conditions, we recommend replacing the covers immediately.

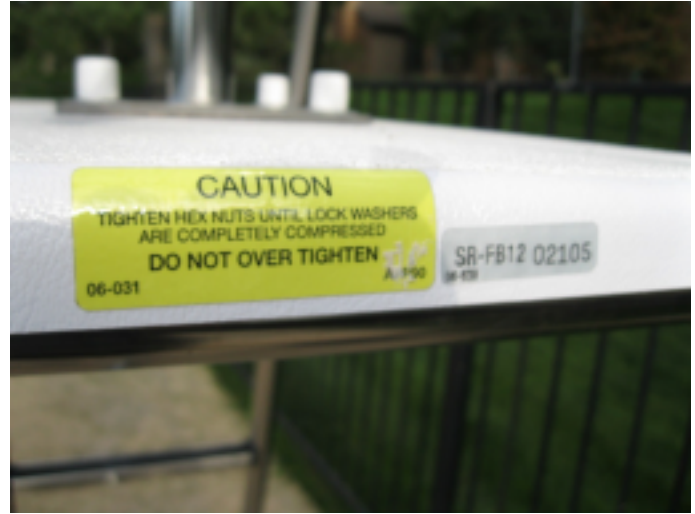
Comp #: 1117 Lifeguard Stand - Replace

Lifeguard stand was new and in good condition. Minor rusting is expected around the base due to exposure to chemicals and moisture from the pool. Replacement cycle for lifeguard stands range from 8 - 10 years, depending on quality of materials used for stand.

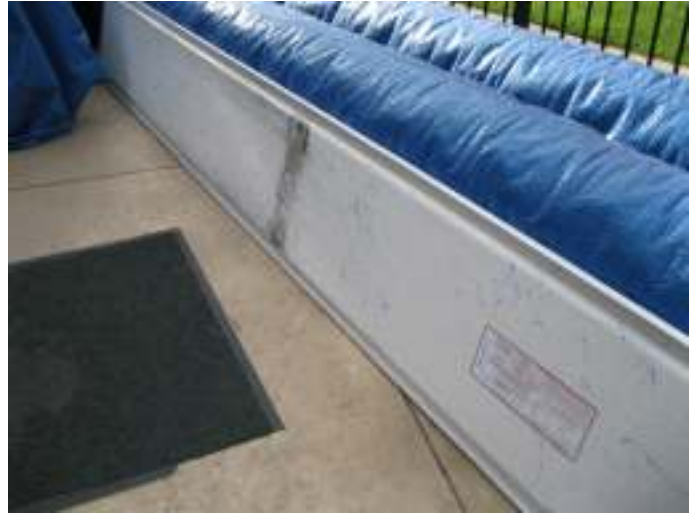
Comp #: 1118 Diving Board - Replace

New diving board was installed at the same time as the pool renovation project in 2013. The estimated cost includes replacement of the hand bars and platform.

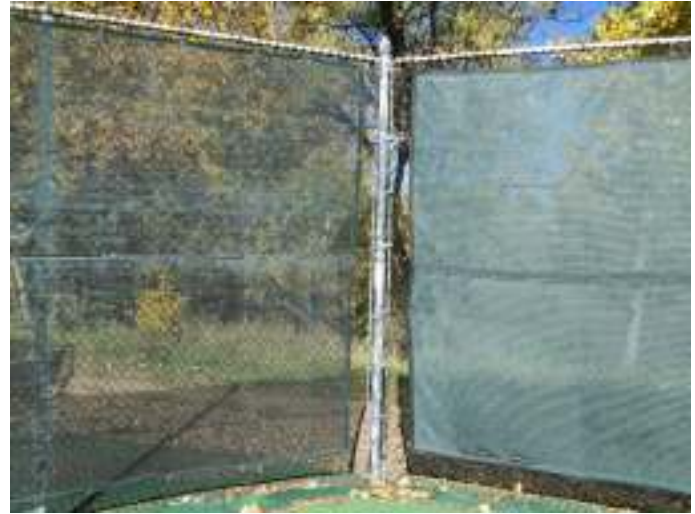
Comp #: 1202 Tennis Court Windscreen - Replace

A few panels had been replaced many years ago, but even the newer panels are thin and worn. In general, the majority of the windscreen is in poor condition and will need to be replaced in the near future.

Best Cost: **\$7,000**
\$0.85/GSF; Estimate to replace

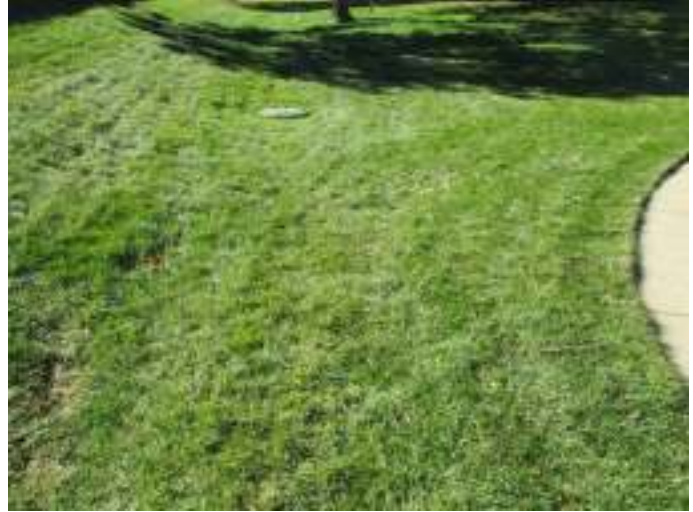
Comp #: 1701 Irrigation System - Rebuild

No reports of major problems with the irrigation system was noted at time of inspection or preparing this report. This system is less than 10 years old, however, systems that reach 15 - 20 years old start to see the need for major renovations and repairs. Therefore, we suggest the association establish a Reserve allowance for major repairs every 5 years. The remaining life is based on the age of the system and when it will reach the age that major repairs will be required.

Estimate for major repairs and renovating system

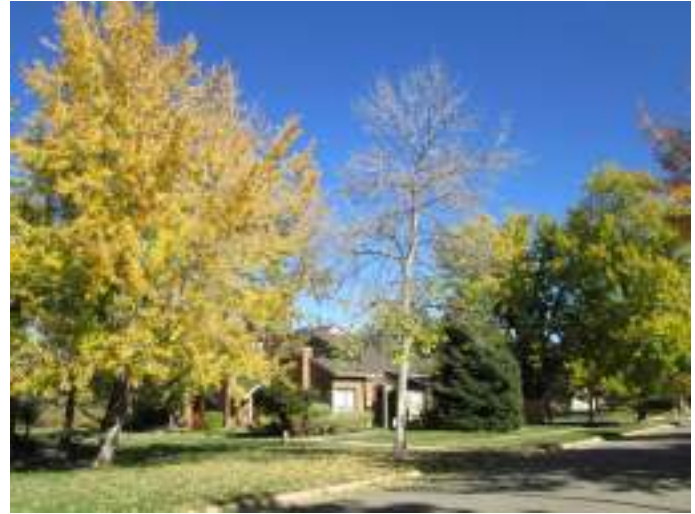
Comp #: 1804 Tree - Replacement

Trees appeared to be healthy and in good condition at time of inspection. It is very difficult to predict a replacement cycle for trees as there are several factors that will contribute to a tree dying. Factors such as disease, infestation of insects, heavy snow storms, etc. can all attribute to eventual tree replacement. Since it is difficult to predict when the replacement will be necessary, Reserve funding is typically not a factor. Therefore, unless requested by the association, Reserve funding will not be included as part of the study for this component.
