**Willow Creek III HOA  
8091 E. Phillips Cir.  
Centennial, CO. 80112**

**Level 2, Platinum Reserve Analysis  
Report Period – 01/01/19 – 12/31/19**

**FINAL  
Version**

**Report was prepared on - Wednesday, August 29, 2018**

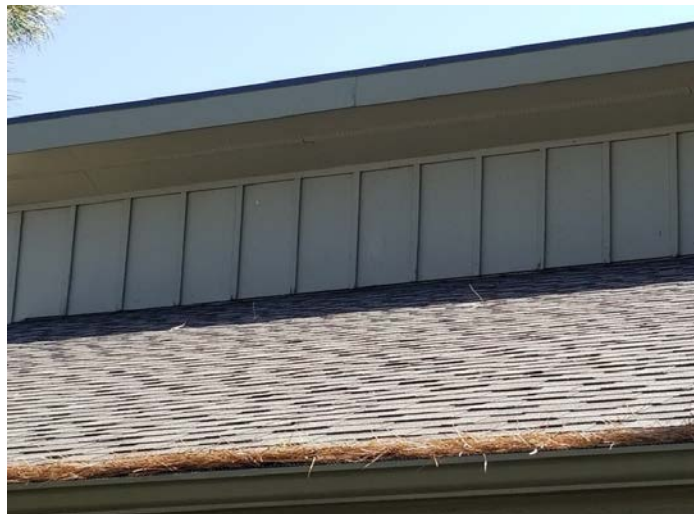
Comp #: 105 Comp Shingle Roof - Replace

- It was reported that the roof was installed in 2015.
- It appears this roof material is rated as a 30 - 40 year product. Despite this rating, a life expectancy of 18 - 20 years is expected in this environment.
- Due to the potentially harsh winters, extensive freeze/thaw cycle, and likelihood of hail events over the useful life of the roof, we typically see associations replacing roofs sooner than the manufacturer's suggested useful life.
- Remaining life is based on age of roof and observed conditions.

\$475/square; Estimate to remove and replace

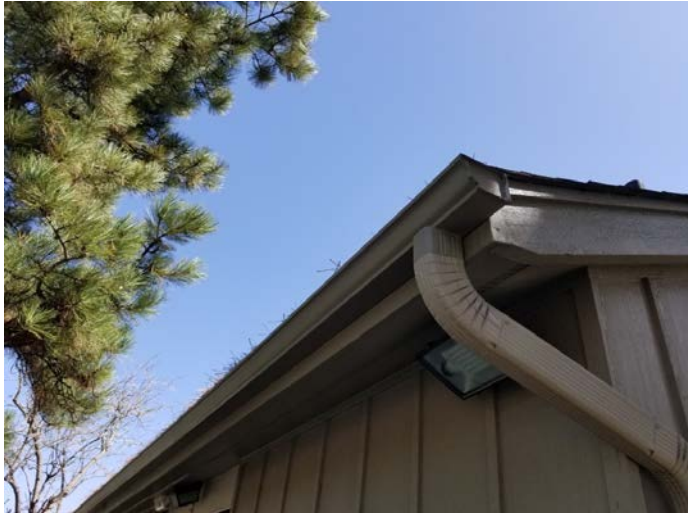
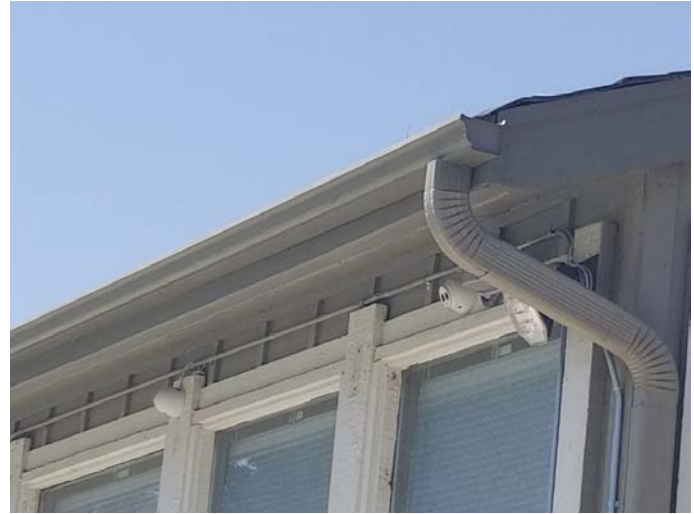
Comp #: 120 Gutters/Downspouts - Replace

- Due to the small quantity of rain gutters and downspouts, we recommend replacing as needed with operating funds.

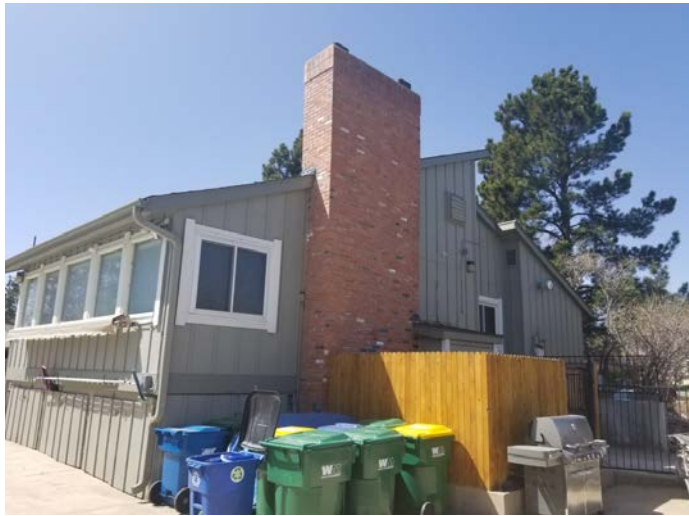
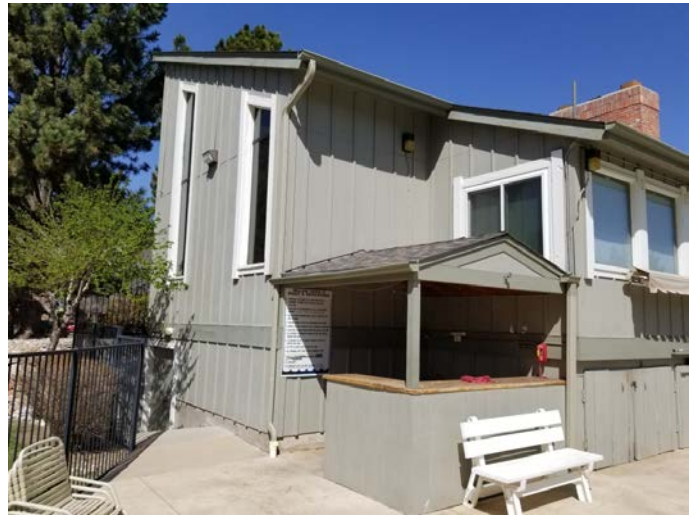
Comp #: 204 Building Ext Surfaces - Repaint

- It was reported that the clubhouse was painted in 2015.
- In this climate, it is recommended that exterior surfaces are painted every 5 - 7 years.
- The exact timeframe depends on the color chosen and the level of exposure to elements, as well as the quality of past paint jobs.
- The remaining life is based on the observed conditions.

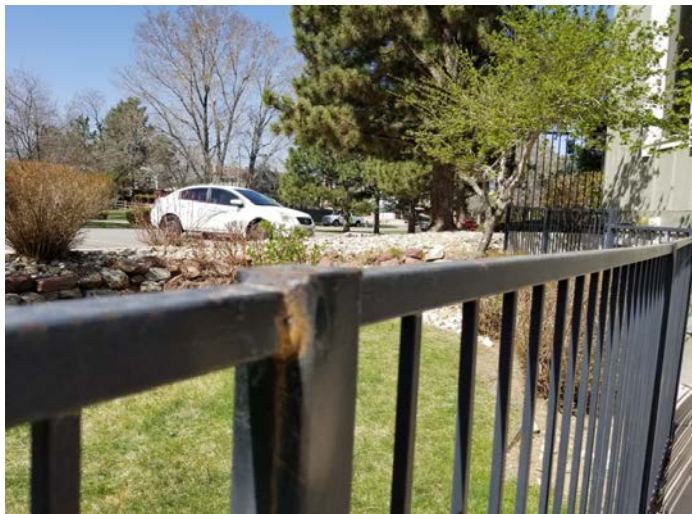
Comp #: 207 Iron Fencing - Repaint

- The paint on the metal surfaces around the pool and clubhouse was in poor condition at the time of the site observation, with several areas of rust and corrosion noted.
- In this climate, we recommend repainting this component every 3 - 4 years to maintain appearance and protect metal surfaces.
- Remaining life based on current condition.

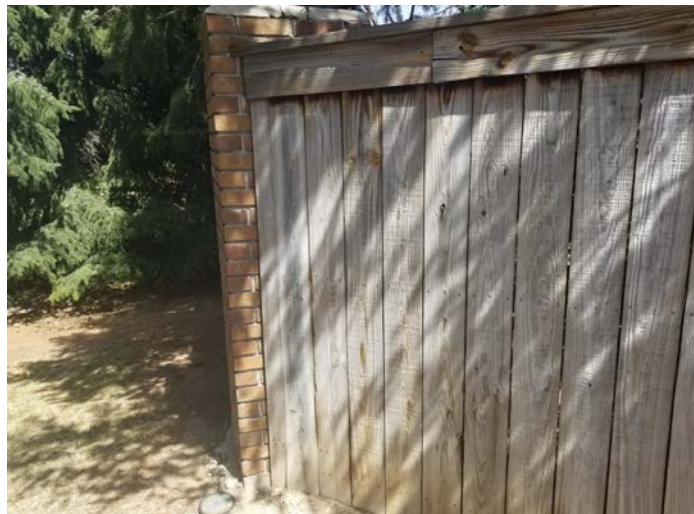
Comp #: 209 Wood Fencing - Restain

- As long as the fence remains unprotected (not sealed), Reserve funding is not required for this component.
- By staining the fence, the replacement cycle may be extended by 5 - 10 years.
- Some associations have the opinion it is not worth the expense to extend the life by only 5 - 10 years.
- Additional benefits to staining include maintaining a proper appearance for the community (no water staining, warped and split boards, etc.).

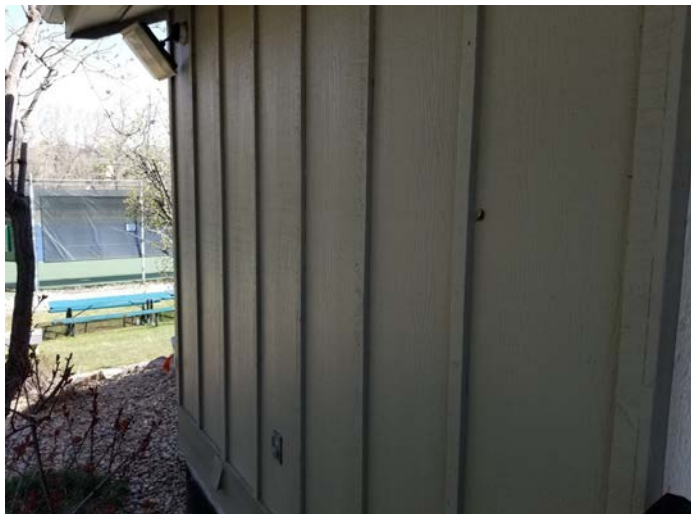
Comp #: 301 Clubhouse Siding - Replace

- The siding materials were in fair condition at the time of the site observation with minimal signs of advanced deterioration noted.
- Typically, this material has a life expectancy of 25 - 30 years. However, due to following proper paint cycles, we have extended the life by a couple years.
- When replacement is required, some associations are deciding to upgrade to a material (fiber cement) that has a longer life expectancy.

\$9.00/GSF; Estimate to replace

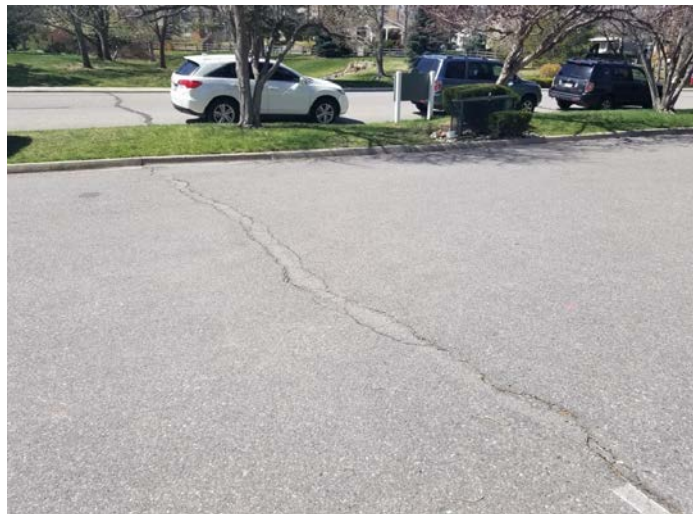
Comp #: 401 Asphalt - Overlay

- The asphalt overlay on the parking lot was in good to fair condition at the time of the site observation.
- The average life expectancy for asphalt surfaces ranges between 20 - 27 years for surfaces that are maintained on a regular schedule.
- Maintenance includes crack fill and repairing small potholes annually as an operating expense.
- In addition, asphalt should be seal coated every 3 - 4 years, depending on the level of traffic and snow removing techniques.

\$3.00/GSF; Higher estimate for local repairs

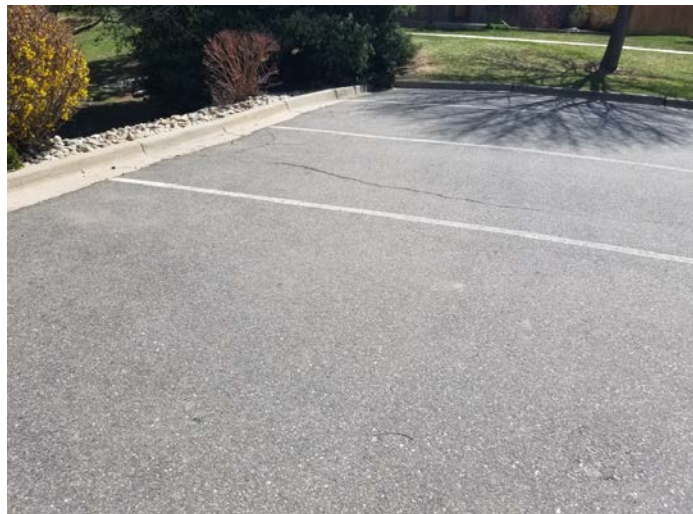
Comp #: 402 Asphalt - Seal Coat/crack fill

- In this environment, expect to seal asphalt every 2 - 3 years, depending on traffic levels and effects from weather.
- Sealcoating is applied to protect the asphalt from ultra-violet rays and water.
- This helps in slowing the process of oxidation and raveling.
- While acting as a protective barrier, it also maintains the appearance of the community to maintain or improve property values.

Higher estimate for some repairs

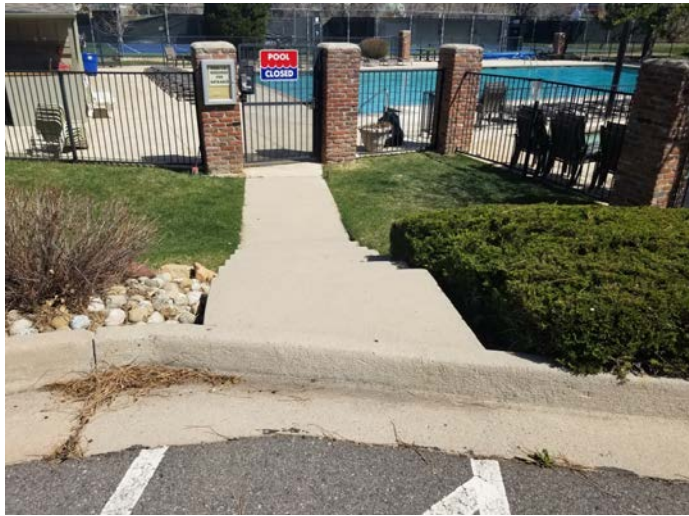
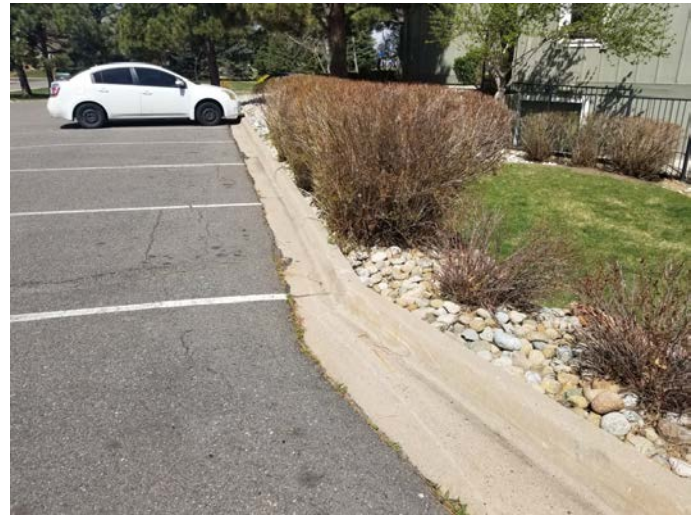
Comp #: 406 Curb and Gutters - Repair

- Curbs and gutters are subject to more advanced deterioration due to trucks and plows hitting them during the year.
- It is unlikely that all concrete surfaces will need to be replaced at the same time.
- Therefore, we suggest establishing a Reserve fund for periodic repairs and replacement of 10% (approx. 140 GSF) every 3 years.
- Coordinate with other concrete surfaces for best cost estimate.

Estimate to repair 10% of area every 3 years

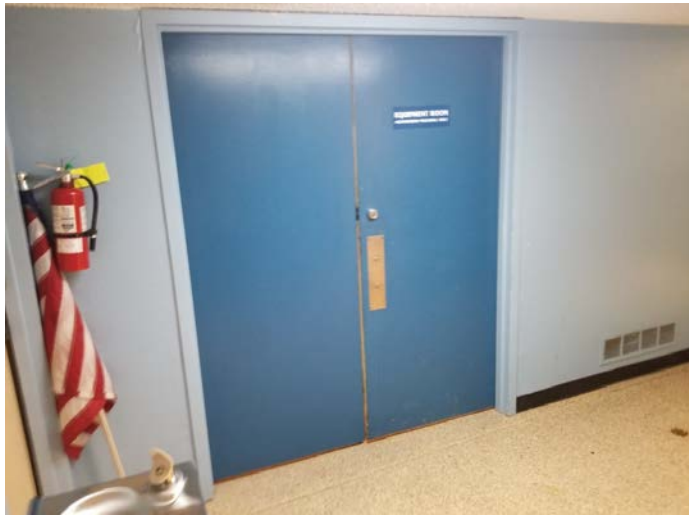
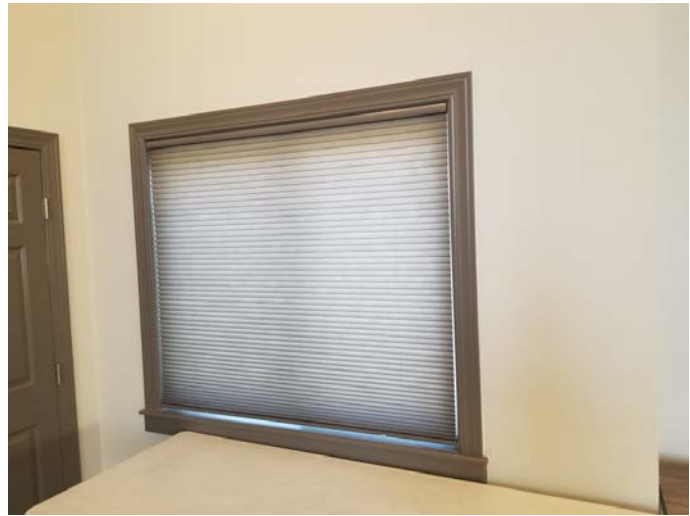
Comp #: 506 Doors/Windows - Partial Replacement

- Based on the expense history, it does not appear that all windows and doors were replaced.
- Therefore, due to varying ages, we have revised the philosophy to include an allowance for partial replacement of windows and doors every 10 years.

Allowance for partial replacement

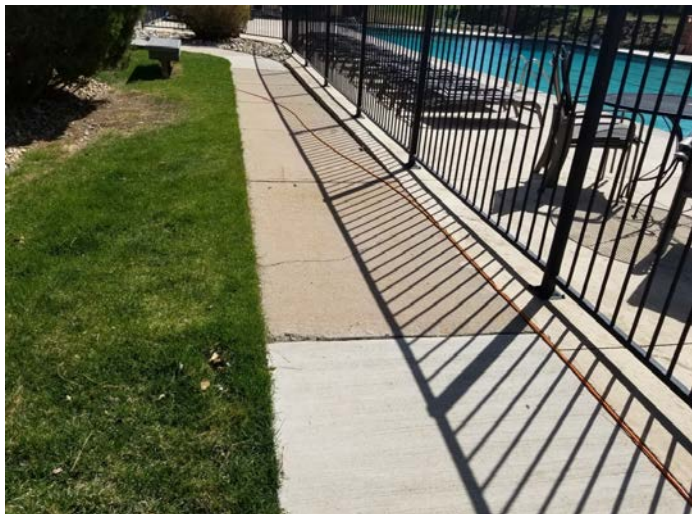
Comp #: 601 Concrete Sidewalks/Decks - Repair

- Similar to other concrete surfaces, it is unlikely that all concrete surfaces will fail and need to be replaced at the same time.
- Therefore, we suggest establishing a Reserve fund for frequent repairs and replacement to a percentage of the area (5% or 3,600 GSF) every 3 years.
- Coordinate repairs with other concrete surfaces for best cost estimate.

Allowance to repair 5% of area every 3 years

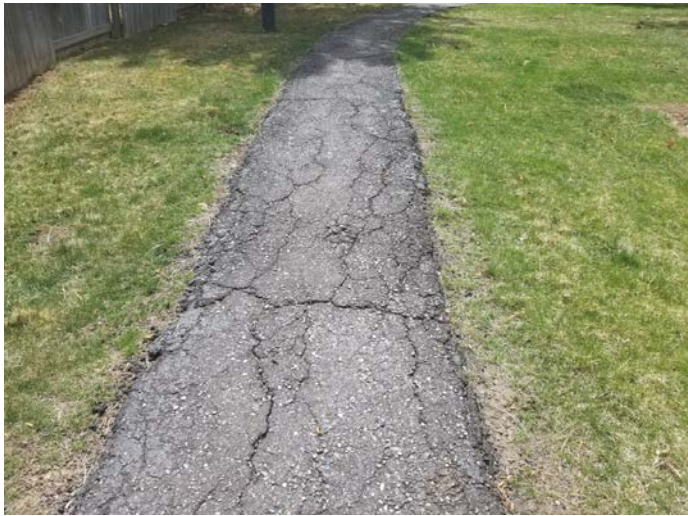
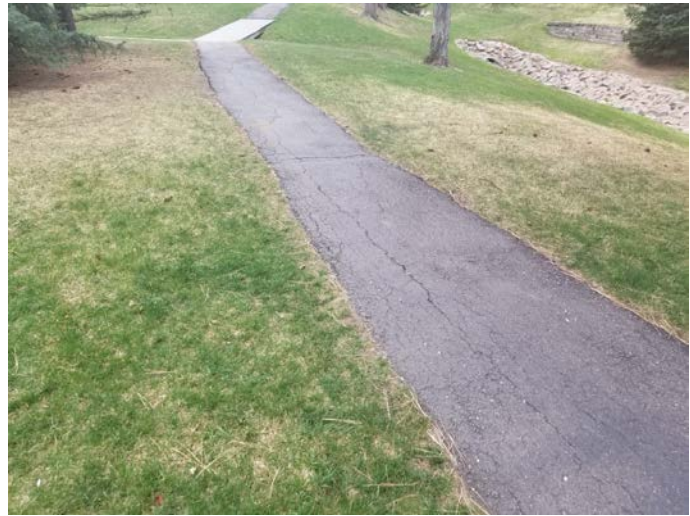
Comp #: 603 Asphalt Paths - Resurface

- The asphalt paths throughout the community appeared to be in fair to poor condition. There were several areas where the asphalt was cracking and deteriorating.
- Remaining life is based on the observed condition and age of the paths.

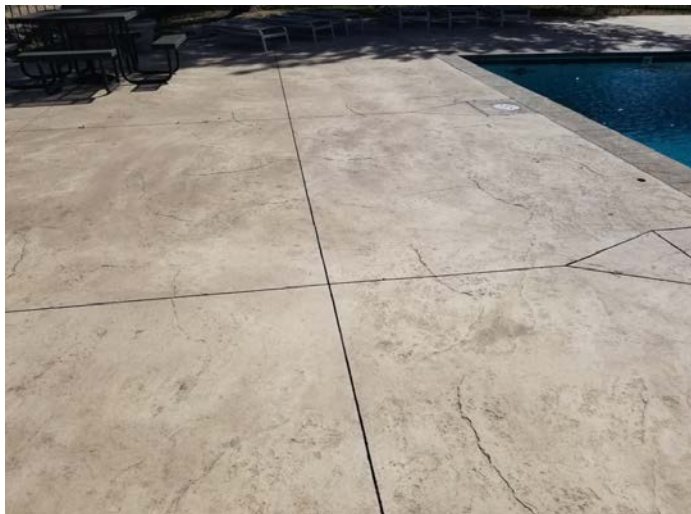
Comp #: 608 Pool Deck - Replace

- The pool deck was in good condition with no significant signs of advanced deterioration noted during the site observation.
- Expect a useful life of 30 - 35 years from this pool deck.
- Remaining life is based on the age of the concrete and observed conditions.

\$15/GSF; Estimate to replace

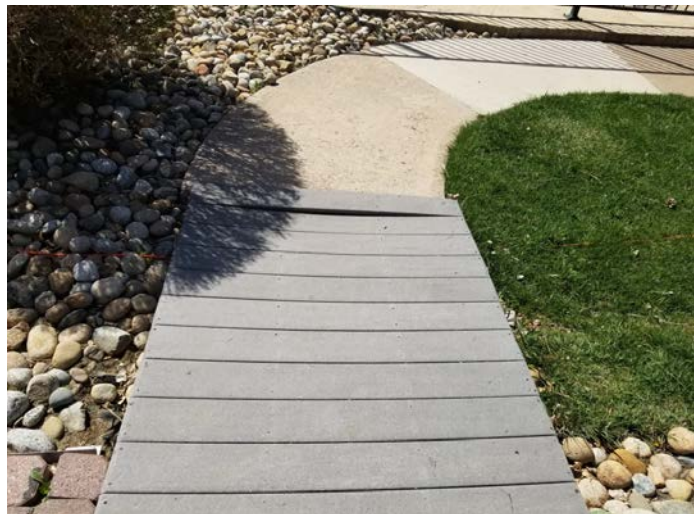
Comp #: 609 Composite Bridges - Replace

- Most composite material manufacturers offer a 25 year limited warranty from against defects.
- However, over a period of time, the material begins to fade and scratch and eventually will become aesthetically unpleasing.
- Therefore, due to the level of use and exposure to the elements, we recommend establishing a replacement cycle of 18 - 22 years.
- We recommend replacing the rail and material at the same time.

\$35/GSF; Estimate to replace with similar

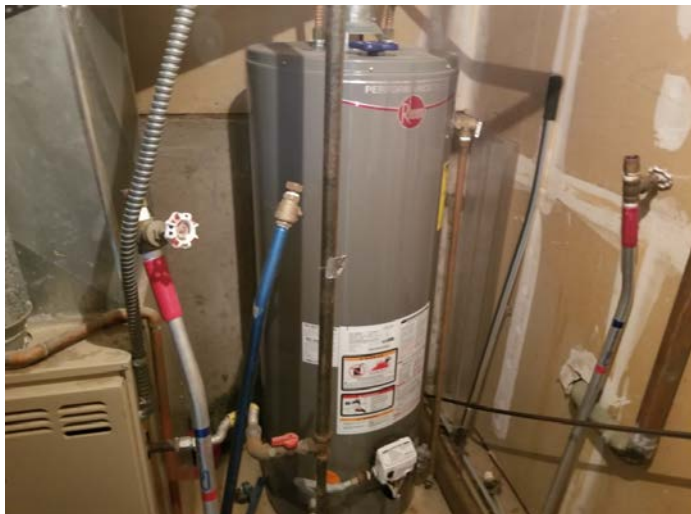
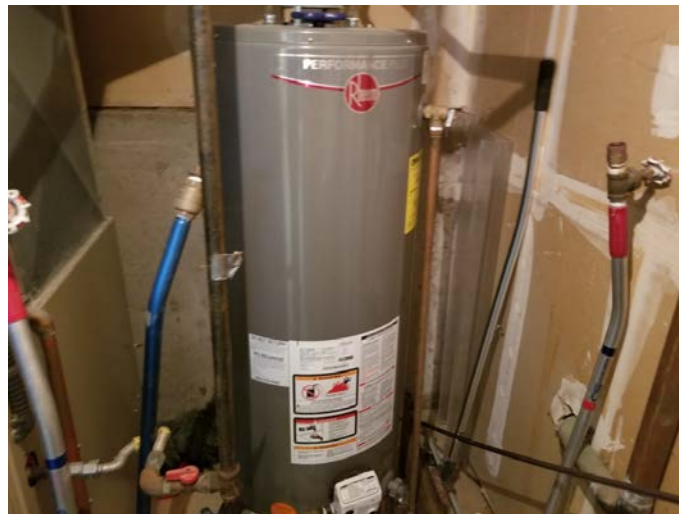
Comp #: 703 Hot Water Heater Tank - Replace

- Joints and connections were in good shape and free from significant rusting and corrosion.
- Depending on the level of use and the quality of the water running through the system, expect a useful life of 12 - 15 years from water heaters with proper maintenance and care.

\$2000/heater; Estimate to replace

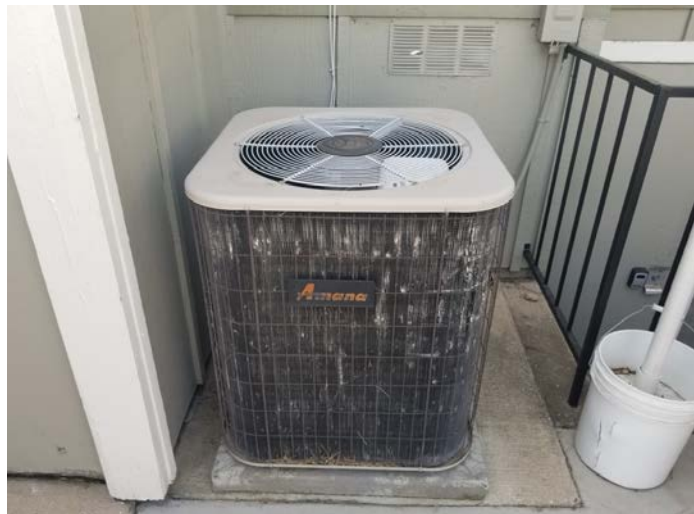
Comp #: 705 HVAC System - Replace

- It was reported that the air conditioning in the clubhouse is not very effective and the units do not operate well.
- In our experience, we have seen the need to replace these units every 18 - 25 years, depending on the level of use and maintenance.
- Remaining life is based on age of the units.

Estimate to replace with same system

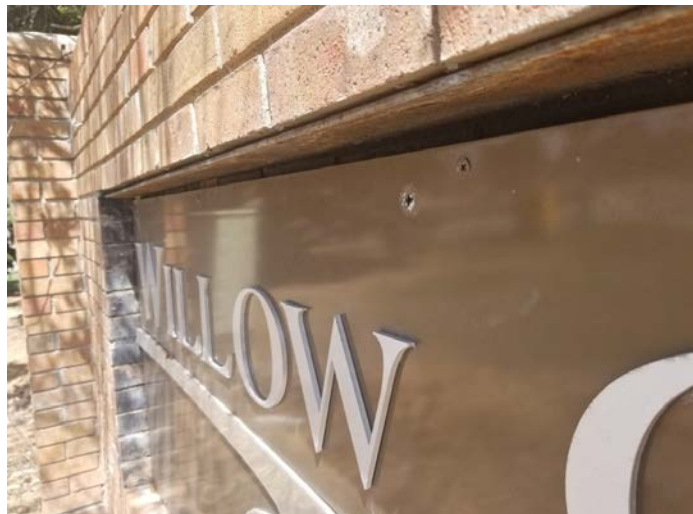
Comp #: 801 Monument - Rebuild

- The monument structure appeared in good condition at time of observation with no noticeable damage to the materials.
- The letters should be replaced on an as needed basis with general operating funds.
- It is unlikely that the monument will require replacement or rebuilding due to the materials failing.

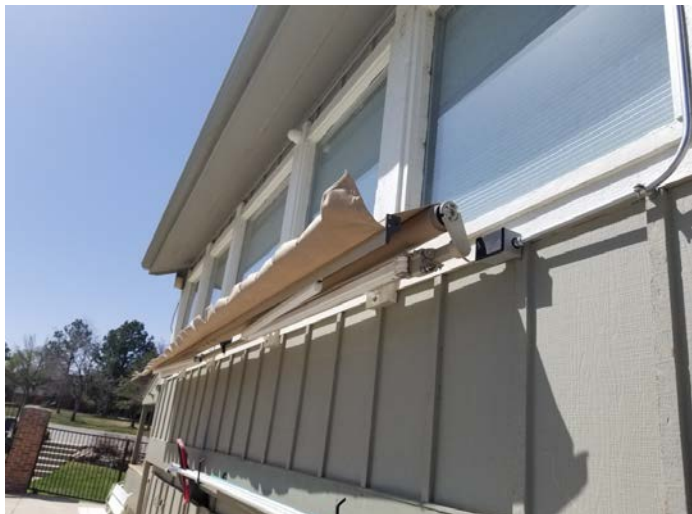
Comp #: 804 Awnings - Replace

- This awning was rolled up during the site observation, so we were unable to look at the fabric to see conditions.
- There were no reports of the awning being replaced.
- Remaining life is based on age of the awning.

Estimate to replace with similar awning

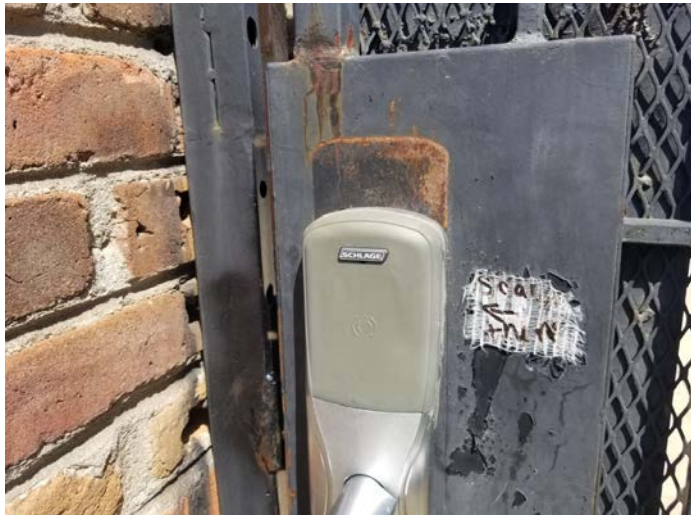
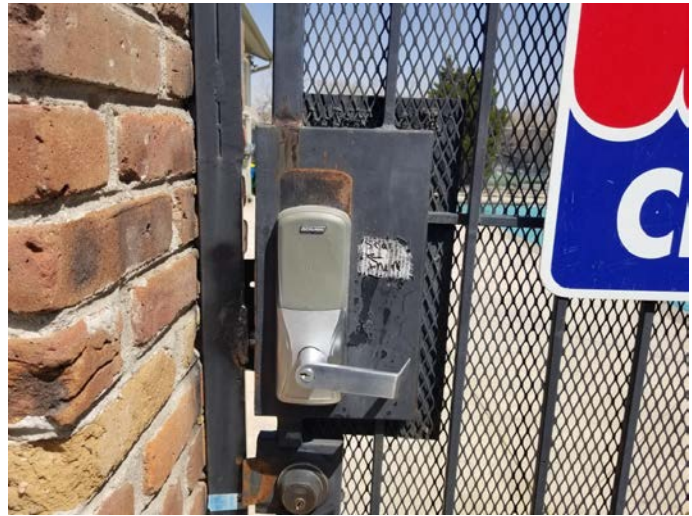
Comp #: 908 Access System - Replace

- While the system will continue to serve the security measures for the building, upgrades to systems will be required every 5 - 6 years due to advancement in technology.
- The remaining life is based on the fact that there are no current problems with the system and there are no plans for immediate replacement.

Estimate to replace

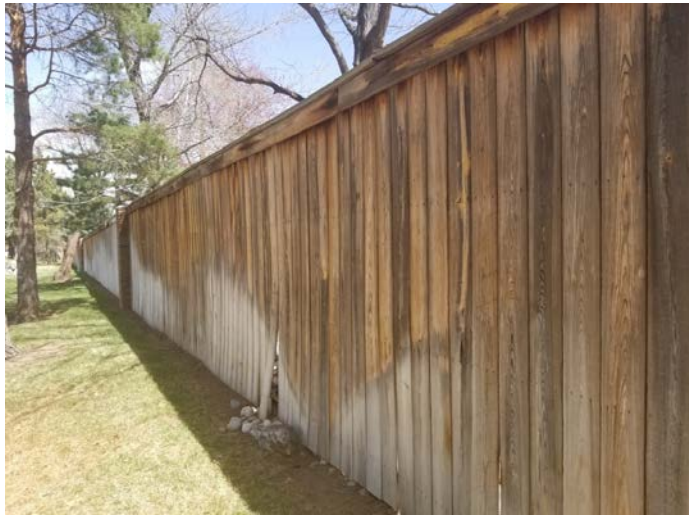
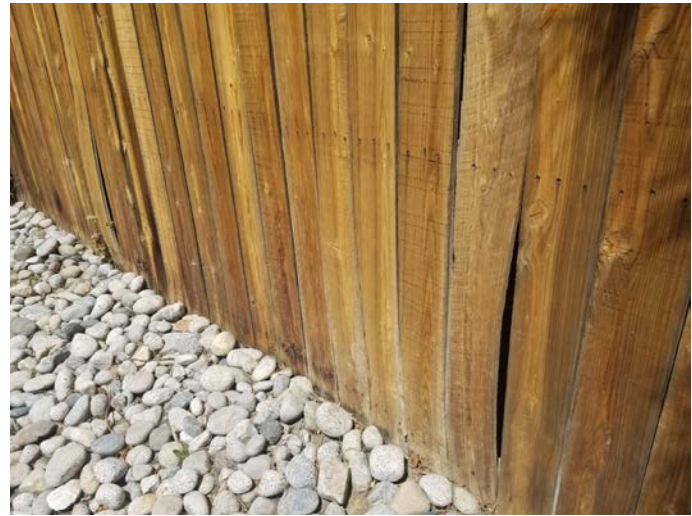
Comp #: 1001 Wood Fencing - Replace

- The replacement cycle is based on the observed quality of fence installed and the current condition.
- In our experience, fences that are stained on a periodic basis (every 3 - 4 years), have a replacement cycle of 20 - 25 years.
- This fencing is not stained and is in fair to poor condition throughout property.
- The remaining life is based on age of fence and observed conditions.

\$29/LF; Estimate to replace

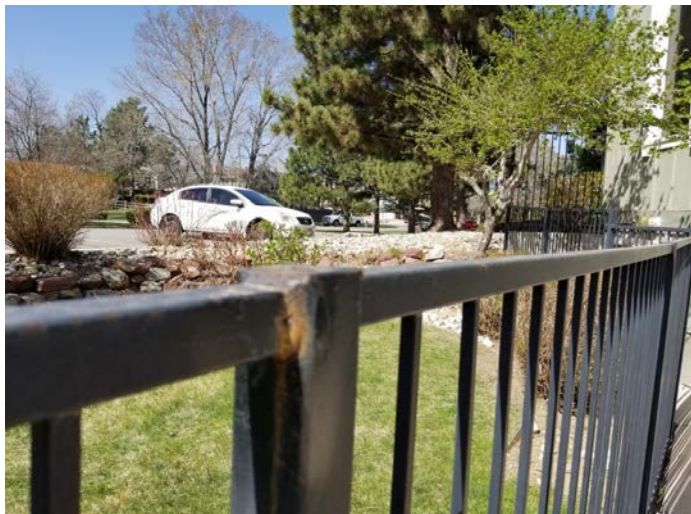
Comp #: 1002 Ironwork Fencing - Replace

- The average life expectancy for metal fences ranges between 25 - 30 years, depending on maintenance schedules and exposure to elements.
- The remaining life is based on age of fence and observed conditions.

\$45/LF; Estimate to replace

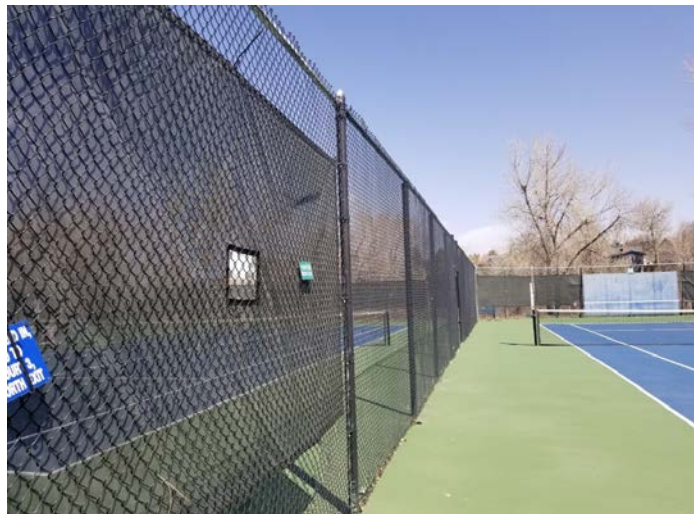
Comp #: 1003 Chain Link Fencing - Replace

- No warped or broken areas noted.
- Replacement for this fencing is included with tennis court replacement.
- Make local repairs as necessary as an operating issue.

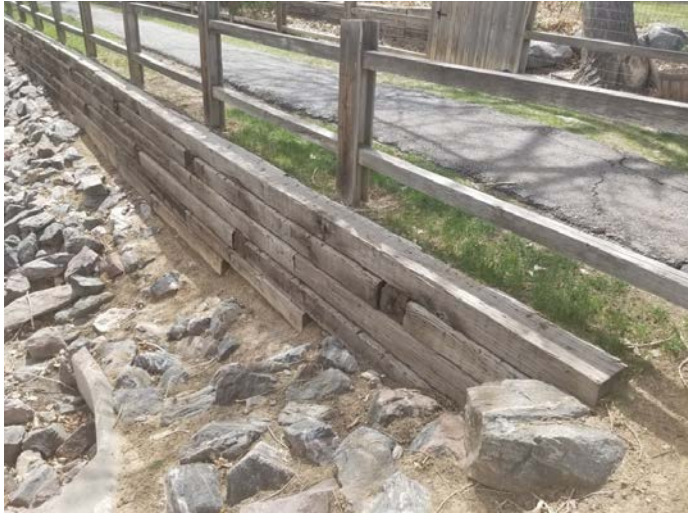
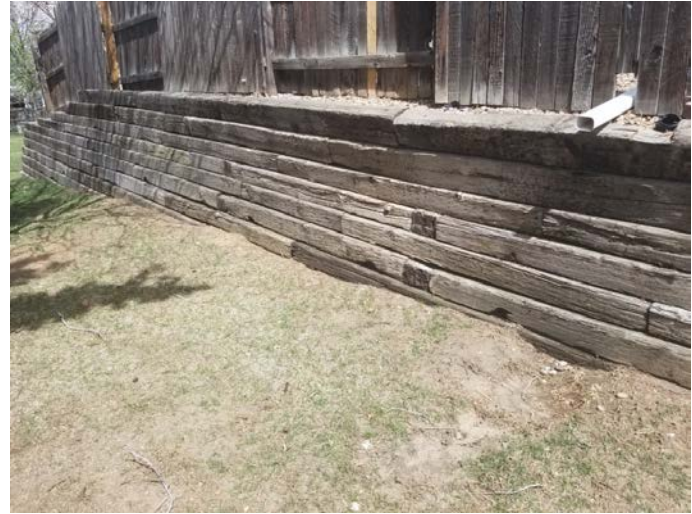
Comp #: 1007 Timber Walls - Major Repairs

- The top timber tends to become the first piece to deteriorate and need to be replaced.
- This type of wall also tends to be susceptible to movement and leaning.
- When replacement is necessary, most associations are converting to block wall for longer life expectancy and less maintenance.

Allowance for major repairs

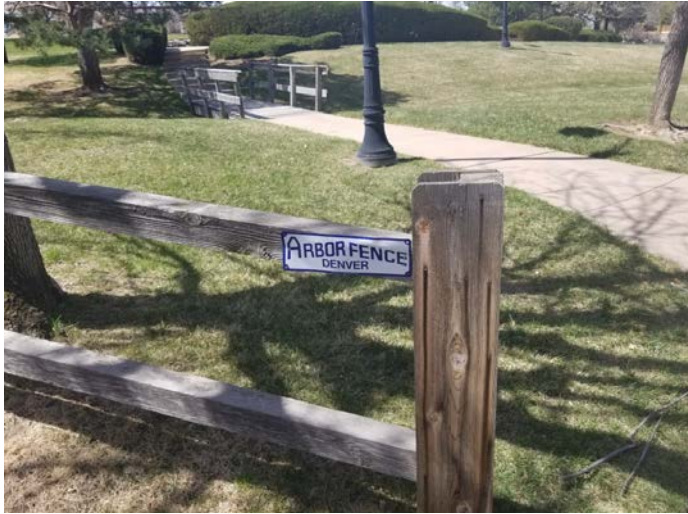
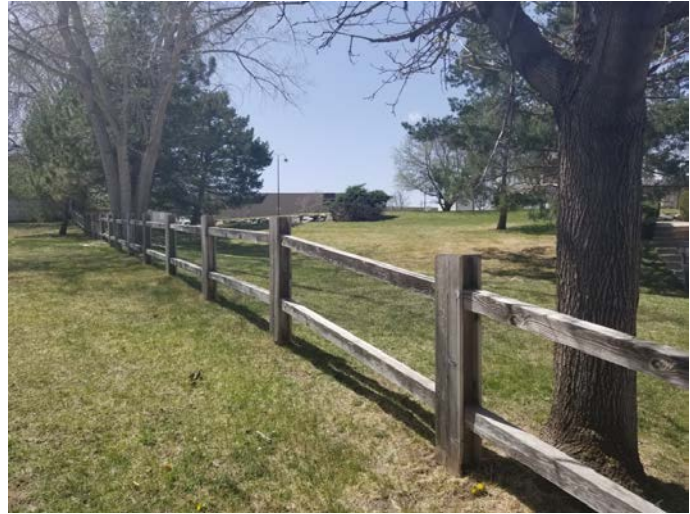
Comp #: 1009 Split Rail Fencing - Replace

- The split rail fencing was in fair condition at the time of the site observation, however, the wood is becoming very dry and starting to crack.
- These fences typically have a life expectancy of 15 - 20 years if properly maintained.
- Remaining life is based on the observed conditions.

\$20/LF; Estimate to replace with similar

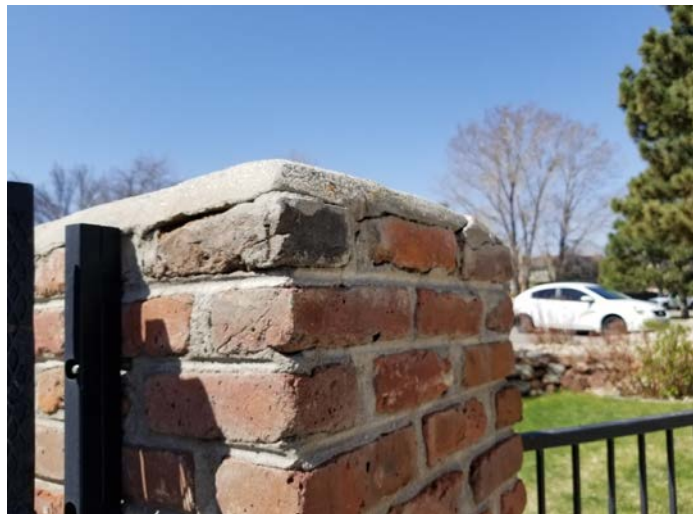
Comp #: 1014 Brick - Major Repairs

- The grout on many columns was beginning to deteriorate and there were significant signs of deterioration noted throughout the property.
- While it is unlikely that the entire wall and columns will need to be replaced at the same time, it is likely that major repairs will be necessary to replace loose or missing stones.
- Depending on the effects from elements, we suggest establishing a Reserve fund for periodic repairs to the wall every 5 years.

Allowance for minor repairs to brick columns

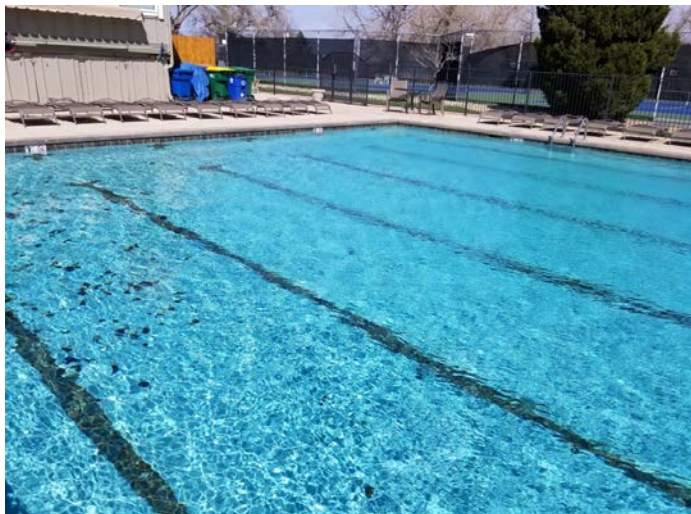
Comp #: 1101 Pool - Resurface

- Expect to resurface pool every 15 - 16 years depending on levels of maintenance and care.
- Due to a significant labor cost savings, we recommend reserving to replace perimeter tile and coping at the same time as resurfacing the plaster.

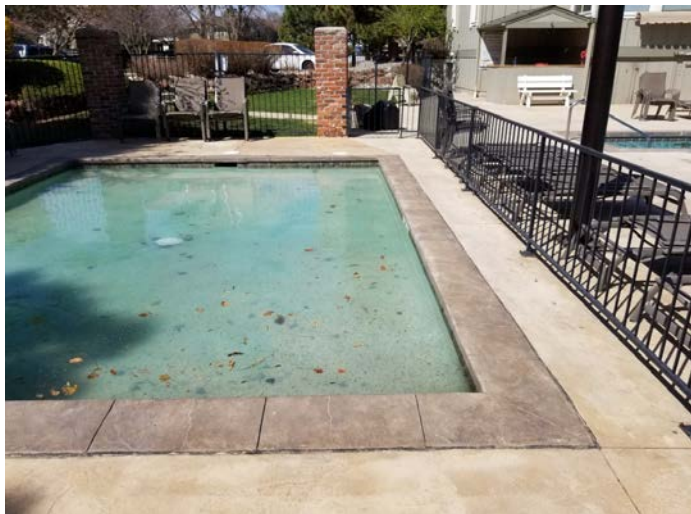
Comp #: 1103 Wader - Resurface

- This type of shallow wading pool typically requires resurfacing more frequently than a full sized pool because a higher concentration of chemicals and higher exposure to UV rays.
- In this capacity, we recommend resurfacing wading pools twice every pool resurface cycle.
- Remaining life is based on the pool resurfacing and observed conditions.

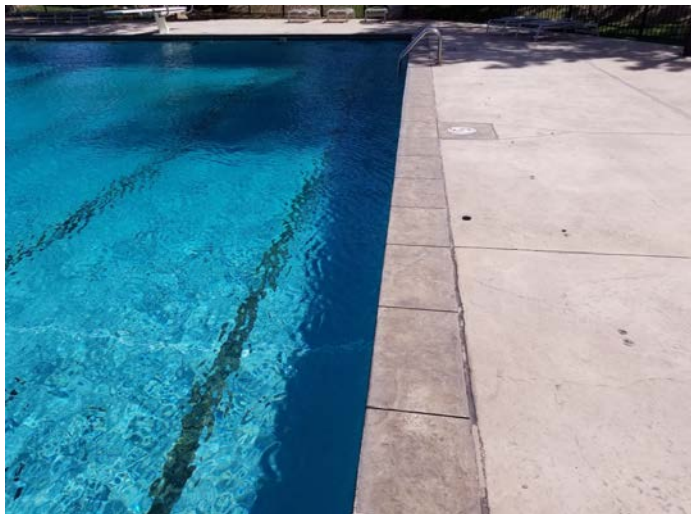
Comp #: 1104 Coping Stone / Tile - Replace

- It is typical to replace these materials every pool resurface cycle to receive the best costs possible.
- Remaining life is based on the age of the new pool area.

\$65/LF; Estimate to replace tile and coping stones

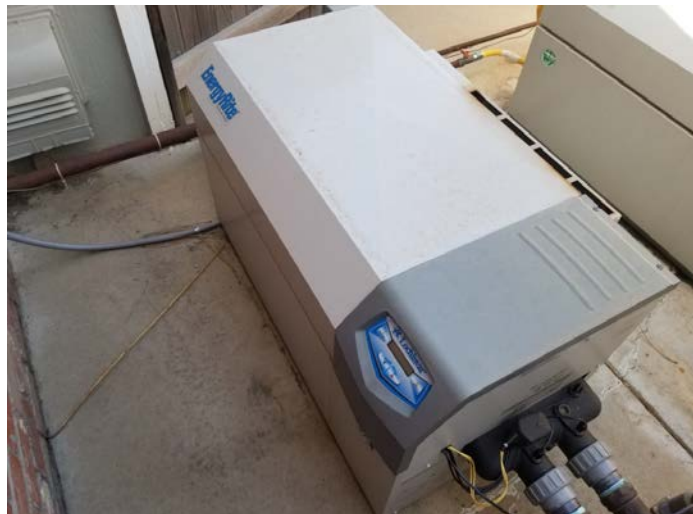
Comp #: 1105 Pool Heater - Replace

- The overall life expectancy depends on the level of maintenance and the quality of the water running through the system.
- For this type of heater, the average replacement cycle will range between 12 - 18 years with proper maintenance and under normal conditions.

\$5000/heater; Estimate to replace

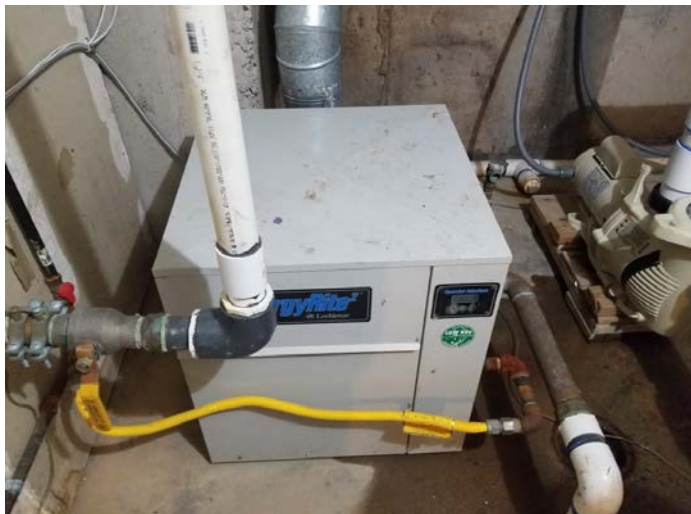
Comp #: 1107 Wader Heater - Replace

- The overall life expectancy depends on the level of maintenance and the quality of the water running through the system.
- For this type of heater, the average replacement cycle will range between 12 - 18 years with proper maintenance and under normal conditions.
- These pools typically have more chemicals that have a harsher impact on the equipment, therefore, the useful life is shorter than a pool heater.

Estimate to replace with similar size and type

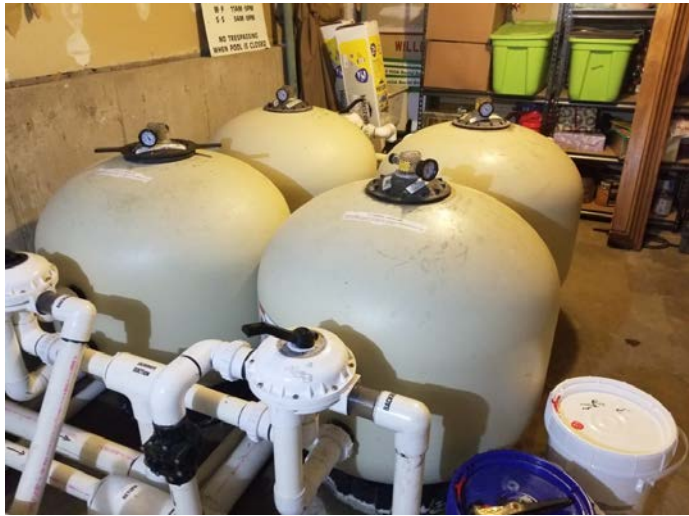
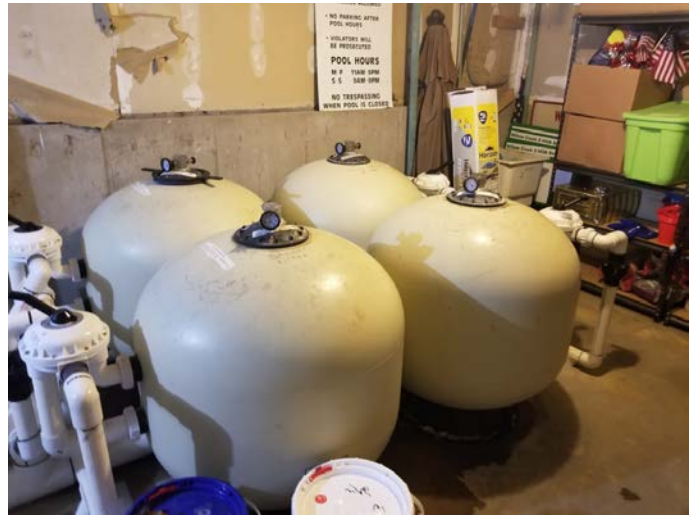
Comp #: 1108 Pool Filter - Replace

- The shell will have an extended useful life of 18 - 20 years and most leaks can be attributed to gaskets and seals that can be replaced on an as needed basis.
- Remove and replace filter sand on an as needed basis using operating funds.

\$1200/filter; Estimate to replace

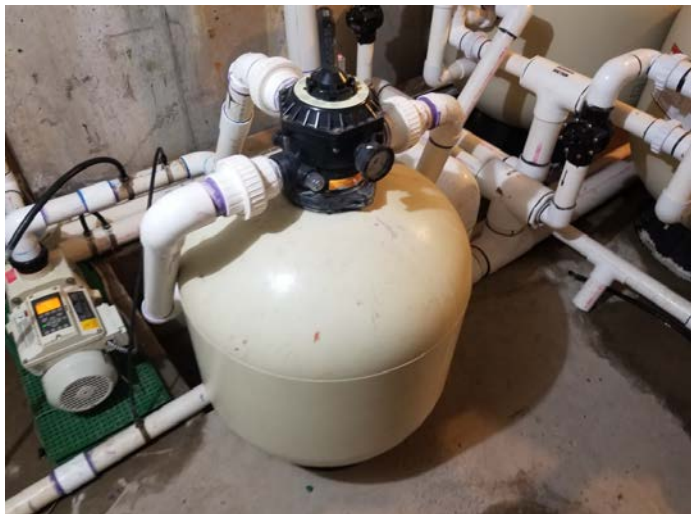
Comp #: 1109 Wader Filter - Replace

- The shell will have an extended useful life of 18 - 20 years and most leaks can be attributed to gaskets and seals that can be replaced on an as needed basis.
- Remove and replace filter sand on an as needed basis using operating funds.

Estimate to replace with similar

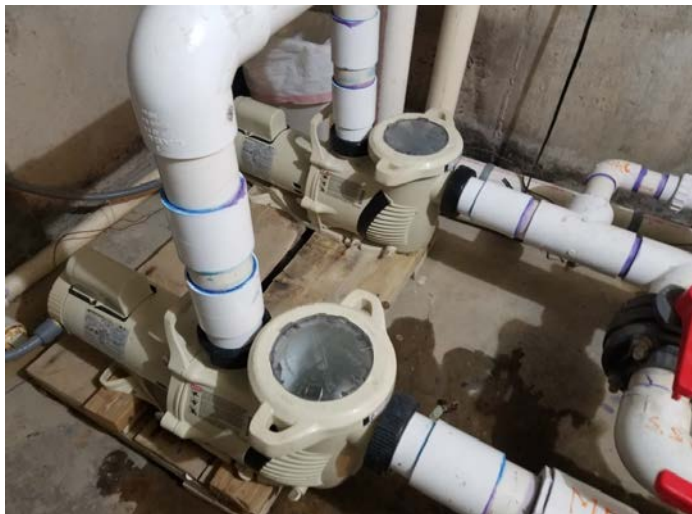
Comp #: 1111 Pool/Wader Pumps - Replace

- The life expectancy for this equipment can differ depending on the level of use and maintenance, as well as the quality of the equipment.
- Therefore, we suggest establishing an allowance for periodic replacement of the equipment.
- Meaning, this is just an allowance to provide the association some funds to replace equipment when required and should not be interpreted as complete replacement of all pumps every 5 years

Allowance for partial replacement every 5 years

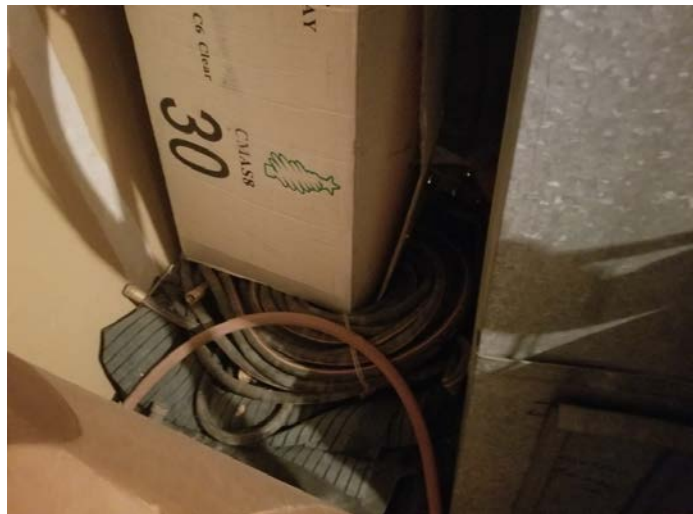
Comp #: 1113 Pool Cover - Replace

- Most pool covers come with a 10 year manufacturers warranty as long as the cover is being stored according to their specific guidelines; check with your pool manufacturer to ensure you are properly storing your pool cover.
- If properly stored and properly maintained, we recommend reserving to replace the pool cover every 10 - 12 years.

\$2.50/GSF; Estimate to replace (>2000 GSF)

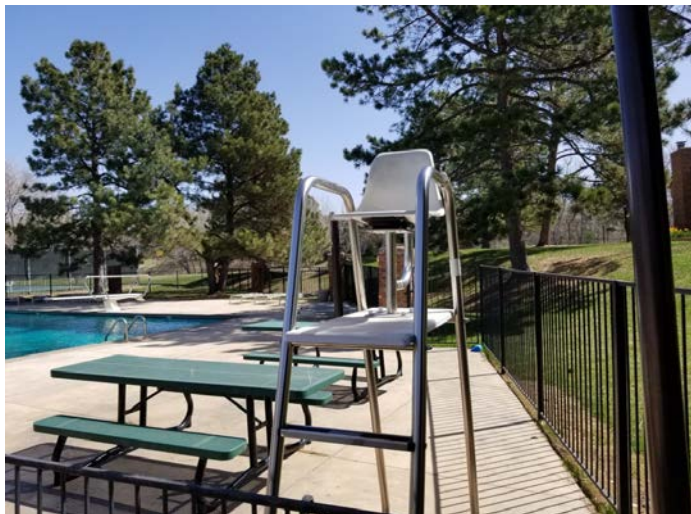
Comp #: 1118 Lifeguard Stand - Replace

- The lifeguard stand was in good to fair condition at the time of the site observation.
- Expect a useful life of 8 - 10 years from this stand.
- Remaining life is based on the observed conditions and age of the stand.

Estimate to replace with similar

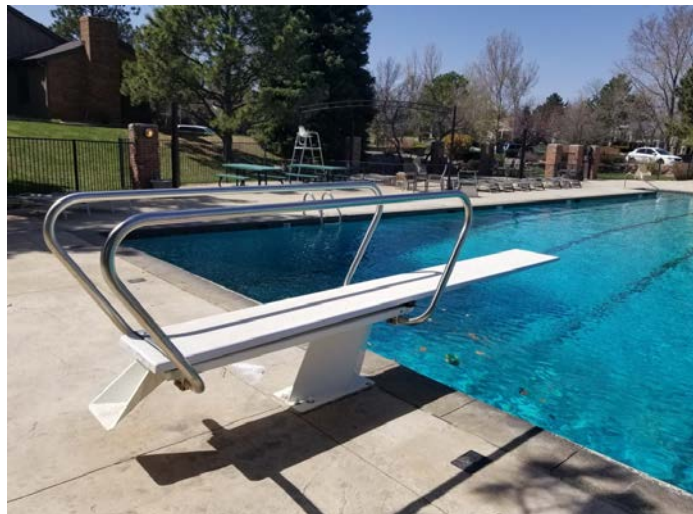
Comp #: 1119 Diving/Starter Boards - Replace

- Diving board appeared to be in good condition at the time of the site observation.
- The estimated cost includes replacement of the hand bars and platform.

Estimate to replace

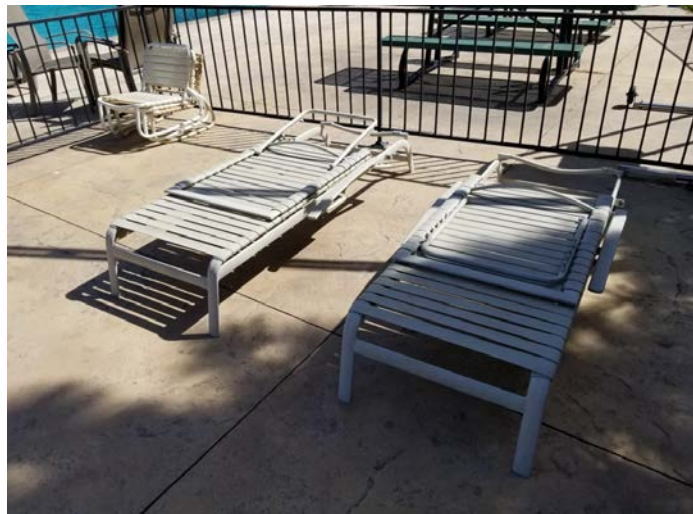
Comp #: 1121 Pool Furniture - Replace (1)

- The average replacement cycle for furniture ranges between 5 - 8 years, depending on the quality of the furniture and the level of use/abuse.
- We suggest storing the furniture inside during non-use seasons for best results and to achieve full life expectancy.

\$175/Piece; Estimate to replace pool furniture

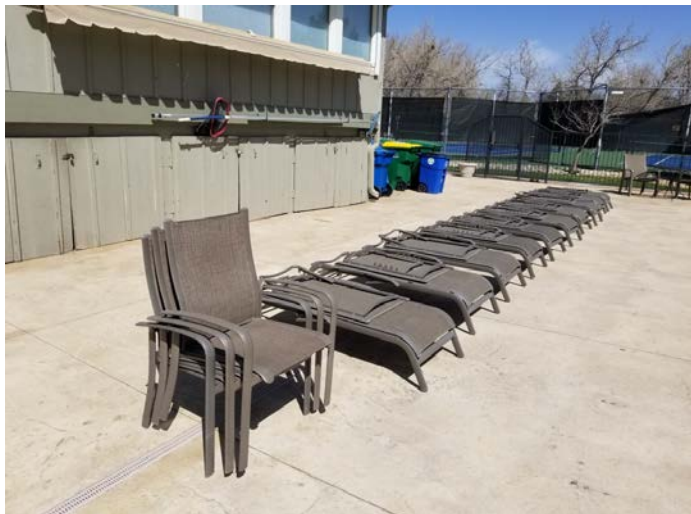
Comp #: 1122 Pool Furniture - Replace (2)

- The average replacement cycle for furniture ranges between 5 - 8 years, depending on the quality of the furniture and the level of use/abuse.
- We suggest storing the furniture inside during non-use seasons for best results and to achieve full life expectancy.

\$175/Piece; Estimate to replace pool furniture

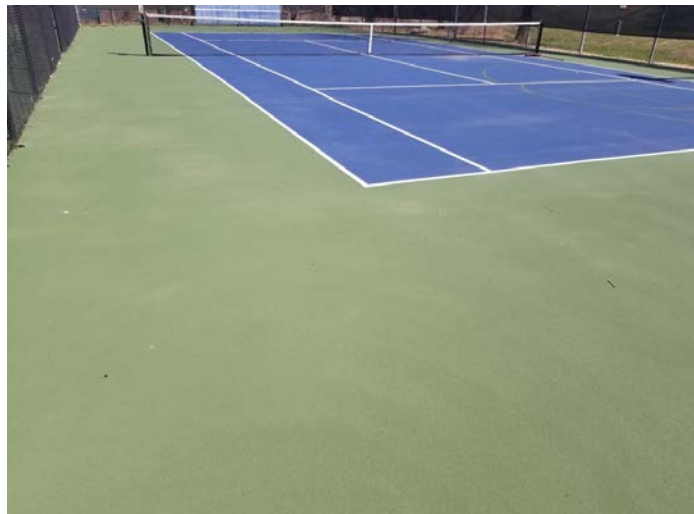
Comp #: 1201 Tennis Court - Replace

- Asphalt tennis courts do not hold up to weather elements in this climate, and asphalt tends to crack very frequently and is a constant maintenance issue.
- It is recommended that the courts be replaced with post tension concrete, and we recommend this happen as soon as possible.
- The association has decided to wait to replace the courts until 2022. We have adjusted the remaining life of the tennis courts to 3 years per their request.

\$60,000/court; Est. to replace with post tension

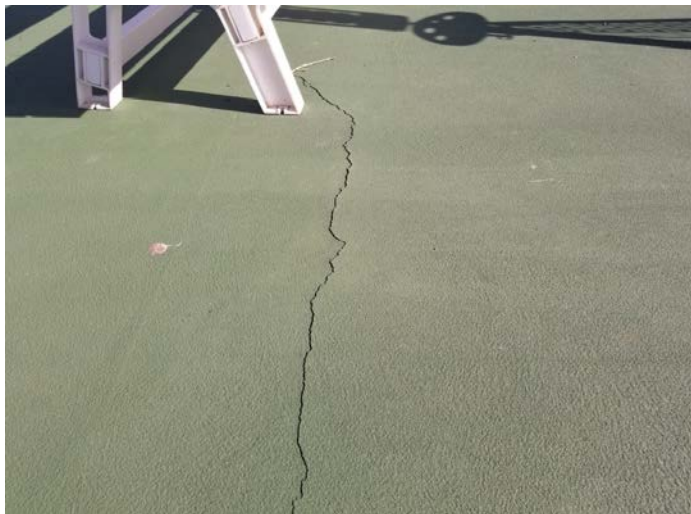
Comp #: 1202 Tennis Court - Recoat/Paint

- The association is planning on replacing these courts with post-tension concrete in 2022.
- Post-tention concrete will also need to be repainted every 5 - 7 years. Some repairs may be necessary as well at this time.
- Remaining life is based on the timing of the court installation.

\$8500/court; Est. to crack fill, repaint/coat

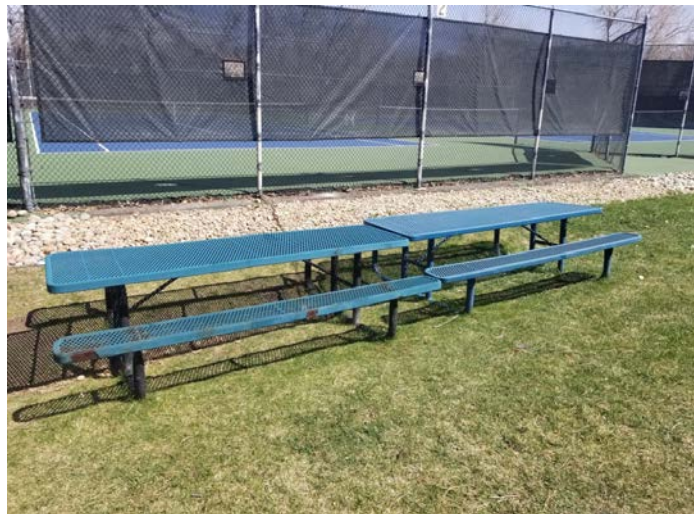
Comp #: 1306 Park Furnishings - Replace

- Expect to replace park equipment approximately every 16 years to maintain appearance.
- Remaining life based on assumed age and observed conditions.

Allowance for partial replacement
