**Willow Creek III HOA  
8091 E. Phillips Cir.  
Centennial, CO. 80112**

**Level 2, Platinum Reserve Analysis  
Report Period – 01/01/19 – 12/31/19**

**FINAL  
Version**

**Report was prepared on - Wednesday, August 29, 2018**

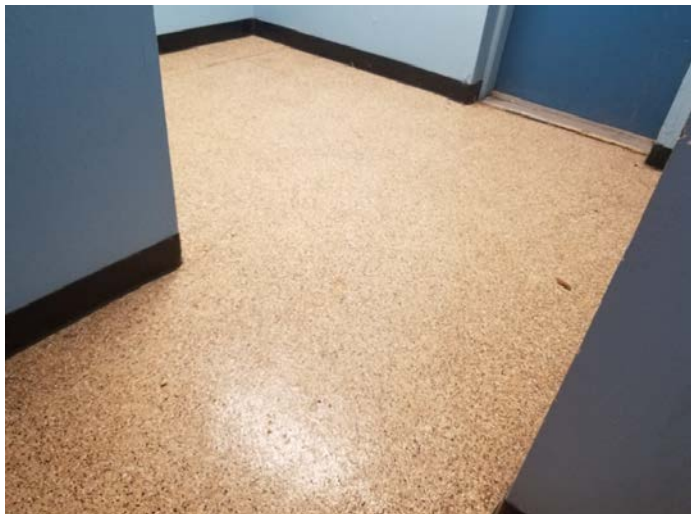
Comp #: 1506 Lower Level Flooring - Recoat

- There were some cracks noted in the floor of the lower level at the clubhouse.
- We recommend recoating this type of flooring every 10 years.
- Remaining life is based on the observed conditions and age.

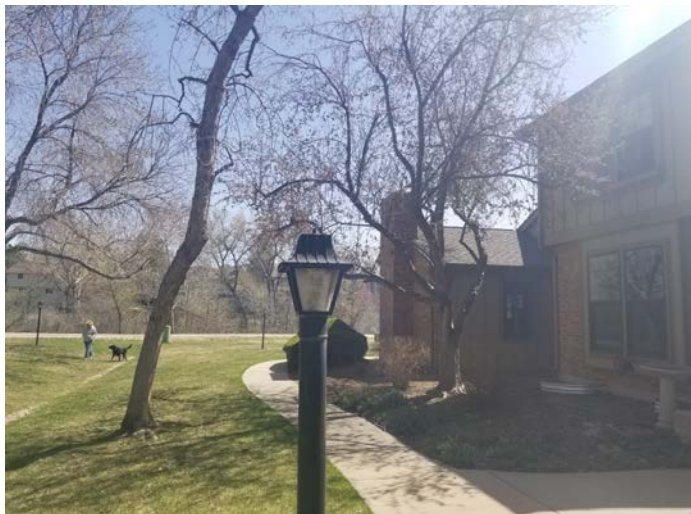
Comp #: 1604 Pole Lights - Replace

- It was reported by the association in the last Reserve Study that these lights will be replaced on an as needed basis with general operating funds.
- Therefore, Reserve funding is not required for this component.

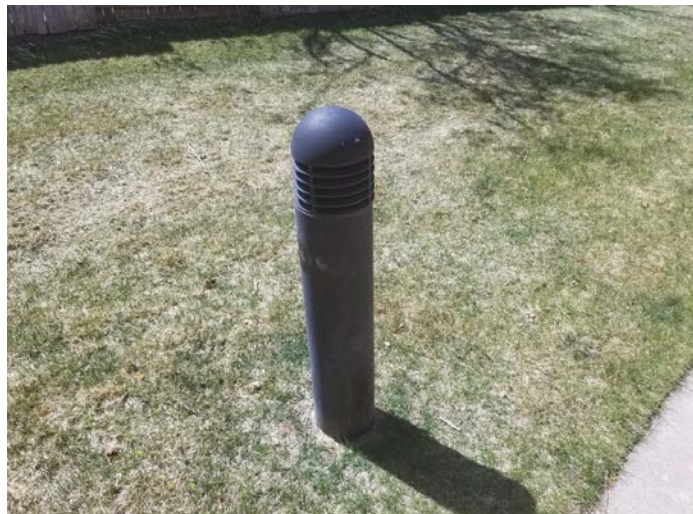
Comp #: 1605 Bollard Lights - Replace

- It was reported by the association in the last Reserve Study that these lights will be replaced on an as needed basis with general operating funds.
- Therefore, Reserve funding is not required for this component.

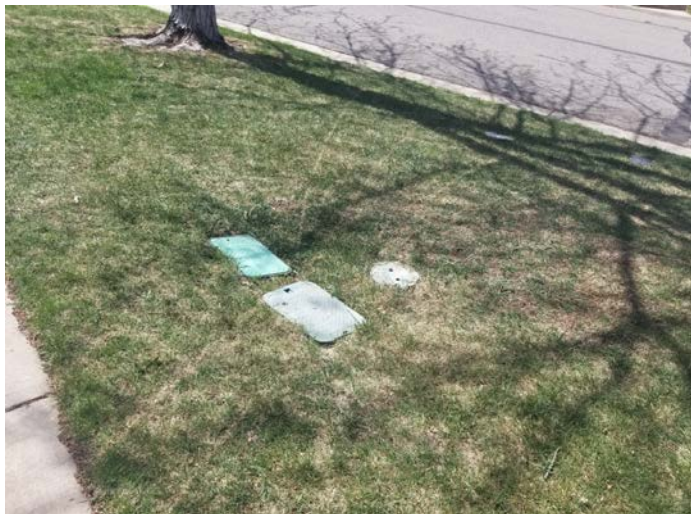
Comp #: 1701 Irrigation System - Rebuild

- This line item is for repairs and replacement that lies outside the scope of routine maintenance: bulk sprinkler head replacement, bulk valve replacement, rerouting lateral lines, rewiring, etc.
- In order to ensure the funds are available for major repairs, we recommend reserving funds for these projects every 4 - 5 years.
- The funding on this line item is for major repairs and is not to be interpreted as complete irrigation system replacement.

Estimate for major repairs and renovating system
