Level 2, Platinum Reserve Analysis

Willow Creek III HOA
8091 E. Phillips Cir.
Centennial, CO. 80112

FINAL VERSION

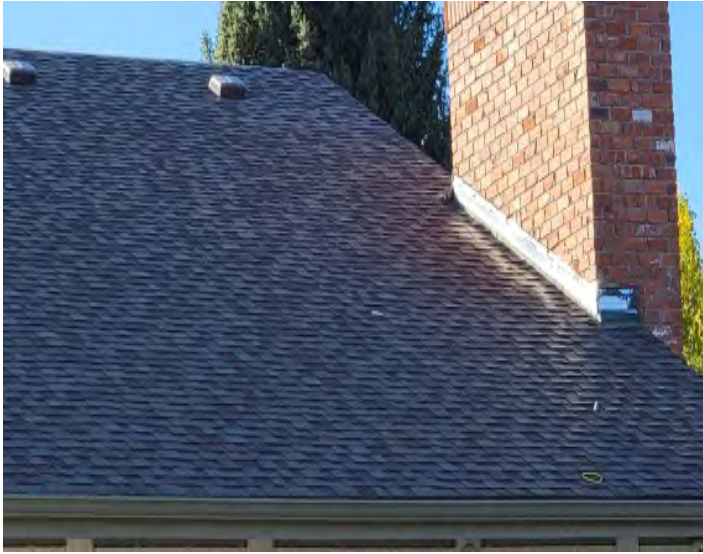
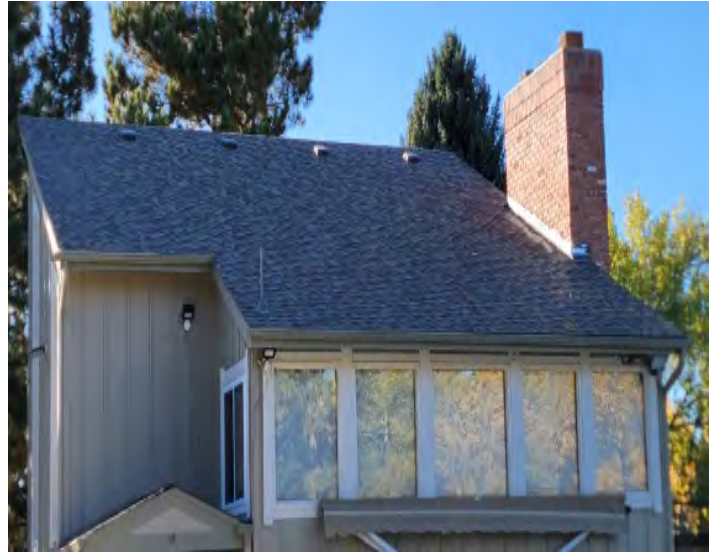
Comp #: 105 Comp Shingle Roof - Replace

- It was reported that the roof was installed in 2015. No reported problems, deterioration looks consistent with roofs 8-10 years old.
- It appears this roof material is rated as a 30 - 40 year product. Despite this rating, a life expectancy of 18 - 20 years is expected in this environment.
- Due to the potentially harsh winters, extensive freeze/thaw cycle, and likelihood of hail events over the useful life of the roof, we typically see associations replacing roofs sooner than the manufacturer's suggested useful life.
- Remaining life is based on age of roof and observed conditions.

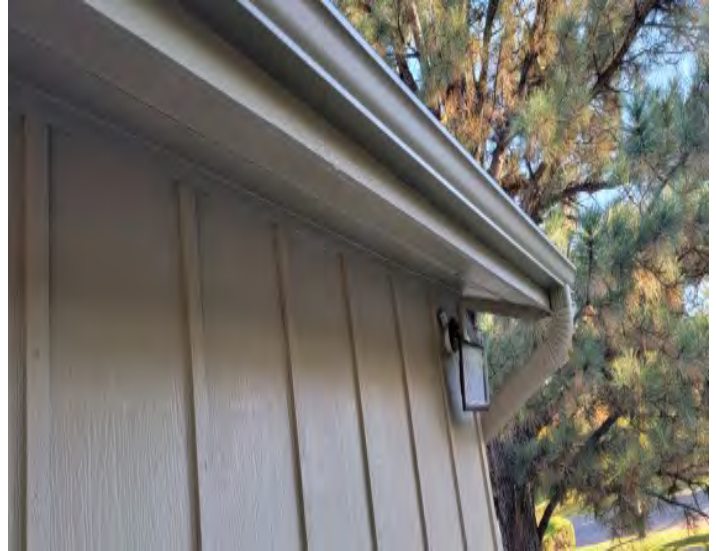
Comp #: 120 Gutters/Downspouts - Replace

- Lines are clogged with pine needles.
- We recommend removing debris at least twice a year to prevent clogging and moisture retention that can cause deterioration.
- Due to the small quantity of rain gutters and downspouts, we recommend replacing as needed with operating funds.

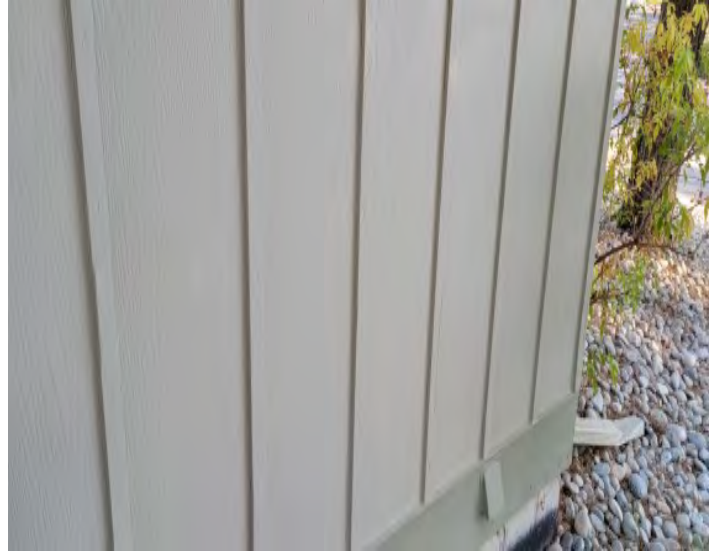
Comp #: 204 Building Ext Surfaces - Repaint

- The last time it was reported the building was painted was in 2015. However, at the time of recent site visit, paint looked fresh and in very good condition if in fact it hasn't been painted for 7 years.
- In this climate, it is recommended that exterior surfaces are painted every 5 - 7 years.
- However, as a result of the observed condition and the age of the paint (7+ years old?), we have extended the painting cycle to 10 years, and adjusted the remaining life accordingly.
- The exact timeframe depends on the color chosen and the level of exposure to elements, as well as the quality of past paint jobs.
- The remaining life is based on the observed conditions.

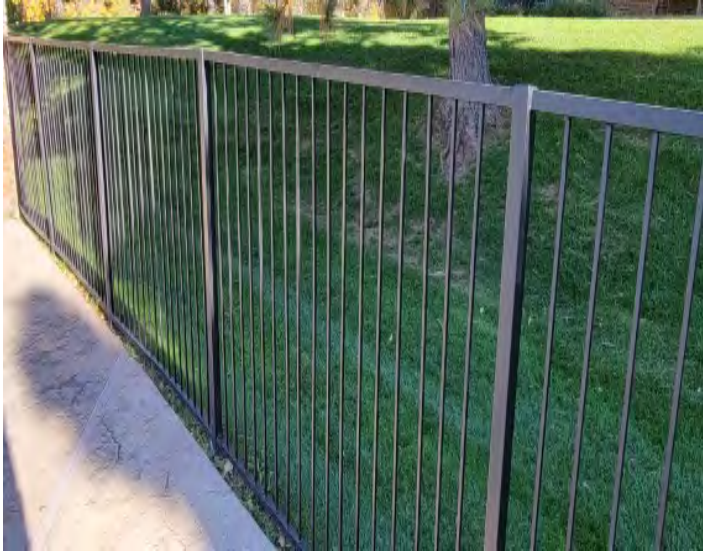
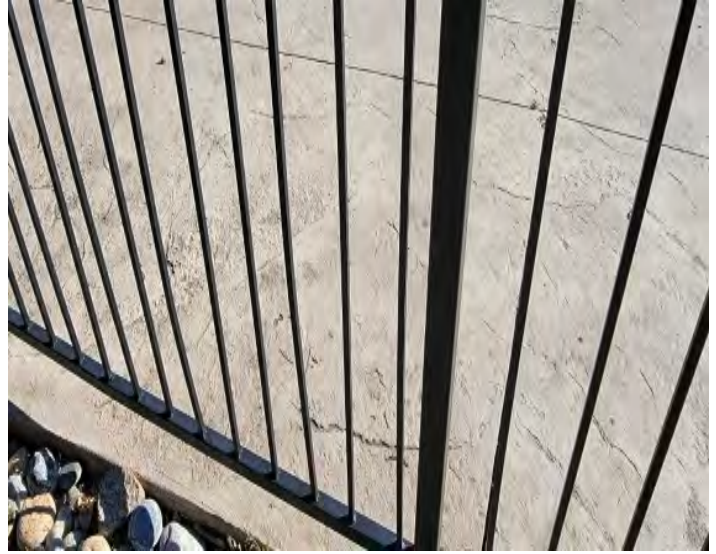
Comp #: 207 Iron Fencing - Repaint

- Paint is faded, but no signs of chipping or flaking paint was noted. No major corrosion was noted either.
- In this climate, we recommend repainting this component every 3 - 4 years to maintain appearance and protect metal surfaces.
- Remaining life based on current condition.
- We suggest coordinating with other painted surfaces for best cost possible.

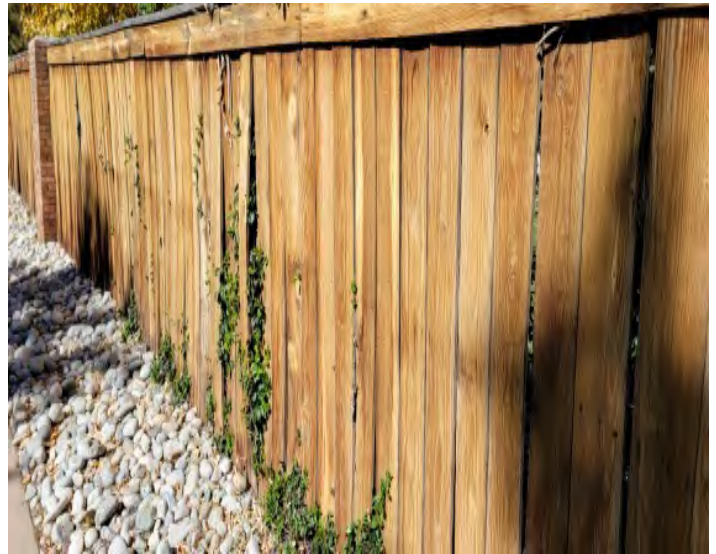
Comp #: 209 Wood Fencing - Restain

- Fence remains as raw materials and not sealed or stained.
- As long as the fence remains unprotected (not sealed), Reserve funding is not required for this component.
- By staining the fence, the replacement cycle may be extended by 5 - 10 years.
- Some associations have the opinion it is not worth the expense to extend the life by only 5 - 10 years.
- Additional benefits to staining include maintaining a proper appearance for the community (no water staining, warped and split boards, etc.).
- If association decides to stain the fence, expect to spend about \$15,000 - \$18,000 every 3 - 4 years.

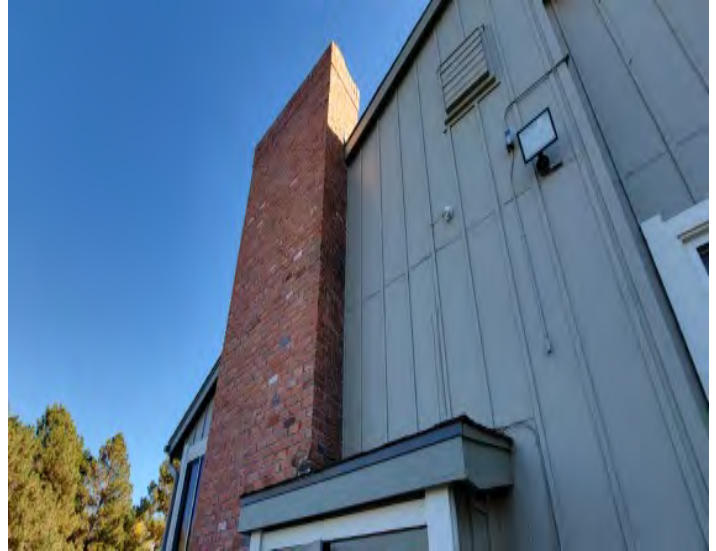
Comp #: 301 Clubhouse Siding - Replace

- Materials are still in fair condition at the time of the site observation with minimal signs of advanced deterioration noted. Association has been maintaining the building well.
- Typically, this material has a life expectancy of 25 - 30 years. However, due to following proper paint cycles, we have extended the life
- When replacement is required, some associations are deciding to upgrade to a material (fiber cement) that has a longer life expectancy.

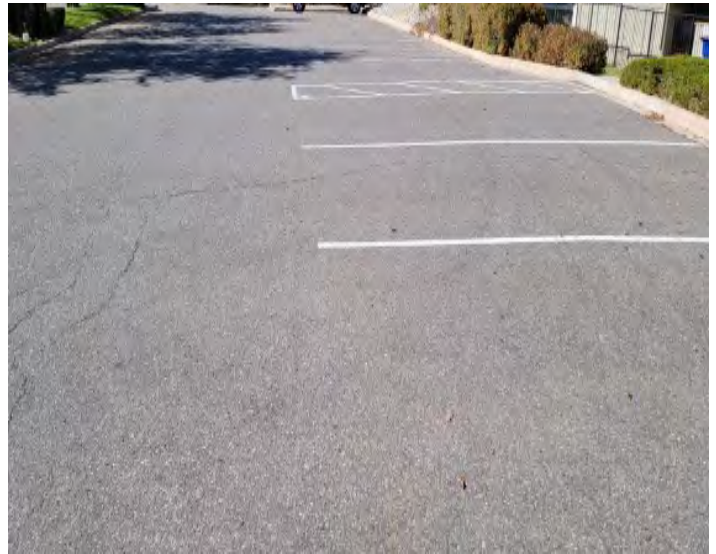
Comp #: 401 Asphalt - Overlay

- Cracks are starting to form in the northeast corner of the parking lot. This area should get repaired with an infrared patch this year before this worsens.
- The average life expectancy for asphalt surfaces ranges between 20 - 27 years for surfaces that are maintained on a regular schedule.
- Maintenance includes crack fill and repairing small potholes annually as an operating expense.
- In addition, asphalt should be seal coated every 3 - 4 years, depending on the level of traffic and snow removing techniques.

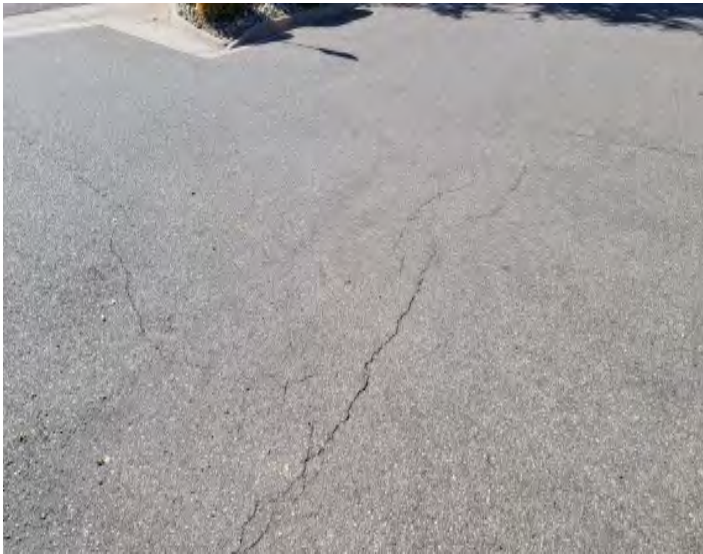
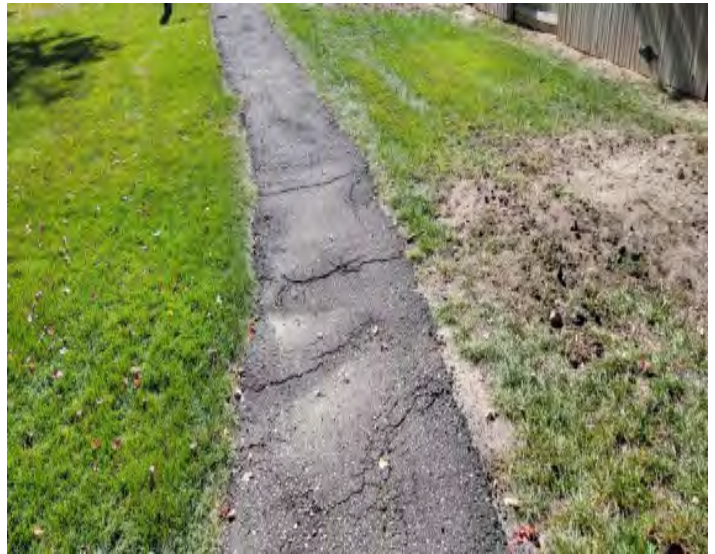
Comp #: 402 Asphalt - Seal Coat/crack fill

- In this environment, expect to seal asphalt every 2 - 4 years, depending on traffic levels and effects from weather.
- The clubhouse parking lot has not been sealed since the overlay in 2012, so it is possible the association does not see a benefit in spending the money to extend the life of the parking lot.
- It is unknown if the pathways have been sealed recently, but many areas need to be replaced due to tripping hazards. It is also unknown if pathways will be replaced with concrete or asphalt.
- Sealcoating is applied to protect the asphalt from ultra-violet rays and water.
- This helps in slowing the process of oxidation and raveling.
- While acting as a protective barrier, it also maintains the appearance of the community to maintain or improve property values.

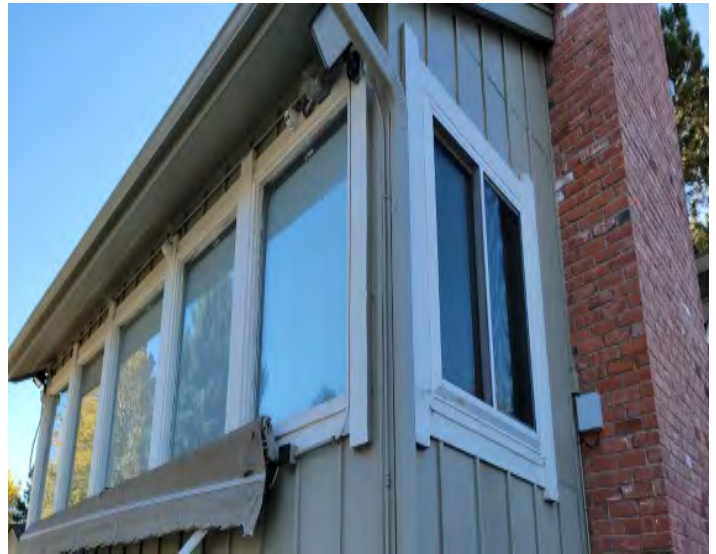
Comp #: 506 Doors/Windows - Partial Replacement

- Conditions and types of windows/doors vary throughout the building. No reported problems with recent leaks or observed conditions with fogging windows due to broken seals
- Based on the expense history, it does not appear that all windows and doors were replaced.
- Therefore, due to varying ages, we have included an allowance for partial replacement of windows and doors every 10 years.

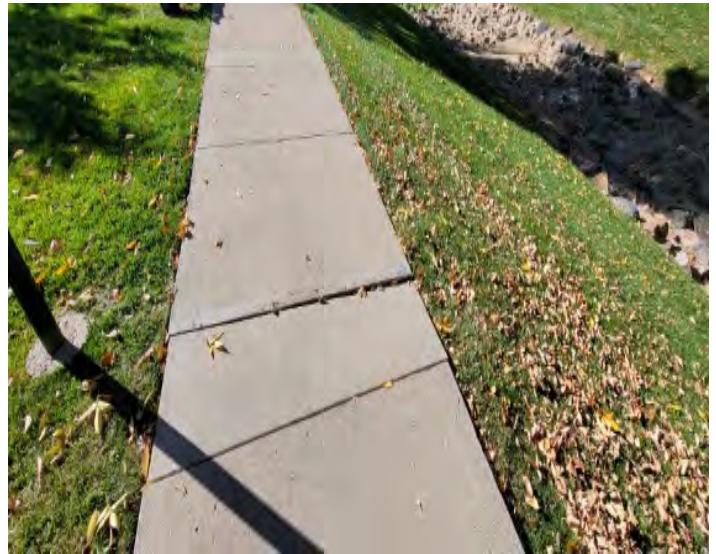
Comp #: 601 Concrete Flatwork - Repair

- A few repairs have been completed, but there are still many areas that have trip hazards.
- Similar to other concrete surfaces, it is unlikely that all concrete surfaces will fail and need to be replaced at the same time.
- Therefore, we suggest establishing a Reserve fund for frequent repairs and replacement to a percentage of the area (5% or 3,725 GSF) every 3 years.
- Coordinate repairs with other concrete surfaces for best cost estimate.

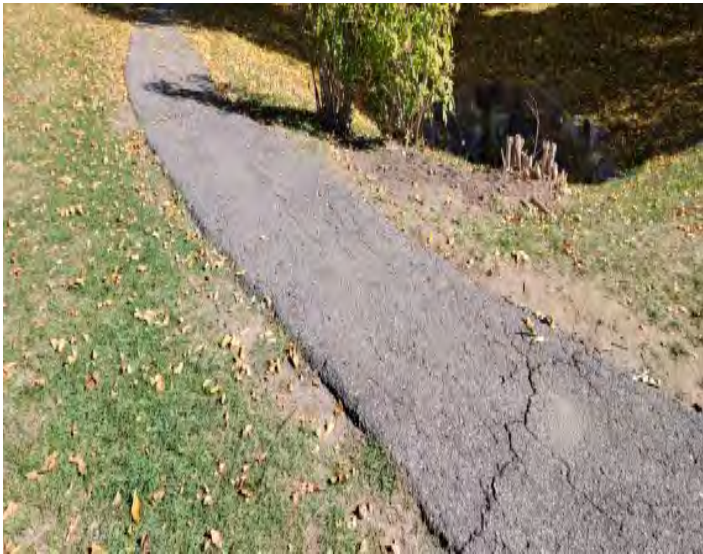
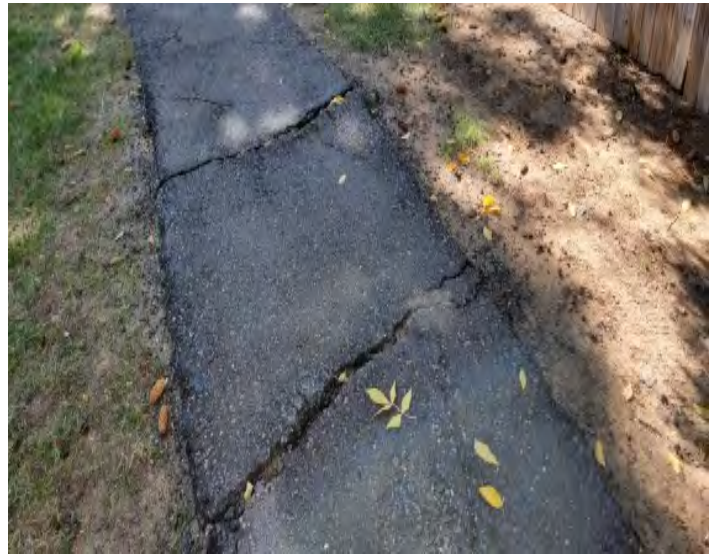
Comp #: 603 Asphalt Paths - Partial Replacement

- In general, the majority of the paths are cracked, lifted, and in poor condition with many trip hazards noted throughout.
- When replacement occurs, we recommend replacing sections with concrete for less maintenance, and easier process to make repairs, or replace sections when necessary.
- Based on observed conditions, we recommend making repairs this year.
- If areas are replaced with concrete, we will move those areas to the concrete line item (component #601)

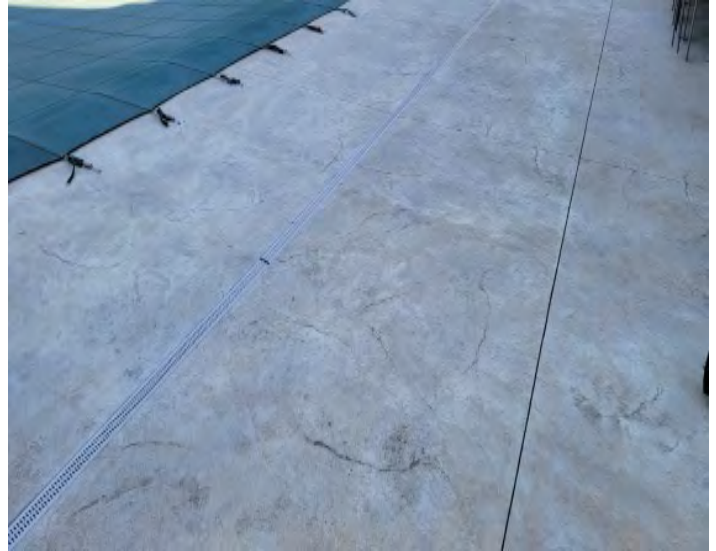
Comp #: 608 Pool Deck - Replace

- There are no signs of deterioration, cracking, or spalling noted at time of site observation.
- Concrete is a custom design with dyed concrete and a stamping. Due to the special design and colored concrete, it is nearly impossible to match repairs to the older
- While periodic repairs will be necessary, we recommend replacing every 30 - 35 years to maintain an appropriate appearance for the community.
- Remaining life is based on the age of the concrete and observed conditions.

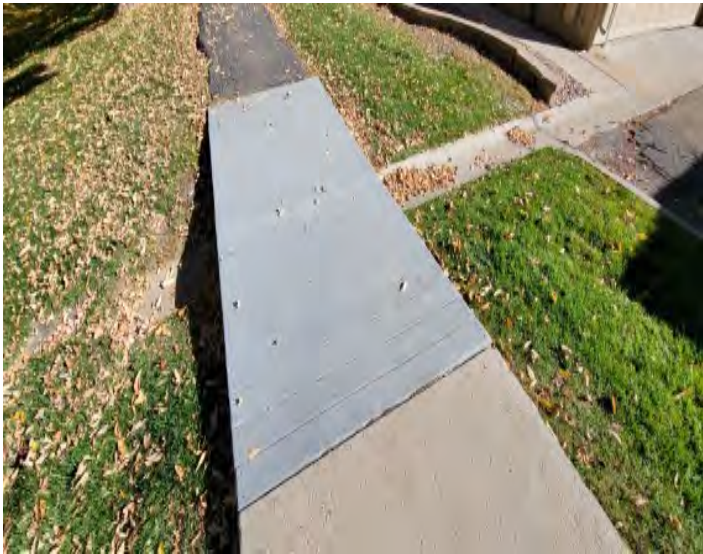
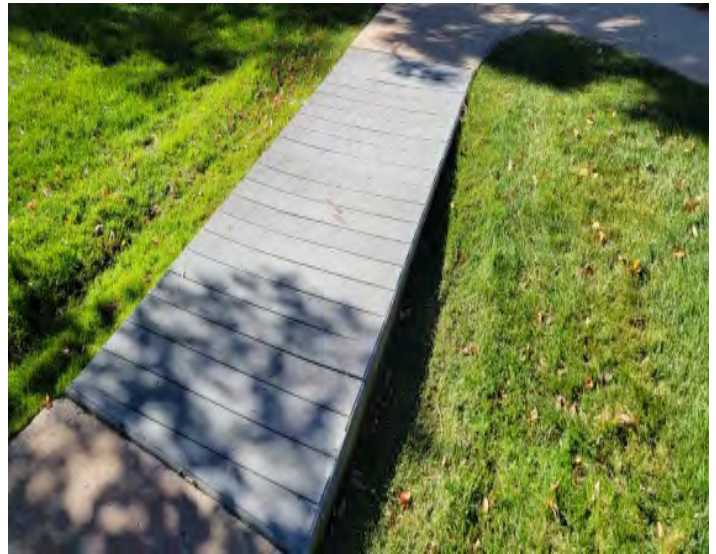
Comp #: 609 Composite Bridges - Replace

- It was observed that the base materials are rotted and the center of the bridge at 8191 and 8172 are sagging. Other bridges are not as bad, but all are nearing the end of the life expectancy.
- Most composite material manufacturers offer a 25 year limited warranty from against defects.
- However, over a period of time, the material begins to fade and scratch and eventually will become aesthetically unpleasing.
- Therefore, due to the level of use and exposure to the elements, we recommend establishing a replacement cycle of 18 - 22 years.
- We recommend replacing the rail and material at the same time.

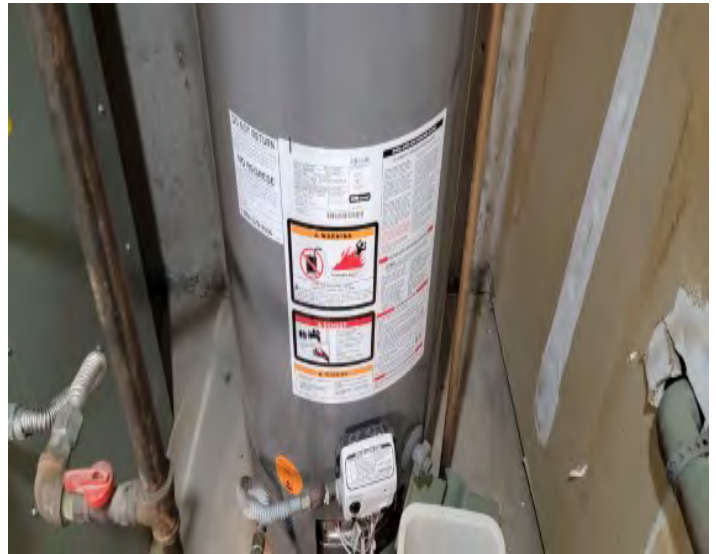
Comp #: 703 Hot Water Heater Tank - Replace

- Heater was functioning well without any issues of heating up water.
- Joints and connections were in good shape and free from significant rusting and corrosion.
- Depending on the level of use and the quality of the water running through the system, expect a useful life of 12 - 15 years from water heaters with proper maintenance and care.

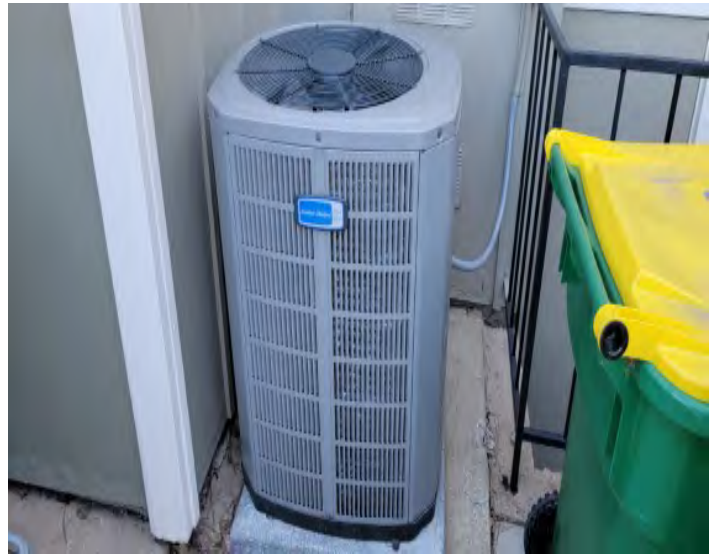
Comp #: 705 HVAC System - Replace

- System was replaced in 2018 and was working well with no reported issues with system.
- No reported problems with operation of units. In our experience, we have seen the need to replace these units every 18 - 25 years, depending on the level of use and maintenance.
- Most clubhouses that are used heavily, like this one, can expect a shorter life expectancy under normal conditions.

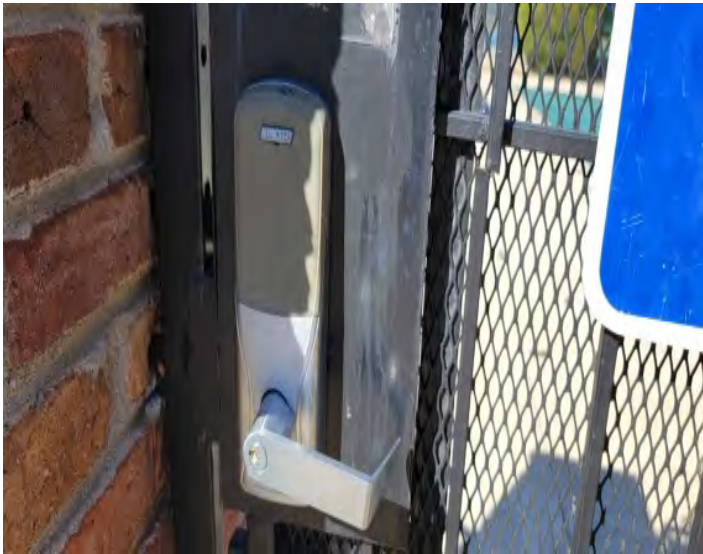
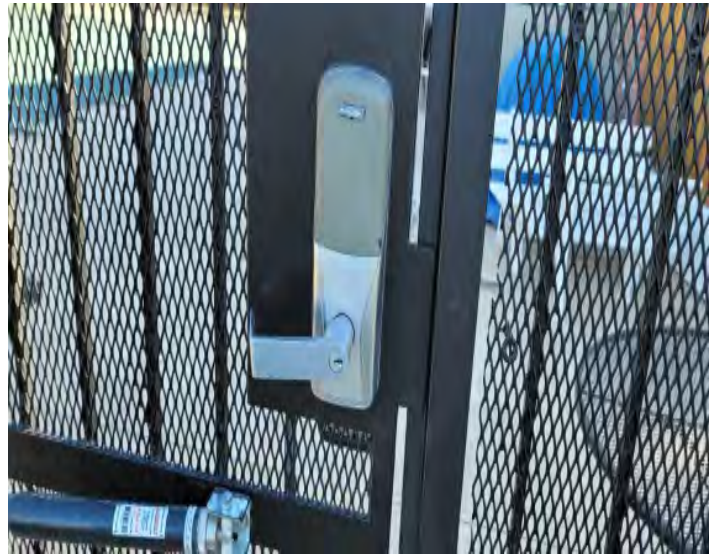
Comp #: 908 Access System - Replace (Pool)

- Pool system was installed in 2016 and assumed to be in good working condition. New locks (same manufacturer, same technology) were installed at the tennis courts when the courts and fences were replaced.
- While the system will continue to serve the security measures for the building, upgrades to systems will be required every 10 - 12 years due to advancement in technology.
- The remaining life is based on the fact that there are no current problems with the system and there are no plans for immediate replacement.

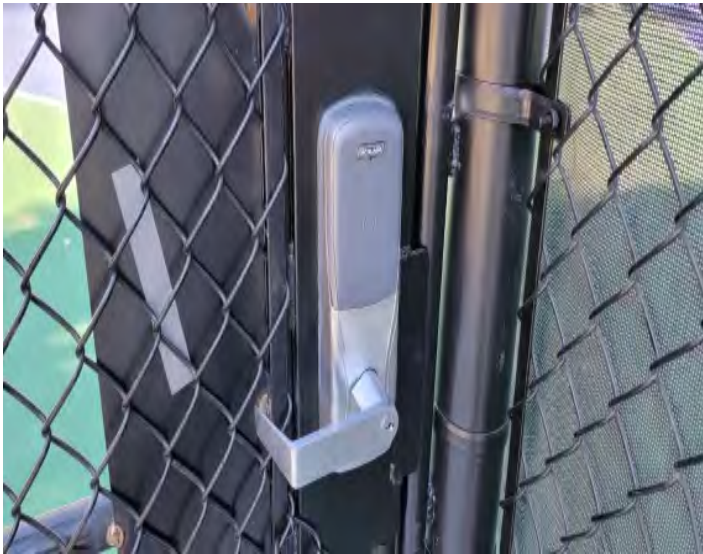
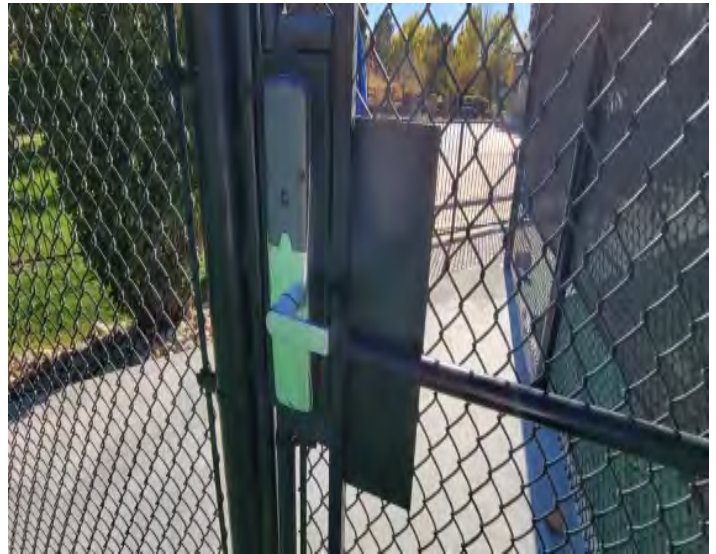
Comp #: 908 Access System - Replace (Tennis)

- New locks (same manufacturer, same technology as pool) were installed at the tennis courts when the courts and fences were replaced.
- While the system will continue to serve the security measures for the building, upgrades to systems will be required every 10 - 12 years due to advancement in technology.
- The remaining life is based on the new locks that were installed in 2022.

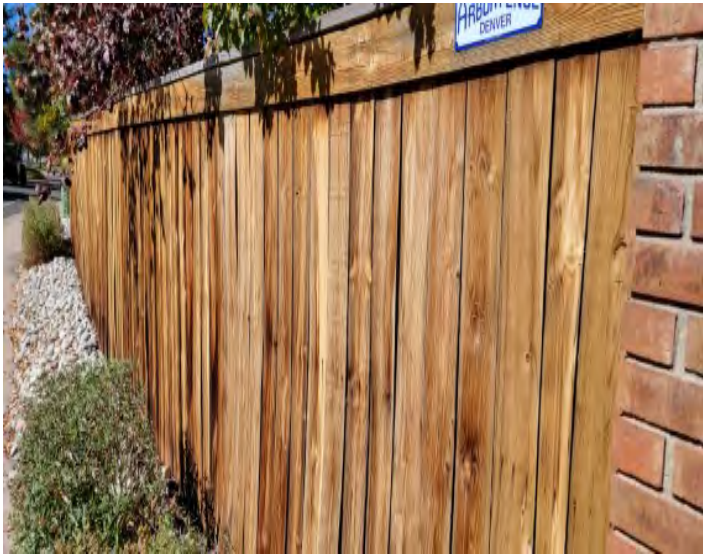
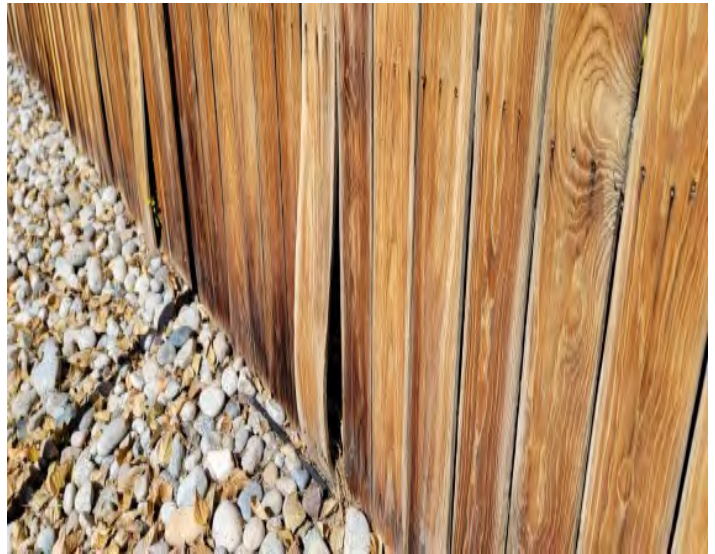
Comp #: 1001 Wood Fencing - Replace

- The replacement cycle is based on the observed quality of fence installed and the current condition.
- In our experience, fences that are stained on a periodic basis (every 3 - 4 years), have a replacement cycle of 20 - 25 years.
- This fencing is not stained and is in fair to poor condition throughout property.
- The remaining life is based on age of fence and observed conditions.
- Association has received bids to replace the fencing, with an option to upgrade to Trex fencing. Estimates are based on replacing with wood fence. If association decides to upgrade to Trex, then the cost difference (\$106,000 to \$250,000) would need to come from a separate source other than the Reserve account.

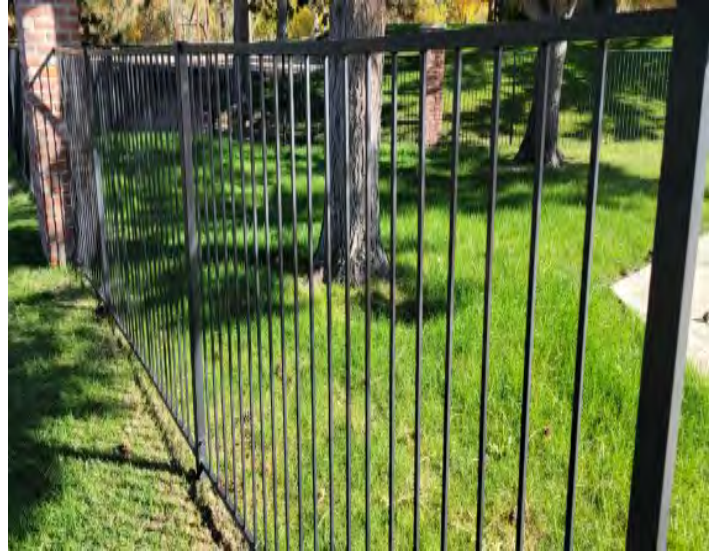
Comp #: 1002 Ironwork Fencing - Replace

- No significant signs of rust or corrosion noted during site evaluation. Fence appeared to be sturdy in sections that were tested.
- The average life expectancy for metal fences ranges between 25 - 30 years, depending on maintenance schedules and exposure to elements.
- We have extended the useful life and the remaining life based on observed conditions.

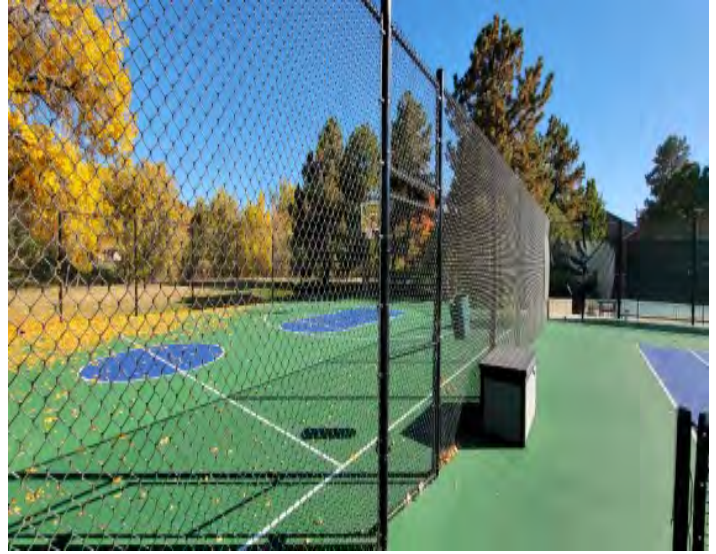
Comp #: 1003 Chain Link Fencing - Replace

- New fencing installed in 2022 when courts were replaced. No unusual conditions noted.
- Replacement for this fencing is included with tennis court replacement.
- Make local repairs as necessary as an operating issue.

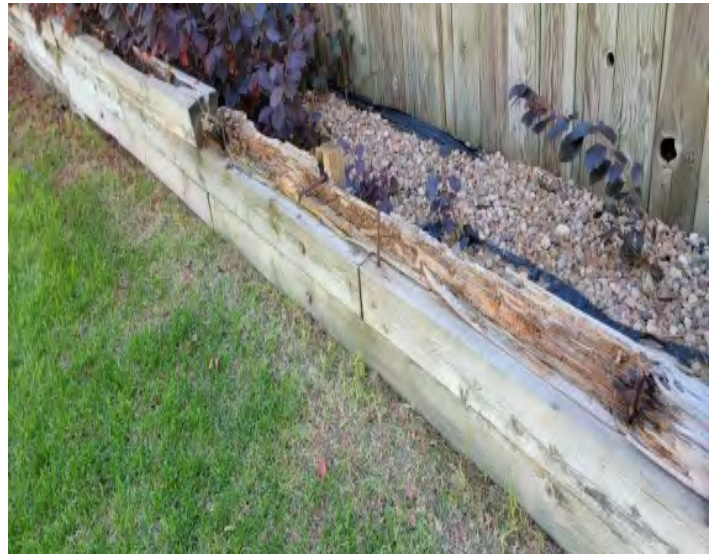
Comp #: 1007 Timber Walls - Major Repairs

- Several walls were leaning and top timbers are rotted out. Many repairs and some replacement is required immediately.
- When replacement is necessary, most associations are converting to block wall for longer life expectancy and less maintenance.

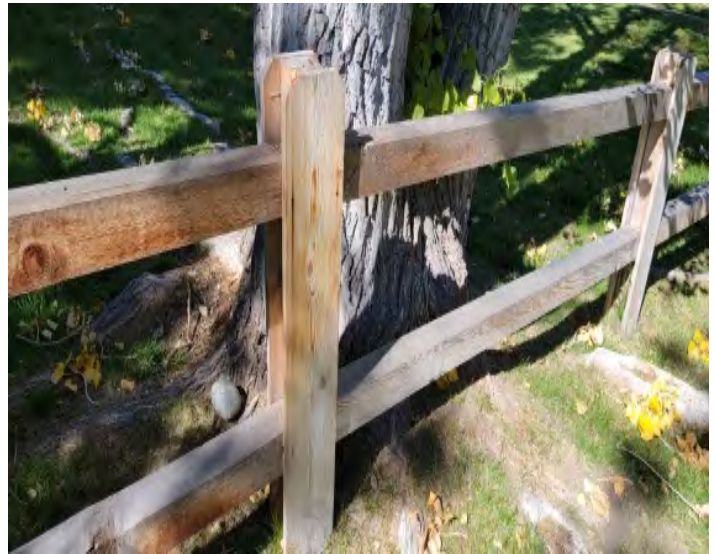
Comp #: 1009 Rail Fencing - Replace

- Fencing on the E. Phillips Cr walkway had at least 4 - 5 rotted posts and needs immediate replacement. There is also evidence of some repairs observed.
- It appears the association repairs/replaces rotted posts and rails when required, as opposed to planning for complete replacement.
- Rather than Reserving for complete replacement every 15 - 20 years, we have changed the philosophy for periodic major repairs and replacement every 4 years.
- Remaining life is based on the observed conditions of some areas that have rotted posts and needs immediate attention to restore to a safe condition.

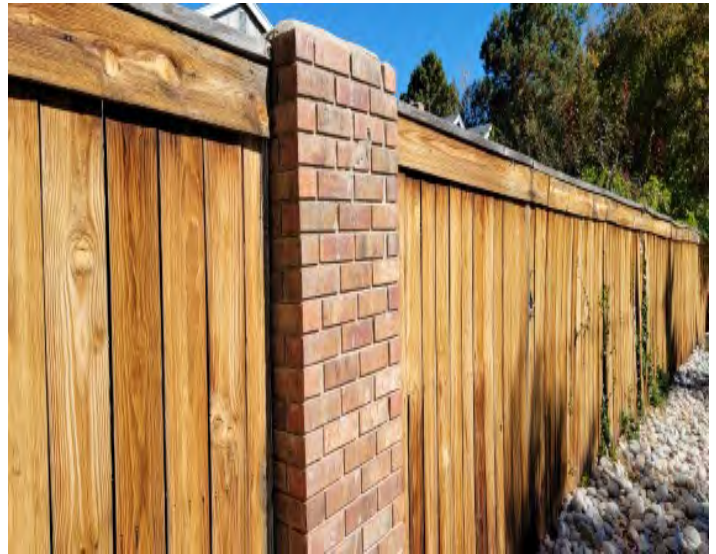
Comp #: 1014 Brick - Major Repairs

- The concrete cap on some columns on perimeter fence is deteriorated and some grout issues was observed throughout. Also noted a few caps that have been replaced around the pool fence and are in good condition. There were no signs of missing or cracked bricks noted.
- While it is unlikely that the entire wall and columns will need to be replaced at the same time, it is likely that major repairs will be necessary to replace loose or missing stones.
- Depending on the effects from elements, we suggest establishing a Reserve fund for periodic repairs to the wall every 5 years.

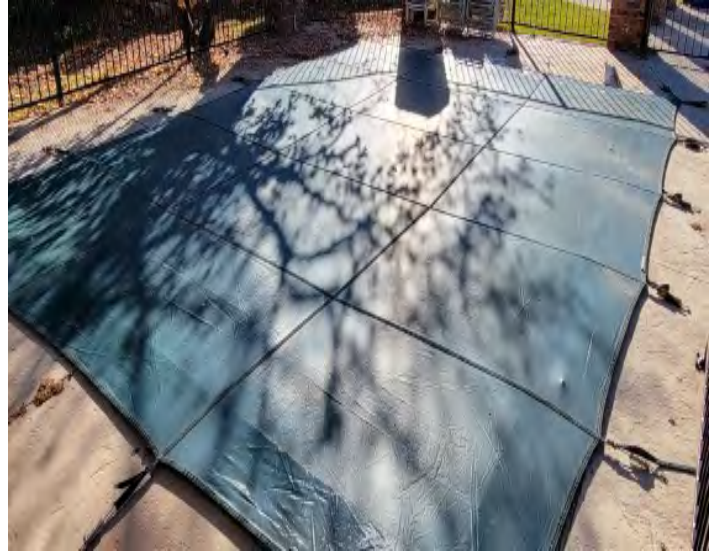
Comp #: 1103 Wader - Resurface

- Pool was covered at time of site observation.
- This type of shallow wading pool typically requires resurfacing more frequently than a full sized pool because a higher concentration of chemicals and higher exposure to UV rays.
- In this capacity, we recommend resurfacing wading pools twice every pool resurface cycle.
- Remaining life is based on the pool resurfacing and observed conditions.

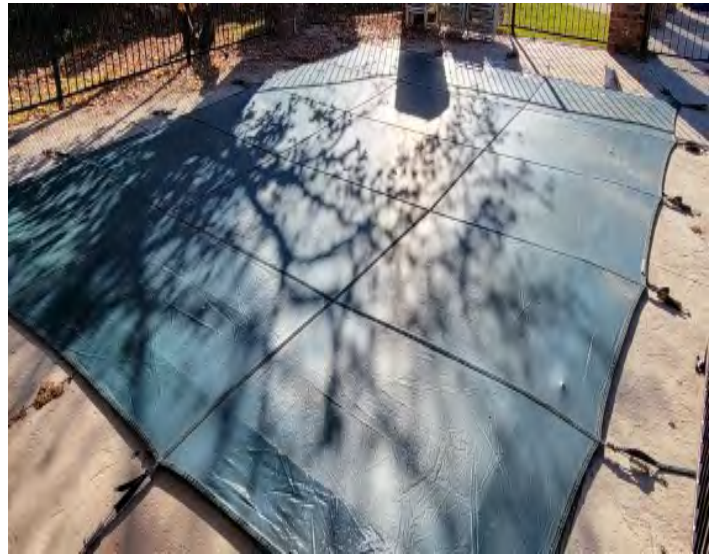
Comp #: 1104 Coping Stone / Tile - Replace

- Pool was covered at time of site observation.
- Coping stones is a poured in place dyed concrete with a stamp design (similar to pool deck, but a darker dye to differentiate the deck from the edge of the pool)
- It is typical to replace these materials every pool resurface cycle to receive the best costs possible.
- Remaining life is based on the age of the new pool area.

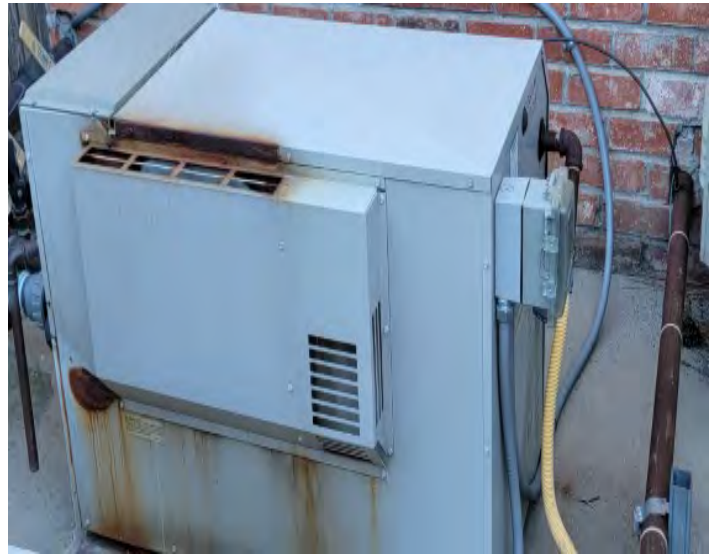
Comp #: 1105 Pool Heater - Replace

- The overall life expectancy depends on the level of maintenance and the quality of the water running through the system.
- For this type of heater, the average replacement cycle will range between 12 - 18 years with proper maintenance and under normal conditions.
- The heaters are exposed to the elements and are starting to rust, which can affect the replacement cycle

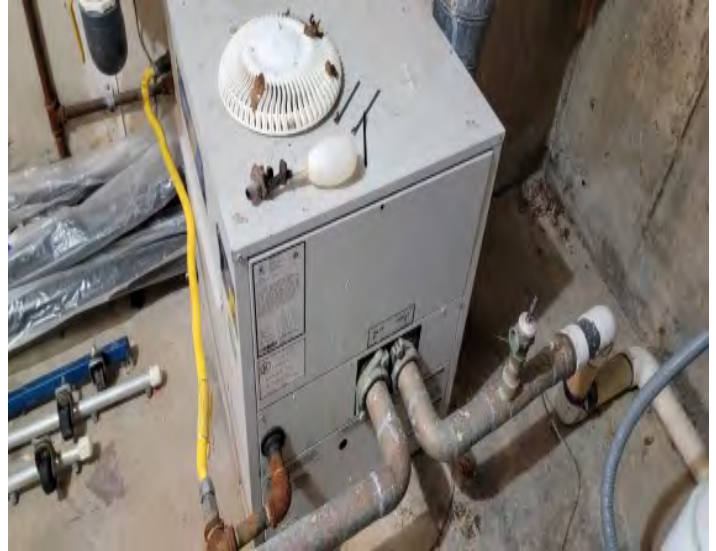
Comp #: 1107 Wader Heater - Replace

- The overall life expectancy depends on the level of maintenance and the quality of the water running through the system.
- For this type of heater, the average replacement cycle will range between 12 - 18 years with proper maintenance and under normal conditions.
- These pools typically have more chemicals that have a harsher impact on the equipment, therefore, the useful life is shorter than a pool heater.
- While the heater is still functional, it has reached the end of its normal life expectancy and the association should plan on replacement at any time in the near future.

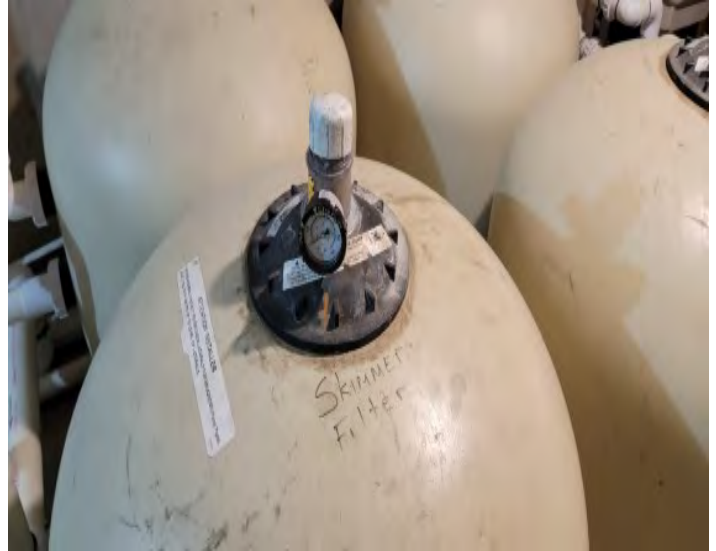
Comp #: 1108 Pool Filter - Replace

- The shell will have an extended useful life of 18 - 20 years and most leaks can be attributed to gaskets and seals that can be replaced on an as needed basis.
- Remove and replace filter sand on an as needed basis using operating funds.
- Filters are about 19 years old and are nearing the end of the typical replacement cycle. Association should be prepared to replace these filters within the next couple years.

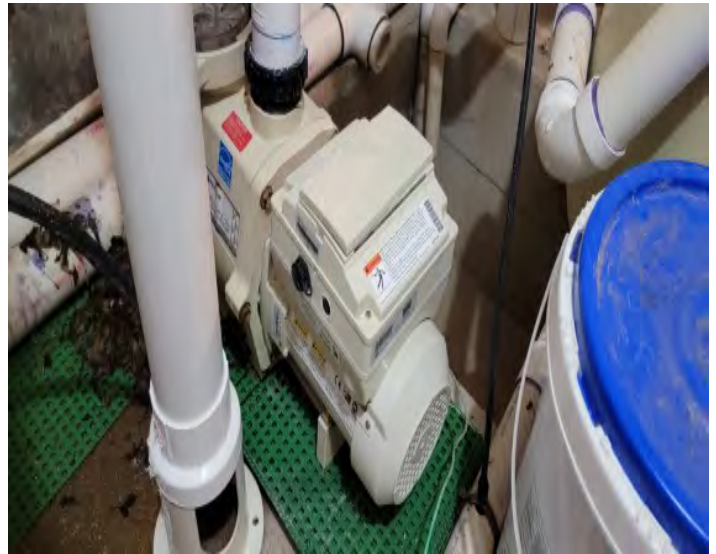
Comp #: 1111 Pool/Wader Pumps - Replace

- Two of the pumps have been replaced since our last site visit in 2018. No reports of when the pumps were replaced.
- The life expectancy for this equipment can differ depending on the level of use and maintenance, as well as the quality of the equipment.
- Therefore, we suggest establishing an allowance for periodic replacement of the equipment.
- Meaning, this is just an allowance to provide the association some funds to replace equipment when required and should not be interpreted as complete replacement of all pumps every 5 years

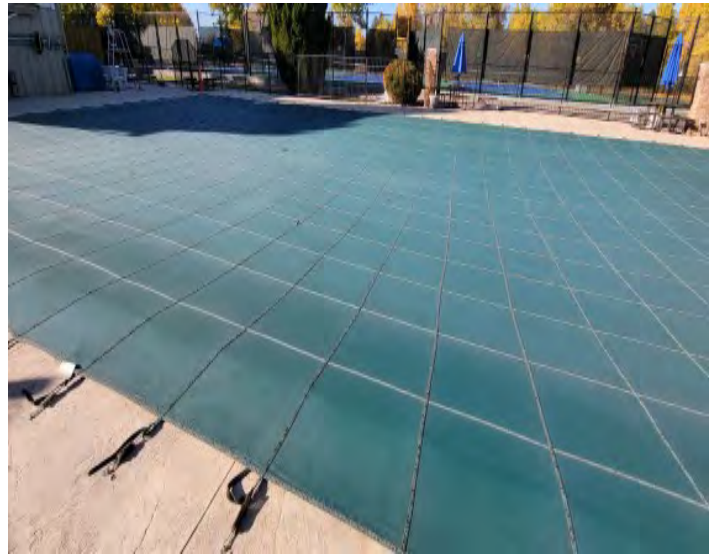
Comp #: 1113 Pool Cover - Replace

- Some small holes were observed in several sections of the cover. Also, the fabric appears to be thinning, which is defeating the purpose of being a safety cover, as it may not hold the weight of a person.
- Most pool covers come with a 10 year manufacturers warranty as long as the cover is being stored according to their specific guidelines; check with your pool manufacturer to ensure you are properly storing your pool cover.
- If properly stored and properly maintained, we recommend reserving to replace the pool cover every 10 - 12 years.
- It is noted at time of site observation, there are small holes in the pool cover.

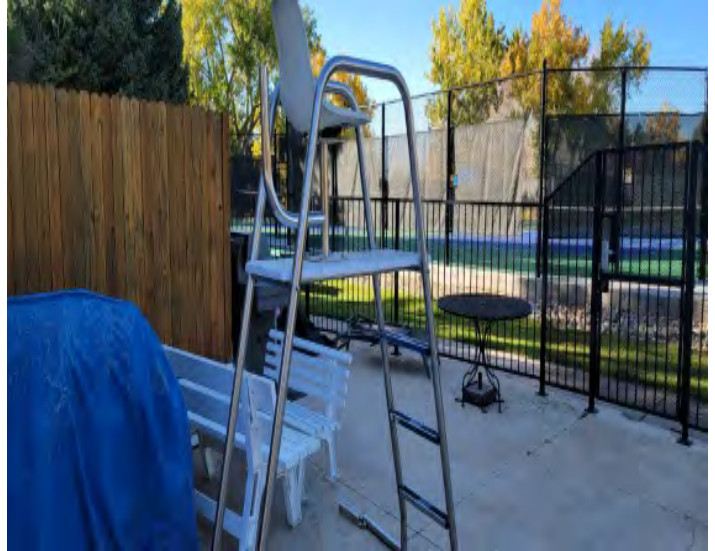
Comp #: 1118 Lifeguard Stand - Replace

- The lifeguard stand was stable and in fair condition with typical signs of wear and tear noted
- The average replacement cycle for lifeguard stands ranges from 12 - 15 years.
- However, based on the observed condition, we extended the replacement cycle a couple years.

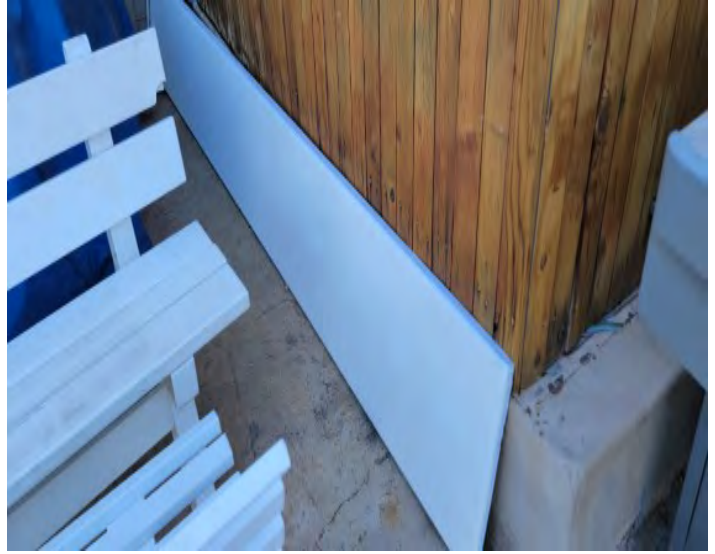
Comp #: 1119 Diving Board - Replace

- No unusual conditions were noted during site visit. There was some minor rusting noted on the base
- On average, these last 15 - 20 years under normal conditions
- The estimated cost includes replacement of the hand bars and platform.

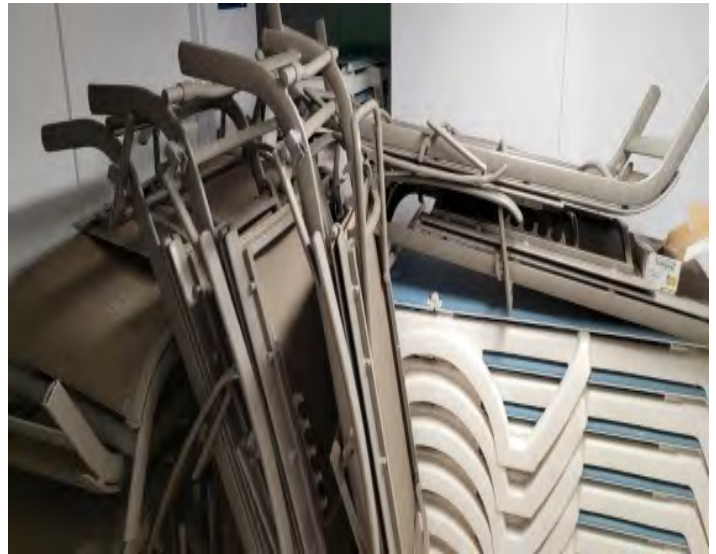
Comp #: 1121 Pool Furniture - Partial Replacement

- It was difficult to observe all pieces because they were still stacked upon each other.
- From what we were able to observe, the furniture is in fair condition with no major signs of broken slings or significant sun damage noted at the time of evaluation.
- Due to varying types of furniture and different levels of use each piece receives, we recommend establishing funds for partial replacement every 4 years.
- This line item is an allowance for partial replacement and should not be misinterpreted as complete replacement of all pieces every 4 years

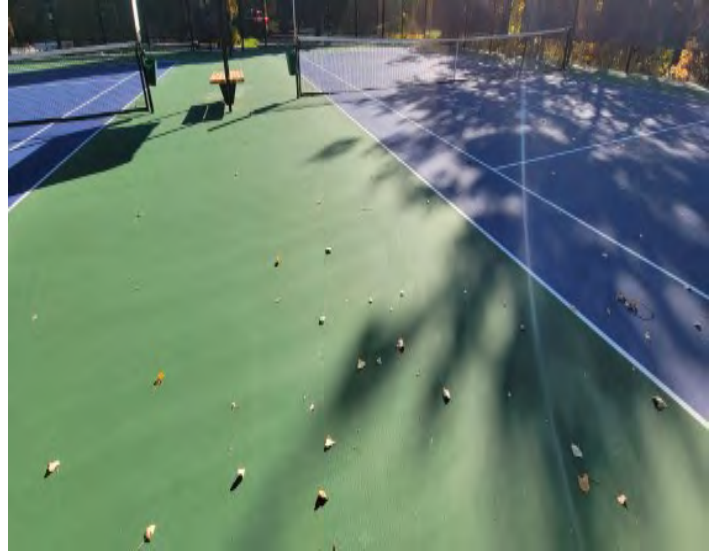
Comp #: 1202 Tennis Court/Basketball - Recoat/Paint

- All courts are new in 2022 and in very good condition
- Depending on the level of use and care, we recommend recoating (also known as resurfacing) the court every 5 - 7 years.
- In between recoating cycles, minor crack fill should be performed as needed with operating funds to prevent the cracks from worsening.

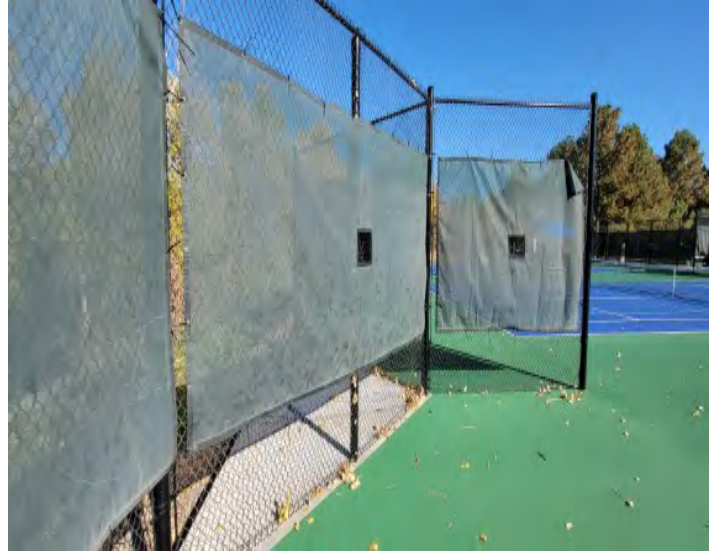
Comp #: 1203 Tennis Court Windscreen - Replace

- The older windscreens were reused when the new courts and fencing was replaced. No tears or holes were observed, but the fabric was dirty and thin in a few areas.
- Expect a useful life of approximately 4 to 8 years from this component.
