Willow Creek III Townhomes

Level 2 Reserve Analysis

Draft
Report

Date of Property Observation - October 23, 2013
Project Manager - G. Michael Kelsen, RS, PRA
Main Contact Person - Mr. Ron Valiga, Community Manager

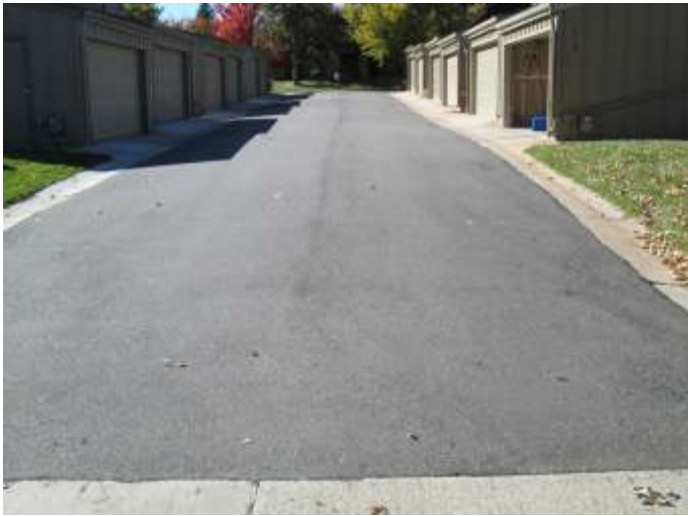
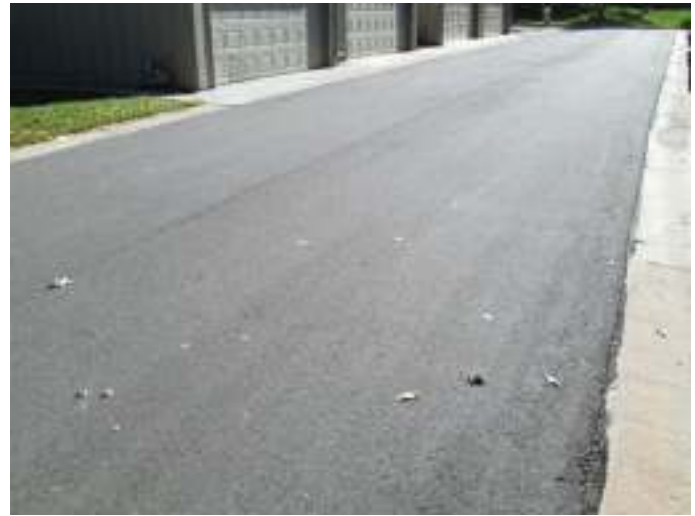
Comp #: 401 Asphalt - Overlay (2012)

These alleyways are newer and in good condition. By reviewing the general ledger that was provided, we are assuming the major expense that was applied in 2012 was for the overlay of these alleys.

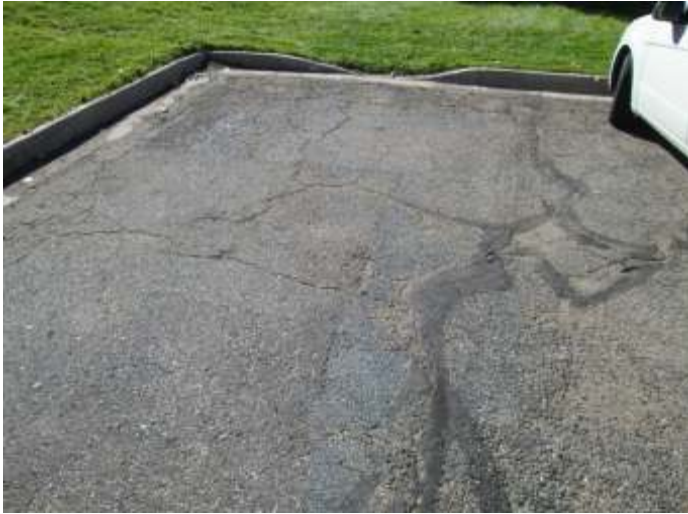
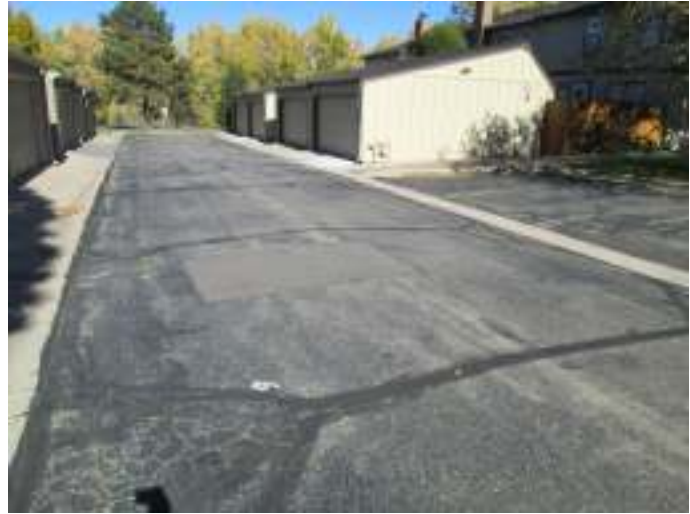
Comp #: 401 Asphalt - Overlay (Original)

*Project History - 10/26/2007 - \$550 (infrared patches), 11/12/2010 - \$5995.47 (description not provided).

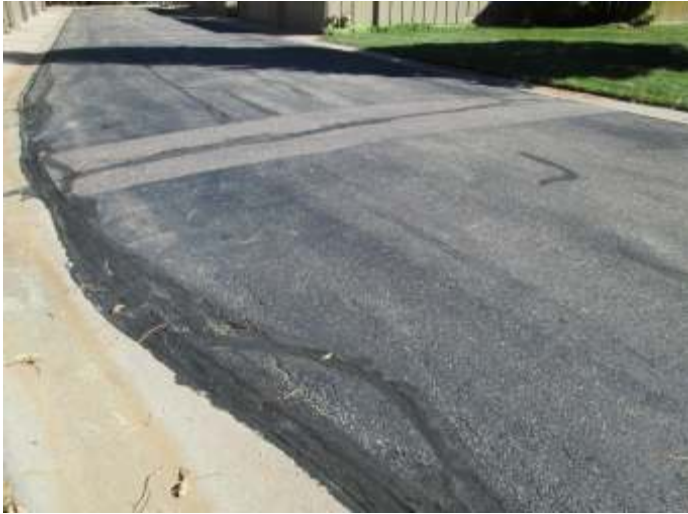
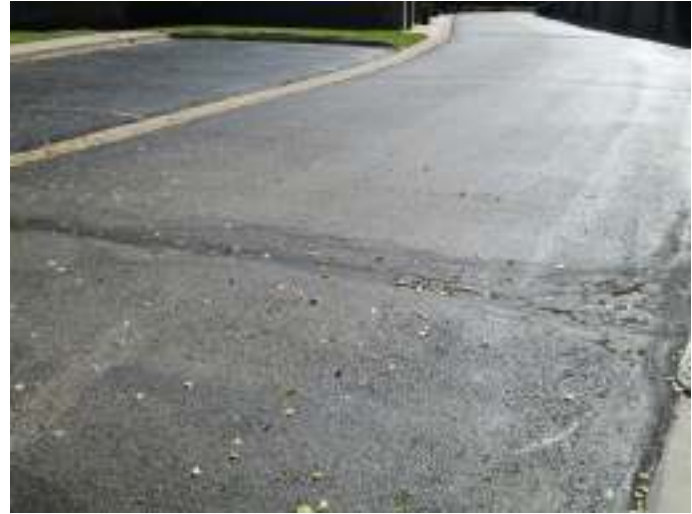
Comp #: 402 Asphalt - Seal Coat/crack fill

Evidence of extensive crack fill. It also appears that a seal coat was applied within the past couple years, but we were unable to confirm this in the ledger that was provided. Based on observed conditions, we recommend this project be completed again in 2015. In this climate, seal coating is recommended every 2 - 3 years. In between seal cycles, asphalt should be crack filled and repaired as a preventative maintenance measure to ensure maximum life expectancy from the material.

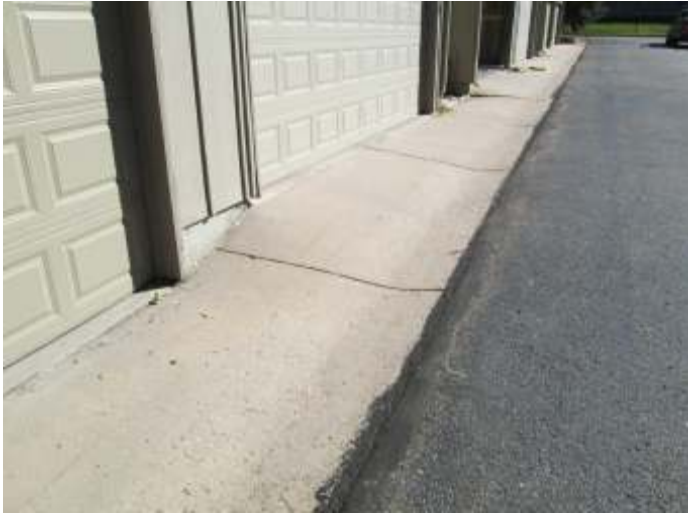
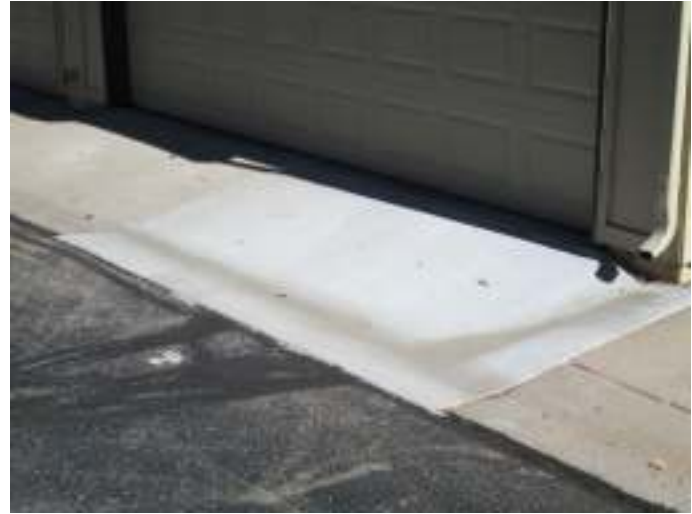
Comp #: 403 Concrete Garage Drives - Repair/Replace

There is evidence of past repairs, as well as older areas that are exhibiting some signs of deterioration and spalling. Due to varying conditions, it is unlikely that all concrete surfaces will fail at the same time. Therefore, we suggest establishing a Reserve fund for periodic repairs and replacement to approximately 10% of the total area (2115 GSF) every 3 years. Repairs should be coordinated with other concrete surfaces and asphalt for best cost estimate since most asphalt companies can also perform concrete work.

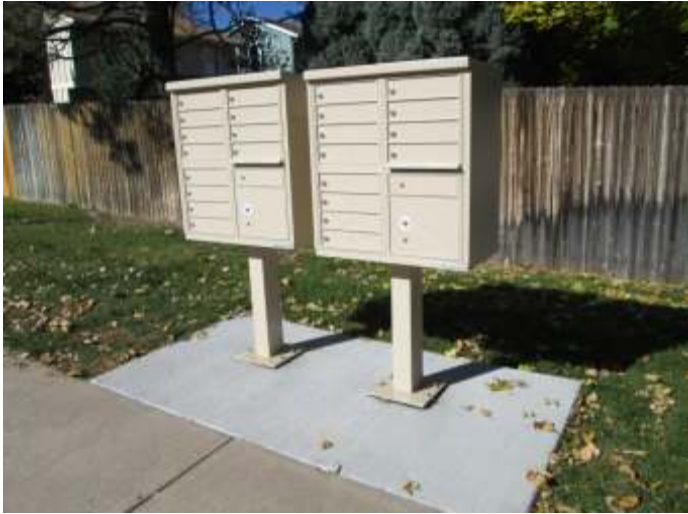
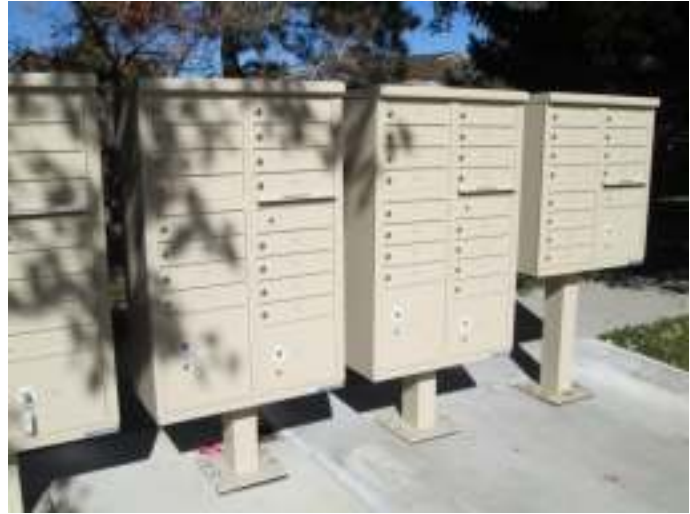
Comp #: 803 Mailboxes - Replace (new)

No unusual conditions noted at time of property observation. According to several manufacturers, the typical life expectancy for this type of mailbox is 15 - 20 years in this environment. Remaining life is based on average age of all units. While it is likely the US Post Office will maintain and replace these boxes in the future, in our experience, we have seen in numerous similar circumstances that the post office makes the association responsible for replacement. Research with the local post office revealed that the boxes are theirs to maintain at this time. Therefore, separate Reserve funding is not required for this component. The association should be prepared to pay for these at some point in the future in case the government changes their policy.

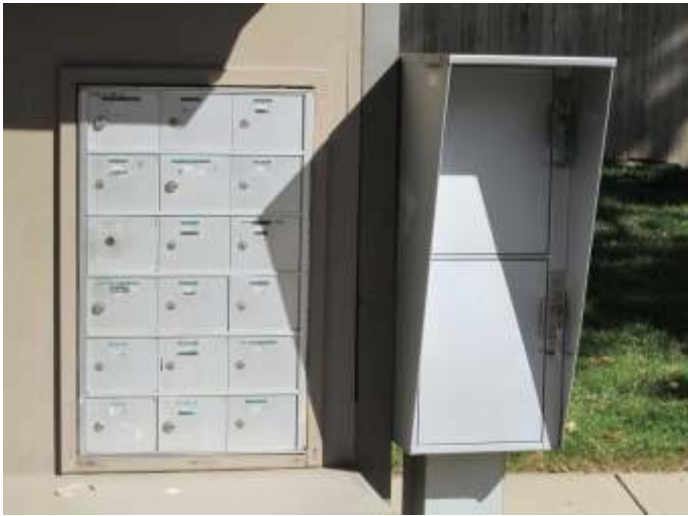
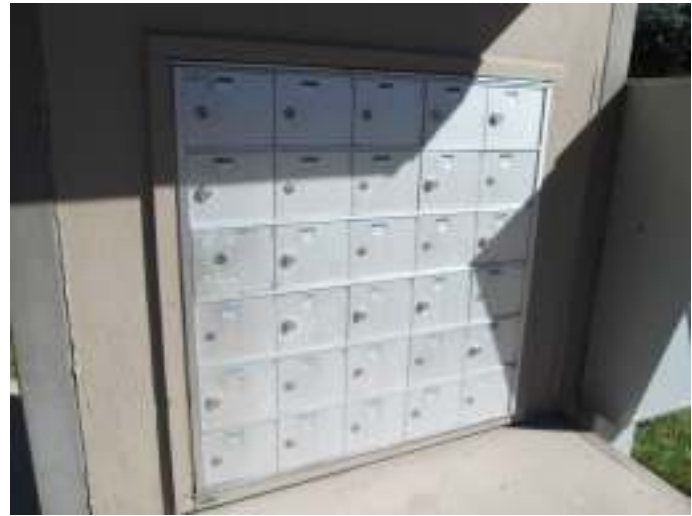
Comp #: 803 Mailboxes - Replace

Assume these structures and boxes will be replaced with Cluster Box Units, similar to the other 4 locations. Our estimate is for demolition and disposal of the structure and installation of the new CBU's.

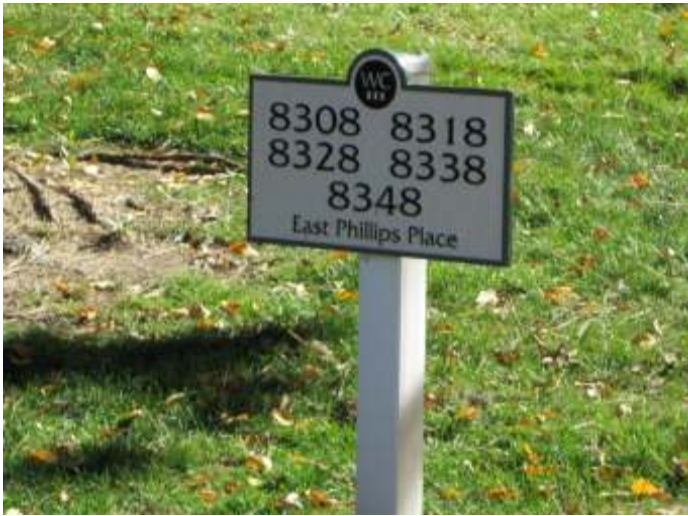
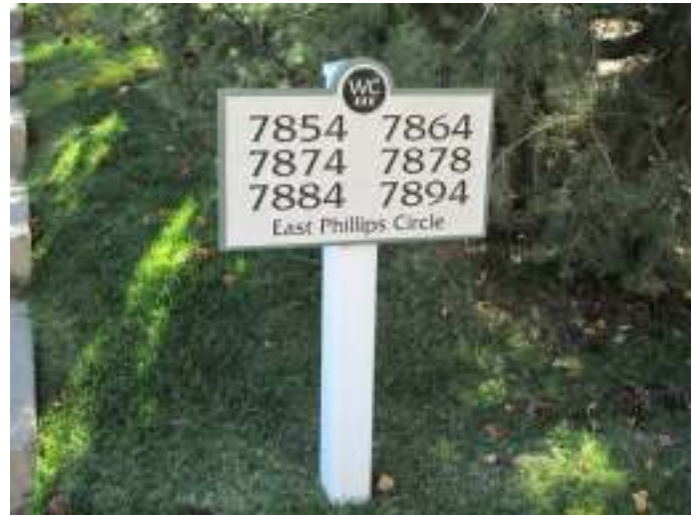
Comp #: 809 Signage - Replace

Signs are legible and in good condition, considering the age of the signs. In our experience, we have seen this type of sign material last 12 - 18 years on average before replacement is required. The remaining life is based on age of the signs and the observed condition.
