**Willow Creek III Townhomes
8101 E. Phillips Cir.
Centennial, CO. 80112**

**Level 2, Platinum Reserve Analysis
Report Period – 01/01/19 – 12/31/19**

**Client Reference Number - 7550
Property Type – Townhomes**

**Fiscal Year End – December 31
Number of units- 197
Date of Property Observation - April 17, 2018**

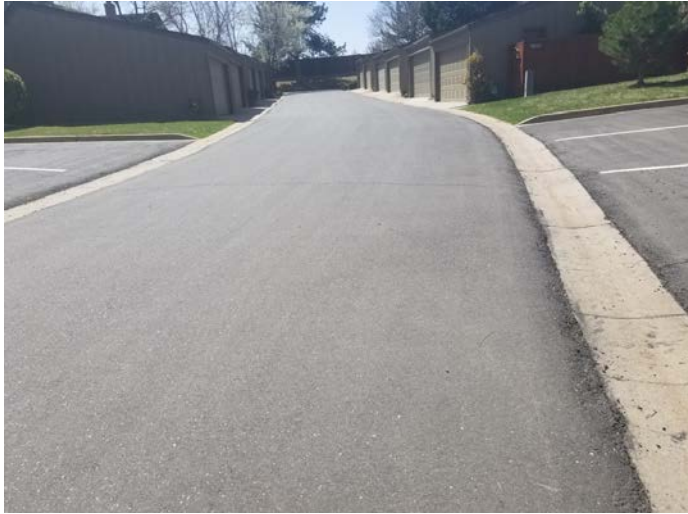
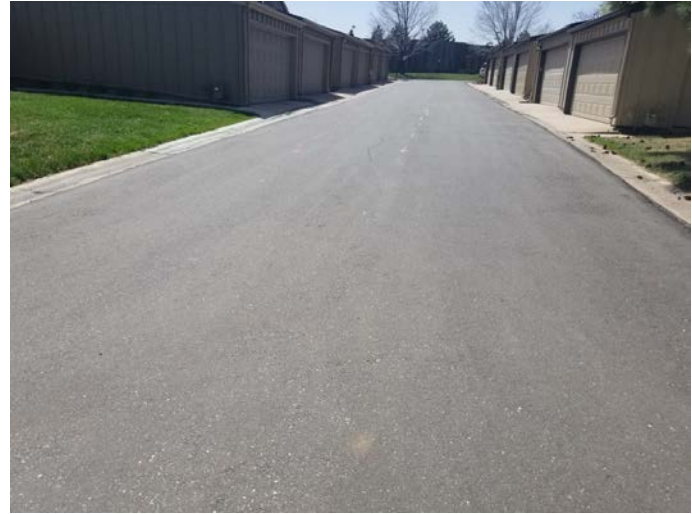
Comp #: 401 Asphalt - Overlay (2017)

- These allies were overlayed in 2017 and were in very good condition at the time of the site observation.
- The average life expectancy for asphalt surfaces ranges between 20 - 27 years for surfaces that are maintained on a regular schedule.
- Maintenance includes crack fill and repairing small potholes annually as an operating expense.
- In addition, asphalt should be seal coated every 3 - 4 years, depending on the level of traffic and snow removing techniques.

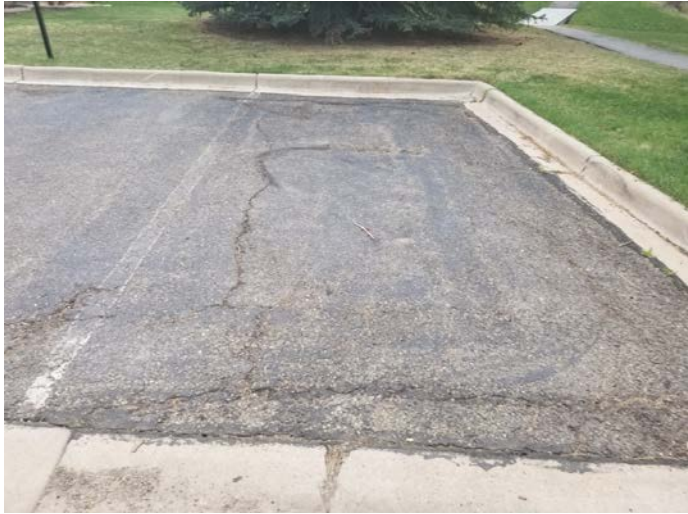
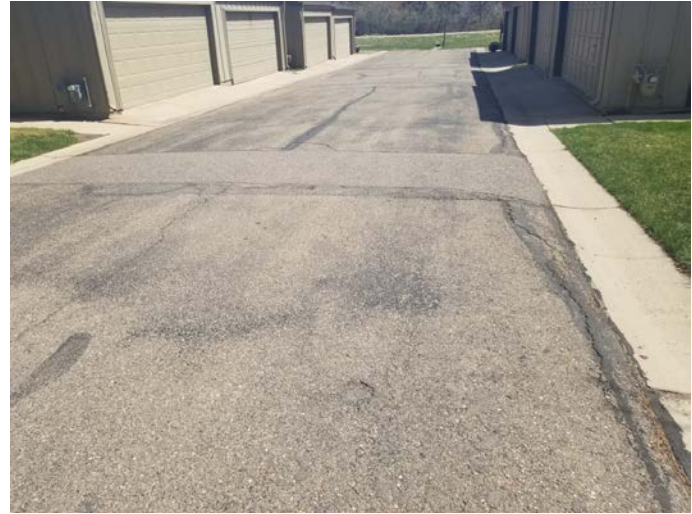
Comp #: 401 Asphalt - Overlay (2018)

- The allies included in this line item are allies that are original to the property, or have not overlayed in many years.
- There were several areas where the asphalt was completely deteriorated, alligating, or settling.
- The average life expectancy for asphalt surfaces ranges between 20 - 27 years for surfaces that are maintained on a regular schedule.
- Maintenance includes crack fill and repairing small potholes annually as an operating expense.
- In addition, asphalt should be seal coated every 3 - 4 years, depending on the level of traffic and snow removing techniques.

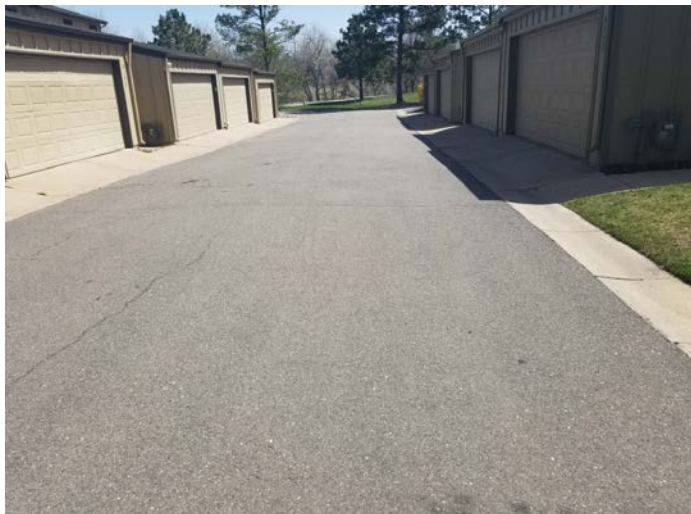
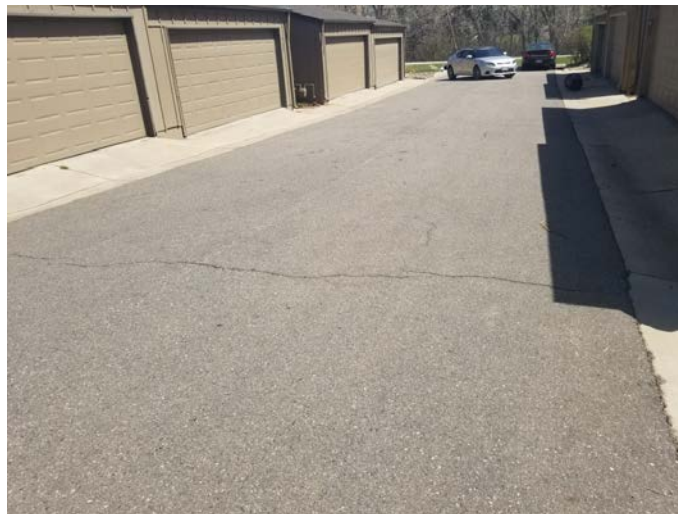
Comp #: 401 Asphalt - Overlay (2012)

- The allies that were replaced in 2012 were in good condition at the time of the site observation, with no signs of advanced deterioration noted.
- The average life expectancy for asphalt surfaces ranges between 20 - 27 years for surfaces that are maintained on a regular schedule.
- Maintenance includes crack fill and repairing small potholes annually as an operating expense.
- In addition, asphalt should be seal coated every 3 - 4 years, depending on the level of traffic and snow removing techniques.

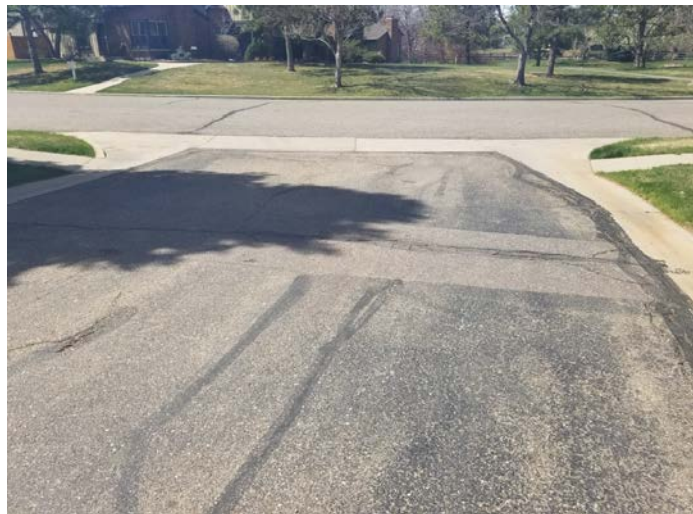
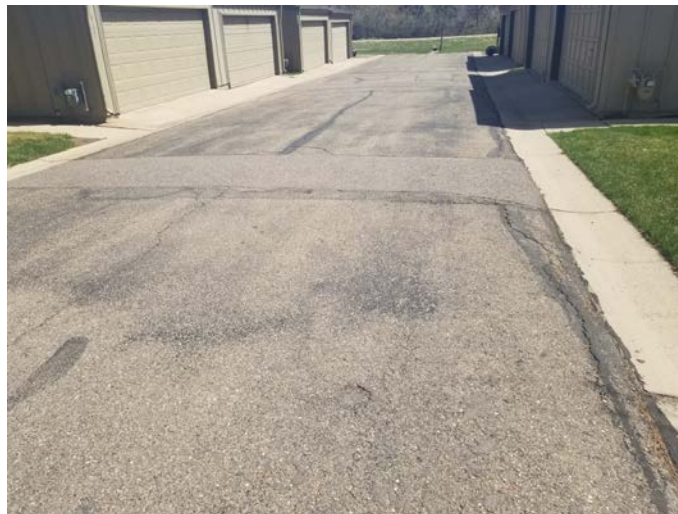
Comp #: 401 Asphalt - Overlay (Original)

- The allies included in this line item are allies that are original to the property, or have not overlayed in many years.
- There were several areas where the asphalt was completely deteriorated, alligating, or settling.
- The average life expectancy for asphalt surfaces ranges between 20 - 27 years for surfaces that are maintained on a regular schedule.
- Maintenance includes crack fill and repairing small potholes annually as an operating expense.
- In addition, asphalt should be seal coated every 3 - 4 years, depending on the level of traffic and snow removing techniques.

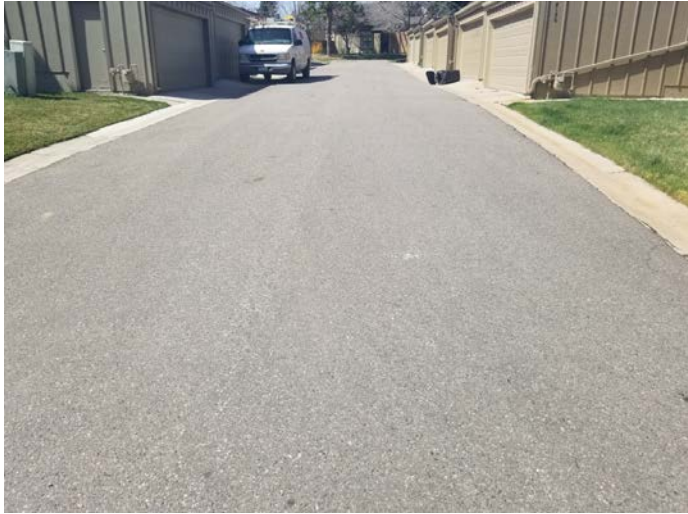
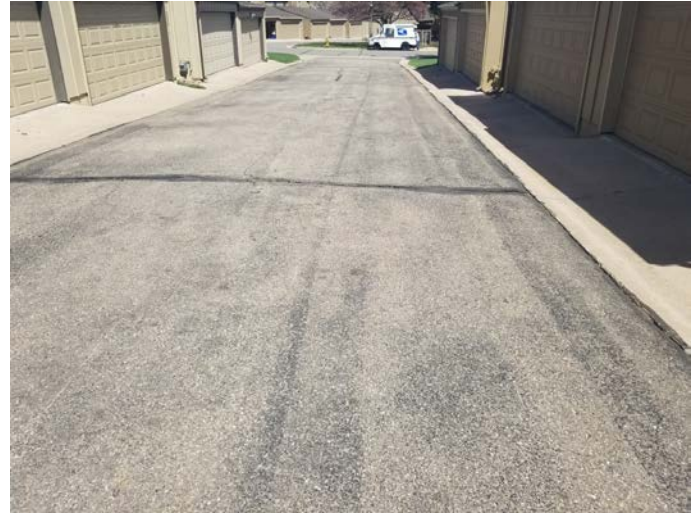
Comp #: 402 Asphalt - Surface Application

- We recommend a surface application is applied to all the allies at the same time. This is to keep costs down and to ensure a consistent look throughout the property.
- It is also recommended a surface application is applied within 12 months of a new overlay.
- In this environment, expect to seal asphalt every 2 - 3 years, depending on traffic levels and effects from weather.
- This helps in slowing the process of oxidation and raveling.
- While acting as a protective barrier, it also maintains the appearance of the community to maintain or improve property values.

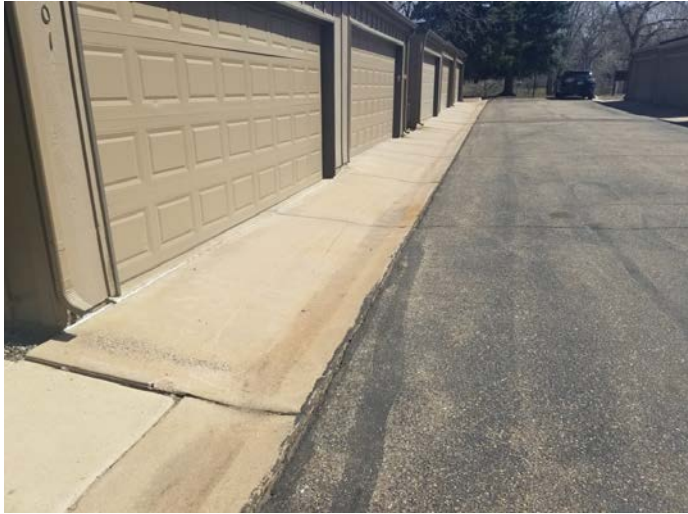
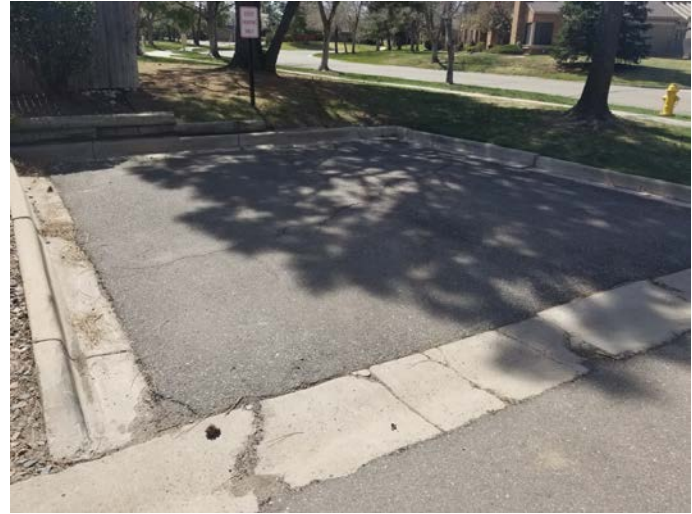
Comp #: 403 Concrete - Repair/Replace

- The average condition of the concrete on the property was fair, however, there were several areas where the concrete was in poor condition.
- Since it is unlikely that all concrete surfaces will fail at the same time, we suggest establishing a Reserve fund for periodic repairs and replacement to approximately 10% of the total area (2,160 GSF) every 3 years.
- Repairs should be coordinated with other concrete surfaces and asphalt for best cost estimate since most asphalt companies can also perform concrete work.

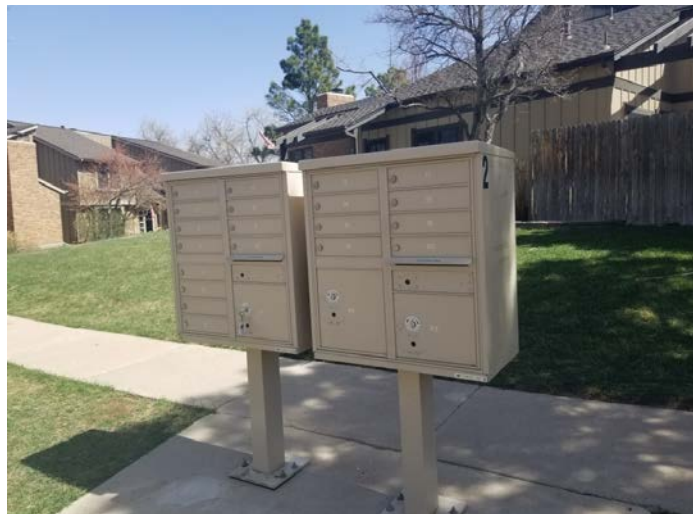
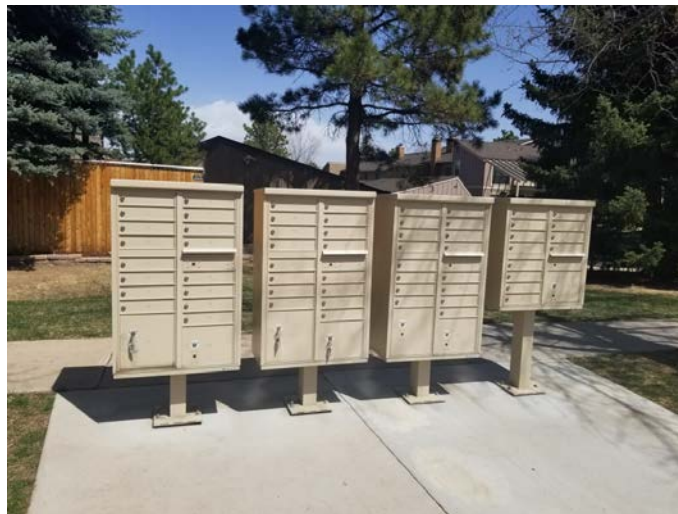
Comp #: 803 Mailboxes - Replace

- The clusterbox units throughout the property were in good to fair condition and appeared to be aging appropriately.
- According to several manufacturers, the typical life expectancy for this type of mailbox is 15 - 20 years in this environment.
- Remaining life is based on average age of all units.
- Per new Postal regulations effective 2012, "all customers are responsible for repairs and replacement of keys, locks, or the boxes/cluster units themselves".

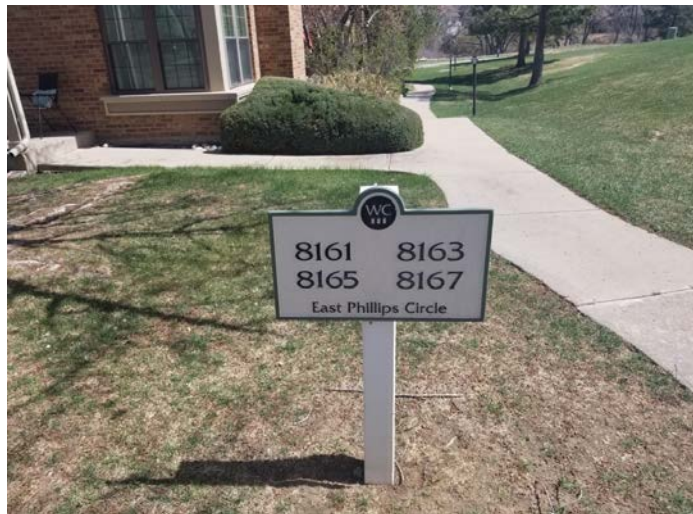
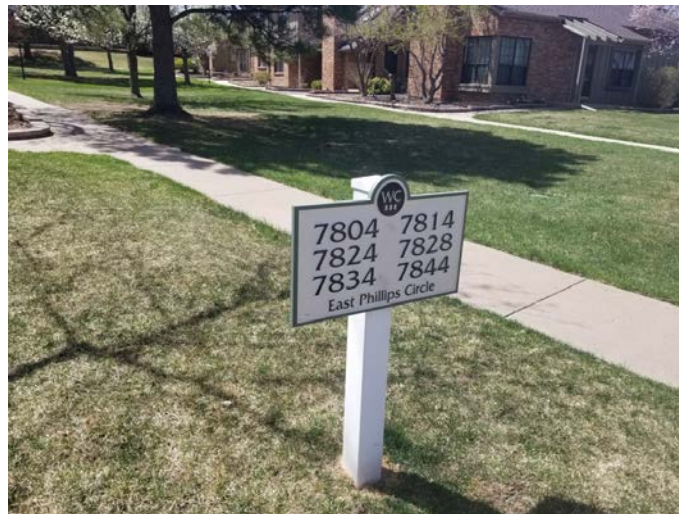
Comp #: 809 Signage - Replace

- The signs were in fair condition at the time of the site observation.
- In our experience, we have seen this type of sign material last 12 - 18 years on average before replacement is required.
- The remaining life is based on age of the signs and the observed condition.

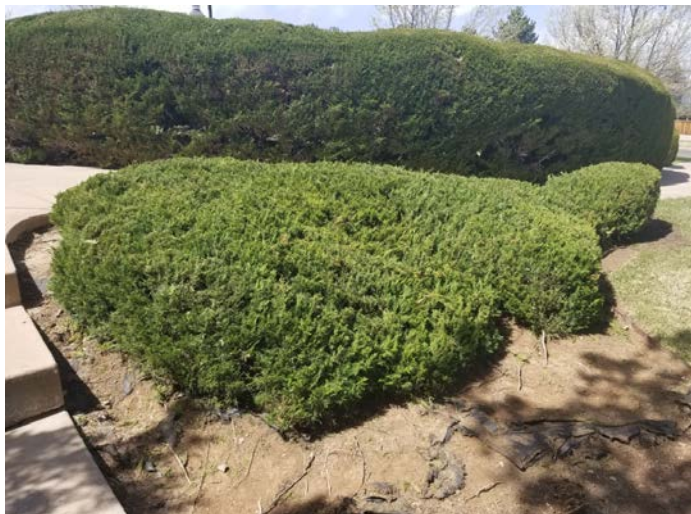
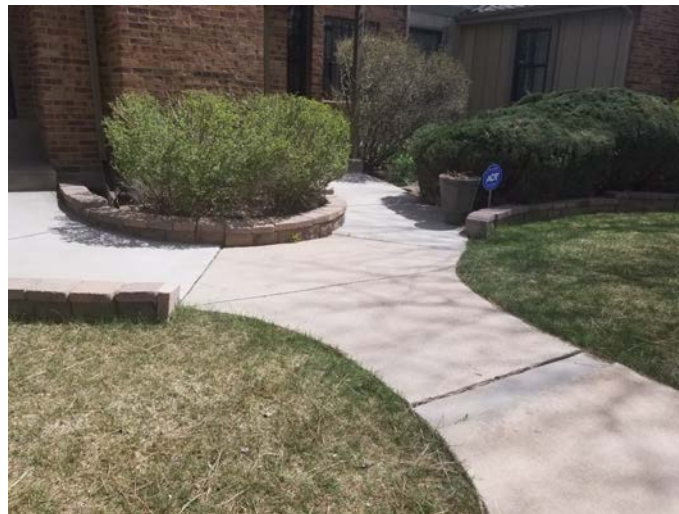
Comp #: 1801 Groundcover - Replenish

- Typically, associations will establish a line item in the operating budget to handle annual replacement of shrubs, plants, grass areas, etc.
- Therefore, separate Reserve funding is not necessary as long as funding has been established in a separate budget.
- If the association prefers to include a funding allowance for groundcover replenishment, then we would need to know how much and how often the current board of directors would prefer to set aside since this would be considered a discretionary expense.

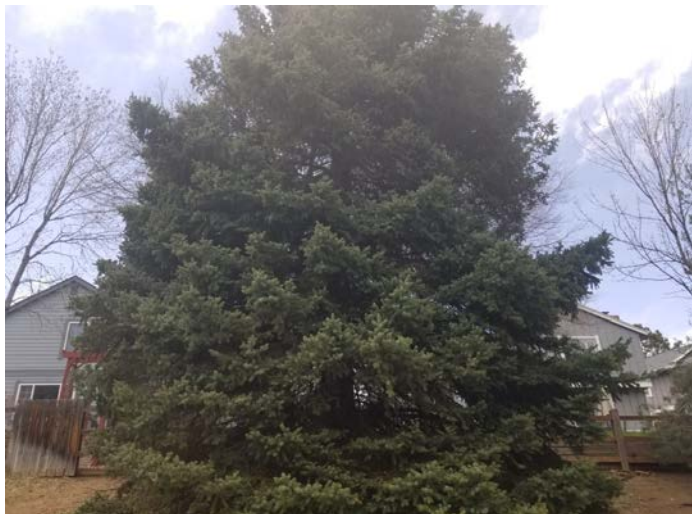
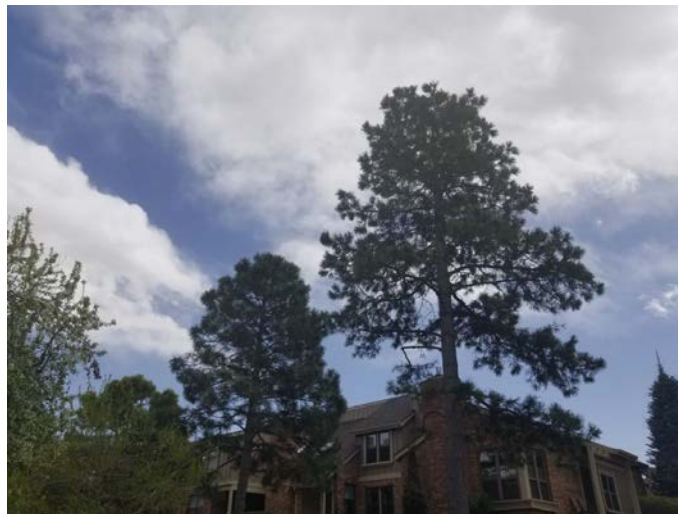
Comp #: 1804 Tree - Replacement/Major Maintenance

- It is very difficult to predict a replacement cycle for trees as there are several factors such as disease, infestation of insects, heavy snow storms, etc. can all attribute to eventual tree replacement.
- Since it is difficult to predict when the replacement will be necessary, Reserve funding is typically not a factor.
- Therefore, unless requested by the association, Reserve funding will not be included as part of the study for this component.
