Level 2, Platinum Reserve Analysis

# Willow Creek III Townhomes 8101 E. Phillips Cir. Centennial, CO. 80112

## FINAL VERSION

Date of Property Observation – October 19, 2022

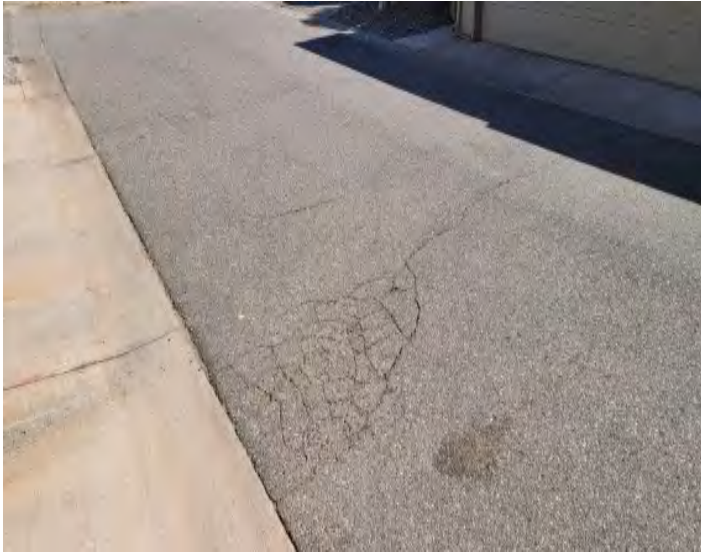
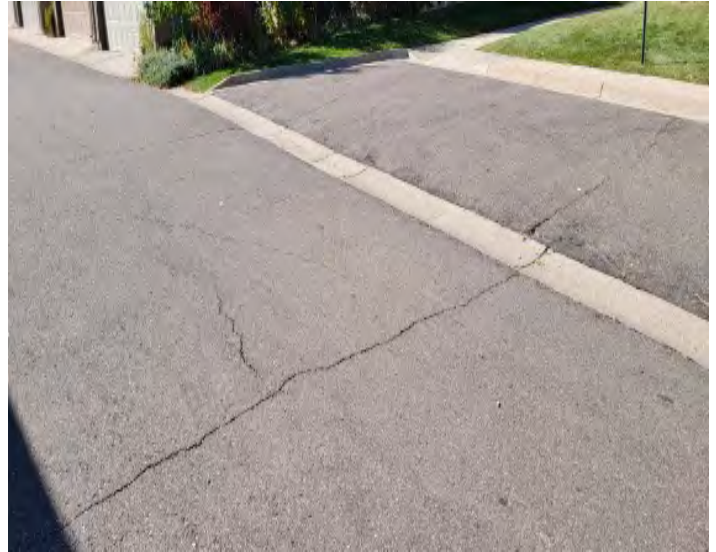
Comp #: 401 Asphalt - Overlay (2012)

- These alleyways that were replaced in 2012 are in fair condition with noted cracking in 8150-8162 alley and in guest parking spaces, and a few alligatored areas that are starting to show signs of potholes. We recommend filling these cracks and repairing (infrared technology) the areas that are forming potholes as soon as possible to prevent complete replacement or advanced deterioration.

- There was also evidence of a major repair in front of 8181-8183 (about 400 GSF)
- The average life expectancy for asphalt surfaces ranges between 20 - 27 years for surfaces that are maintained on a regular schedule.

- Maintenance includes crack fill and repairing small potholes annually as an operating expense.
- In addition, asphalt should be seal coated every 2 - 3 years, depending on the level of traffic and snow removing techniques.

- NOTE: Cost for a major overlay is higher on a per GSF basis due to the small area each cycle.

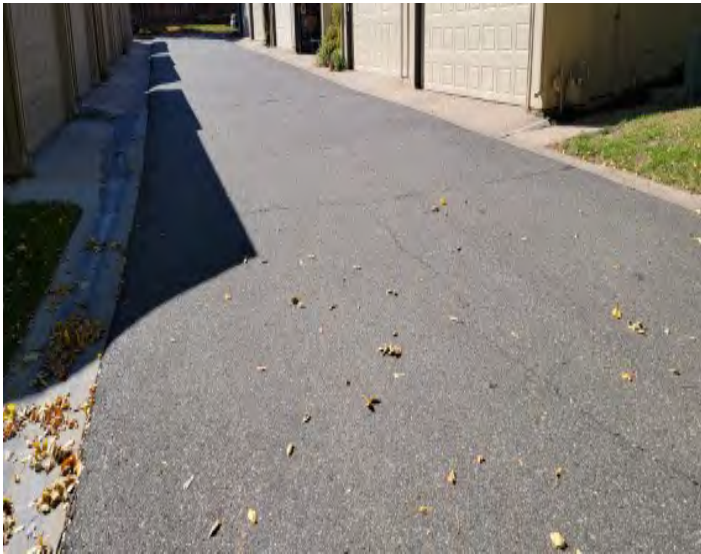
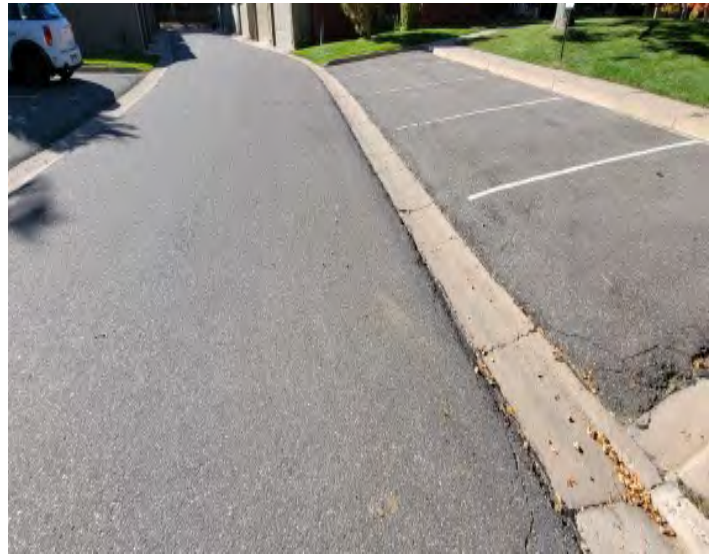
Comp #: 401 Asphalt - Overlay (2017)

- These alleyways that were replaced in 2017 are in good to fair condition with some minor cracking noted. We recommend filling these cracks as soon as possible to prevent complete replacement or advanced deterioration.
- The average life expectancy for asphalt surfaces ranges between 20 - 27 years for surfaces that are maintained on a regular schedule.
- Maintenance includes crack fill and repairing small potholes annually as an operating expense.
- In addition, asphalt should be seal coated every 2 - 3 years, depending on the level of traffic and snow removing techniques.
- NOTE: Cost for a major overlay is higher on a per GSF basis due to the small area each cycle.

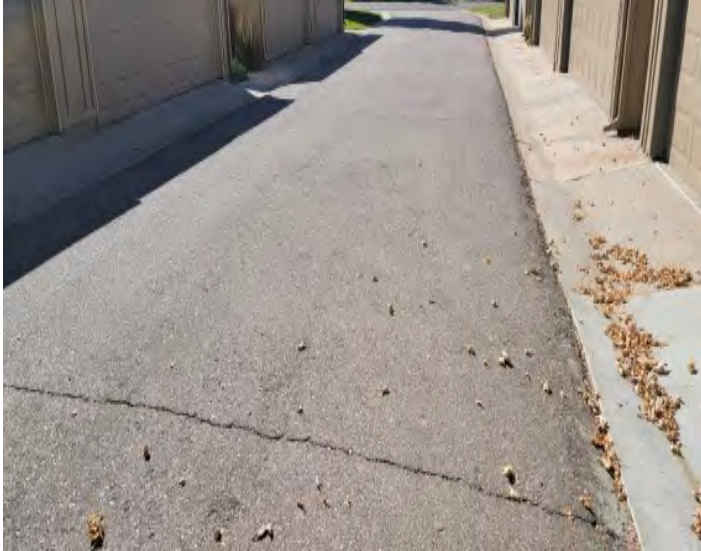
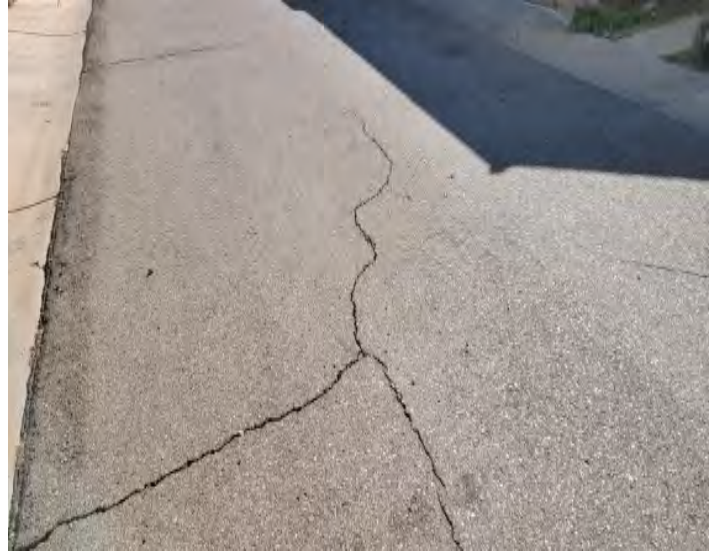
Comp #: 401 Asphalt - Overlay (2018)

- These alleyways that were replaced in 2018 are in good to fair condition with some cracking noted. We recommend filling these cracks as soon as possible to prevent complete replacement or advanced deterioration.
- The average life expectancy for asphalt surfaces ranges between 20 - 27 years for surfaces that are maintained on a regular schedule.
- Maintenance includes crack fill and repairing small potholes annually as an operating expense.
- In addition, asphalt should be seal coated every 2 - 3 years, depending on the level of traffic and snow removing techniques.
- NOTE: Cost for a major overlay is higher on a per GSF basis due to the small area each cycle.

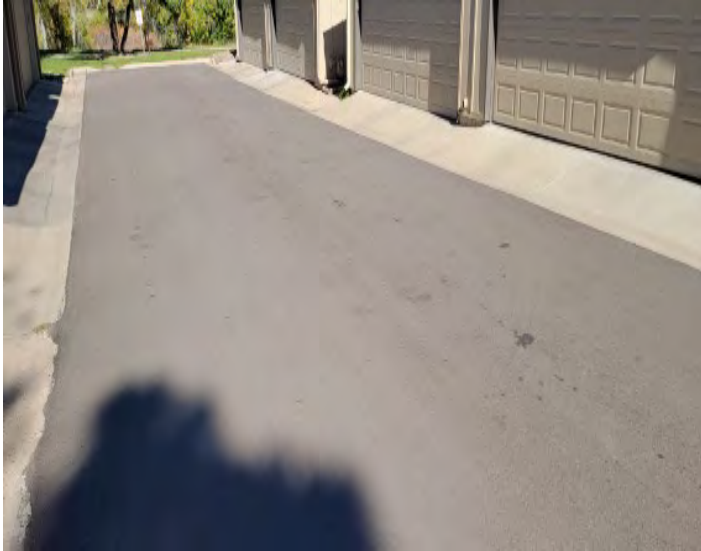
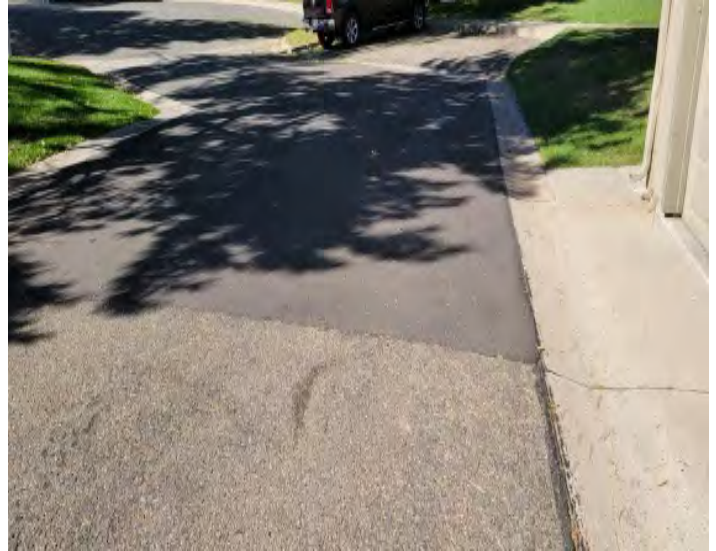
Comp #: 401 Asphalt - Overlay (2020)

- These sections appear to have been done within the past 2 - 3 years.
- The average life expectancy for asphalt surfaces ranges between 20 - 27 years for surfaces that are maintained on a regular schedule.
- Maintenance includes crack fill and repairing small potholes annually as an operating expense.
- In addition, asphalt should be seal coated every 2 - 3 years, depending on the level of traffic and snow removing techniques.
- NOTE: Cost for a major overlay is higher on a per GSF basis due to the small area each cycle.

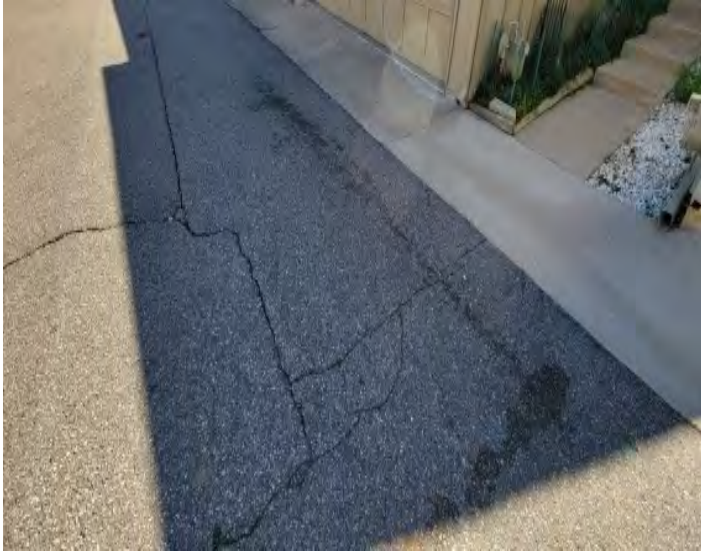
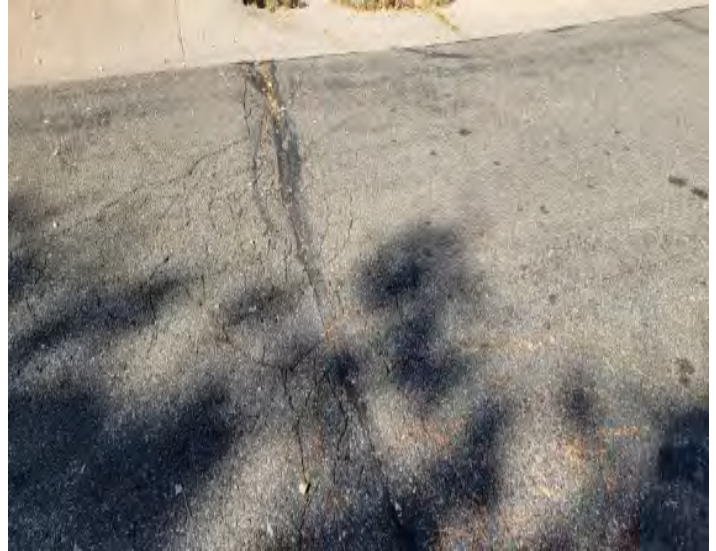
Comp #: 401 Asphalt - Overlay (Original)

- The alleys in these sections are older and have not been overlaid in many years.
- There were several areas where the asphalt was completely deteriorated, alligating, or settling.
- The average life expectancy for asphalt surfaces ranges between 20 - 27 years for surfaces that are maintained on a regular schedule.
- Maintenance includes crack fill and repairing small potholes annually as an operating expense.
- In addition, asphalt should be seal coated every 3 - 4 years, depending on the level of traffic and snow removing techniques.

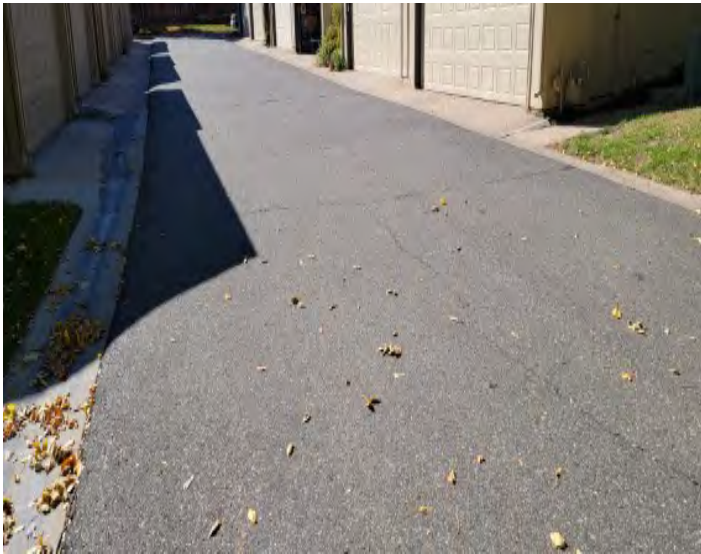
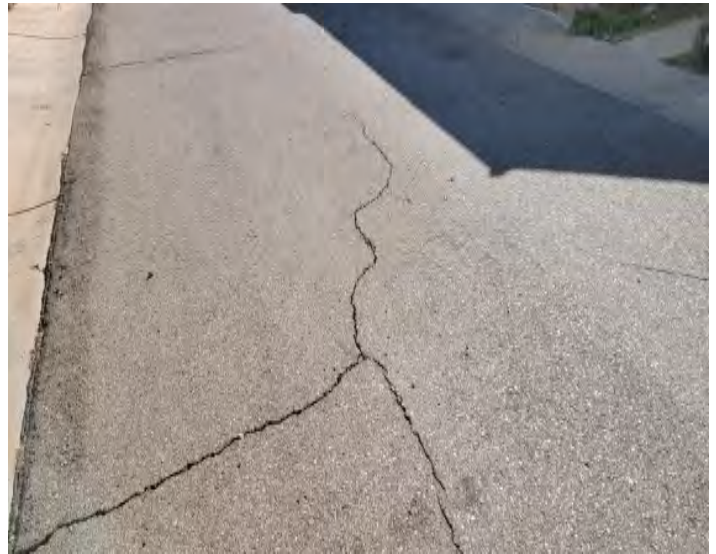
Comp #: 402 Asphalt - Surface Application (A)

- We recommend a surface application is applied to all the alleys at the same time.
- This line item is for the sections of the community that have not been sealed since they were overlaid, dating back to the alleys that were done in 2012
- It is also recommended a surface application is applied within 12 months of a new overlay.
- In this environment, expect to seal asphalt every 2 - 4 years, depending on traffic levels and effects from weather.
- This helps in slowing the process of oxidation and raveling.
- While acting as a protective barrier, it also maintains the appearance of the community to maintain or improve property values.

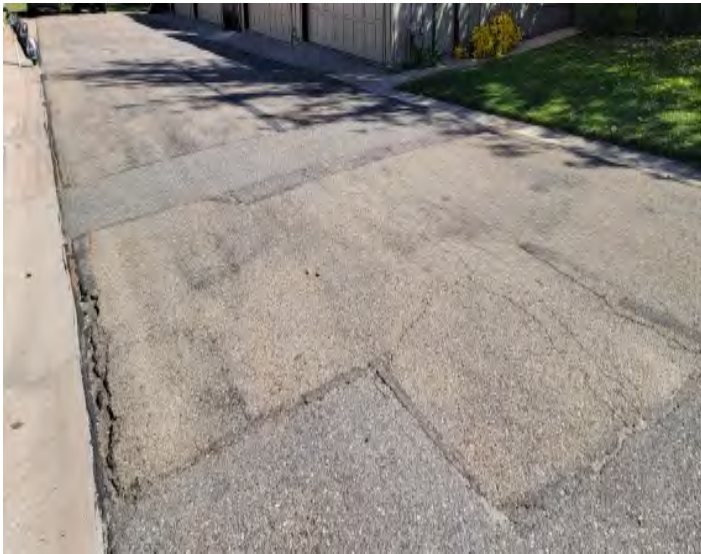
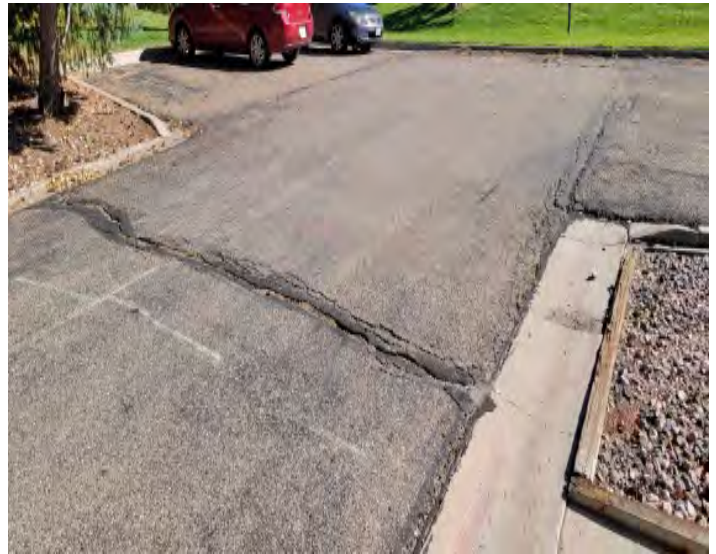
Comp #: 402 Asphalt - Surface Application (B)

- It is important to maintain a proper seal cycle to protect the integrity of the asphalt and prevent extensive cracking, development of potholes, and loss of emulsion, which will lead to advanced deterioration.
- The condition of this surface is beyond the benefit of a seal coat.
- As a result, we are recommending a rotomill and overlay, or possible replacement of the existing surface.
- Industry professionals suggest seal coating within 12 months of a new overlay.
- Therefore, due to timing of an overlay (during summer months), we recommend seal coating the summer following a new overlay.

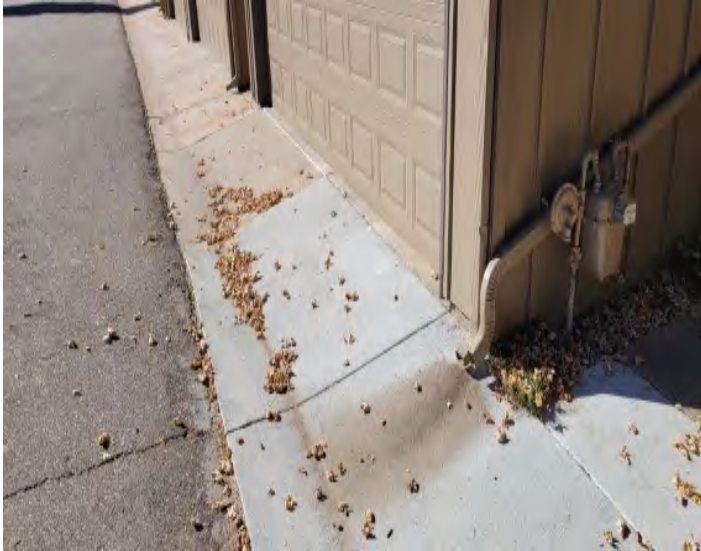
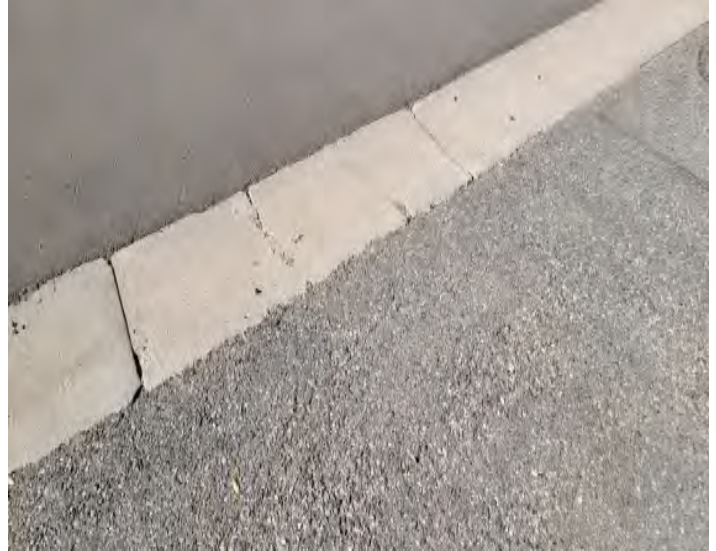
Comp #: 403 Concrete - Repair/Replace

- Conditions of concrete varies throughout the community. There is evidence of recent repairs (about 425 GSF) in aprons in front of 8109, 8134-8132, 8078 and 7844.
- There are other areas that are in poor condition throughout community
- Since it is unlikely that all concrete surfaces will fail at the same time, we suggest establishing a Reserve fund for periodic repairs and replacement to approximately 15% of the total area (3,240 GSF) every 4 years.
- Repairs should be coordinated with other concrete surfaces and asphalt for best cost estimate since most asphalt companies can also perform concrete work.

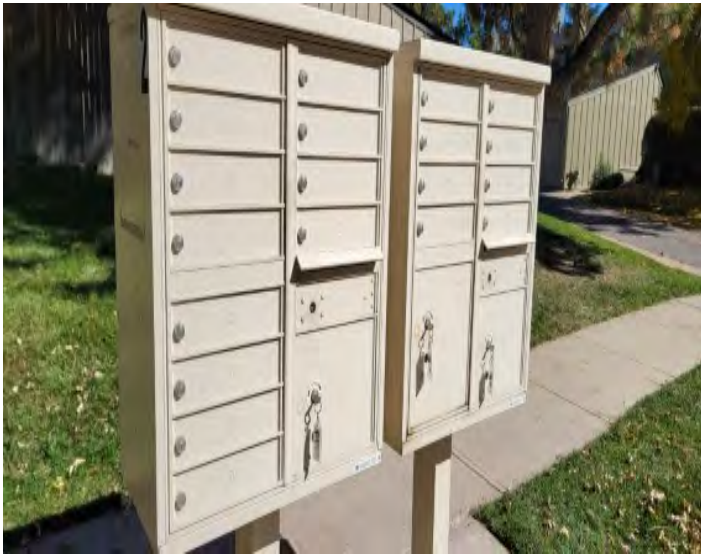
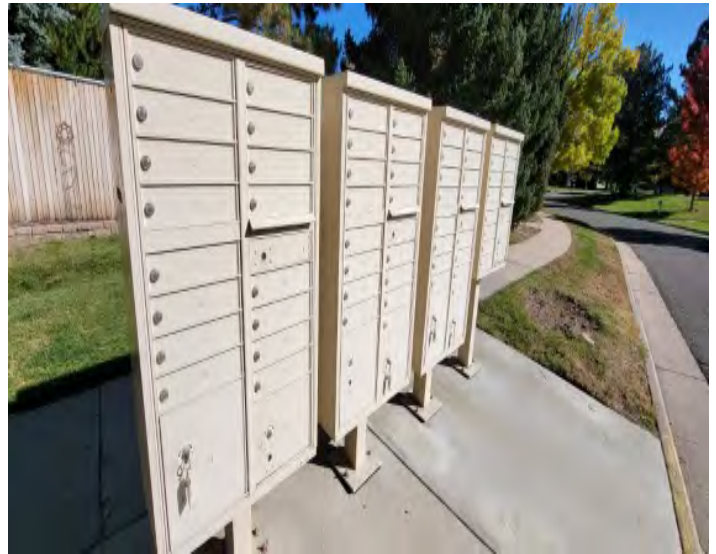
Comp #: 803 Mailboxes - Replace

- Boxes were replaced about 10 years ago and exhibiting normal signs of wear and deterioration
- According to several manufacturers, the typical life expectancy for this type of mailbox is 20 - 25 years in this environment.
- Remaining life is based on average age of all units.
- Per new Postal regulations effective 2012, "all customers are responsible for repairs and replacement of keys, locks, or the boxes/cluster units themselves".

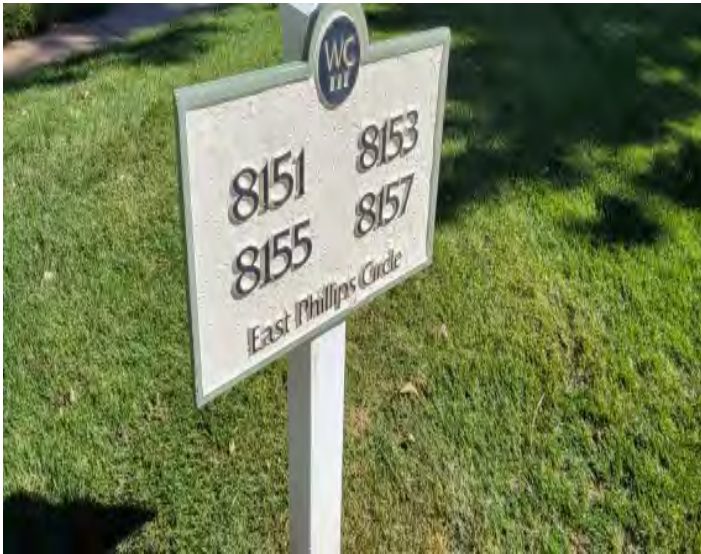
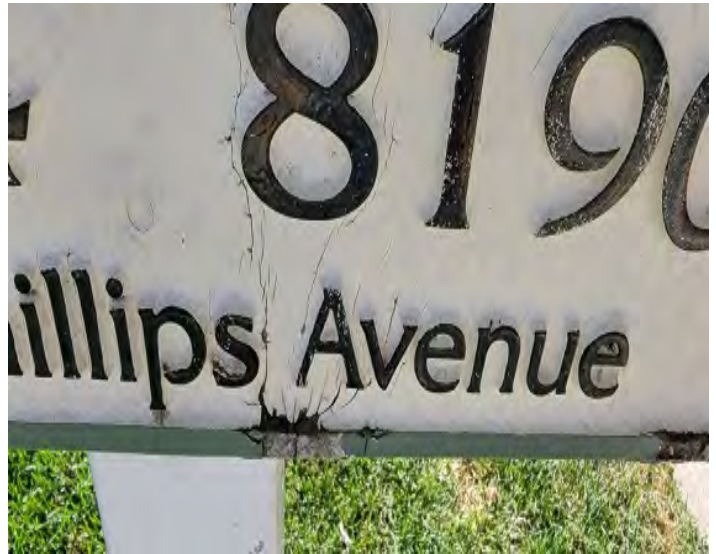
Comp #: 809 Signage - Replace

- Conditions of signs vary with several that are deteriorated and cracked edges, but none are broken and missing
- In our experience, we have seen this type of sign material last 12 - 18 years on average before replacement is required.
- While several signs are legible and intact, we recommend planning on replacing all at the same time in the next couple years to maintain a consistent appearance and to obtain the best replacement cost possible.
- The remaining life is based on age of the signs and the observed condition.

NOTE: exact cost of a new sign will depend on the type of materials selected by the Board at the time of replacement

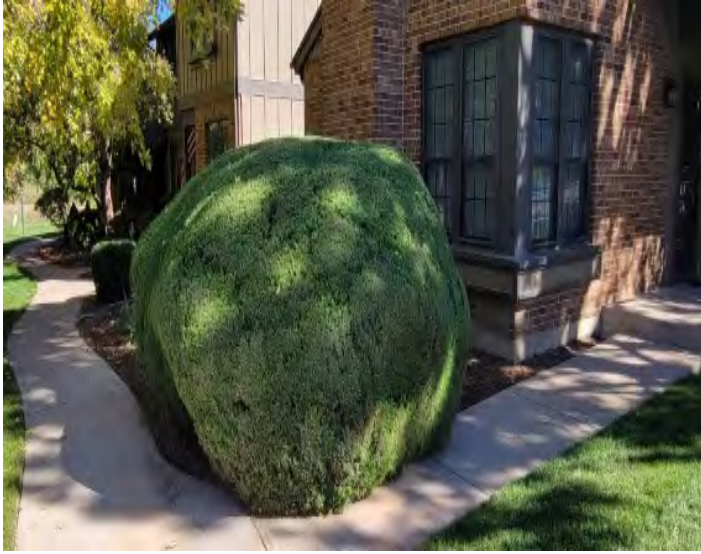
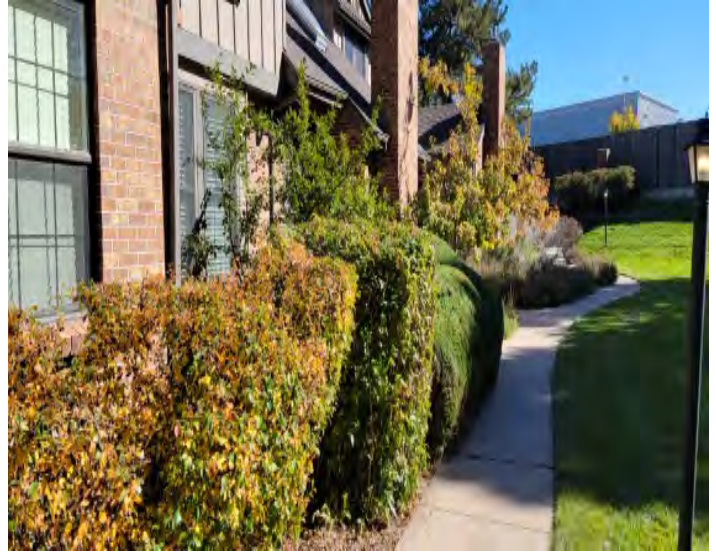
Comp #: 1801 Groundcover - Replenish

- This line item, similar to irrigation repairs, is for projects that lie outside the scope of routine maintenance.
- In order to preserve an attractive curb appeal and to maintain the health of the plants and shrubs, we recommend reserving for refurbishment projects every 2 - 3 years.
- This line item is for cyclical refurbishment and should not be considered as complete landscaping replacement.

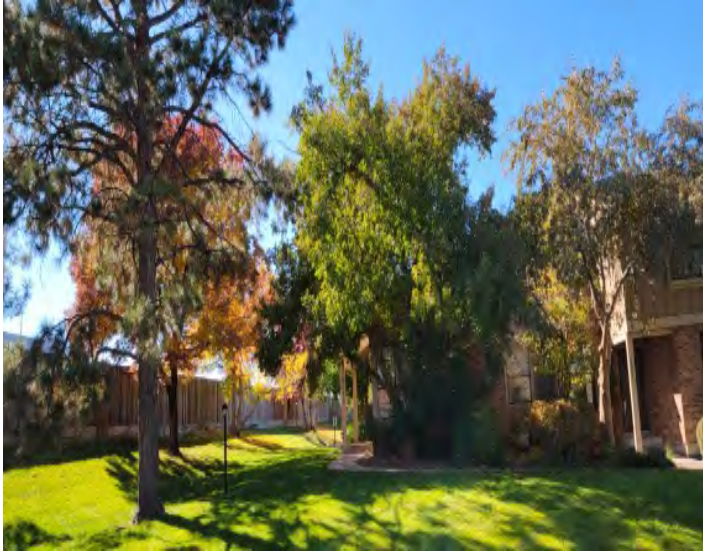
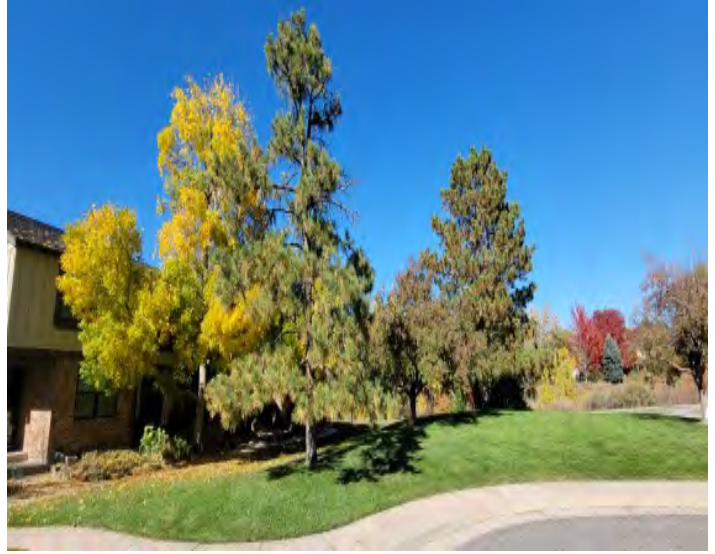
Comp #: 1804 Tree - Replacement/Major Maintenance

- It is very difficult to predict a replacement cycle for trees as there are several factors that will contribute to a tree dying.
- Factors such as disease, infestation of insects, heavy snow storms, etc. can all attribute to eventual tree replacement.
- Since it is difficult to predict when the replacement will be necessary, Reserve funding is typically not a factor.
- However, based on our recent experience, an allowance for periodic replacement has been included.
