Willow Creek III HOA

Level 2 Reserve Analysis

Report Period – 01/01/14 – 12/31/14

Date of Property Observation - October 23, 2013
Project Manager - G. Michael Kelsen, RS, PRA
Main Contact Person - Mr. Ron Valiga, Community Manager

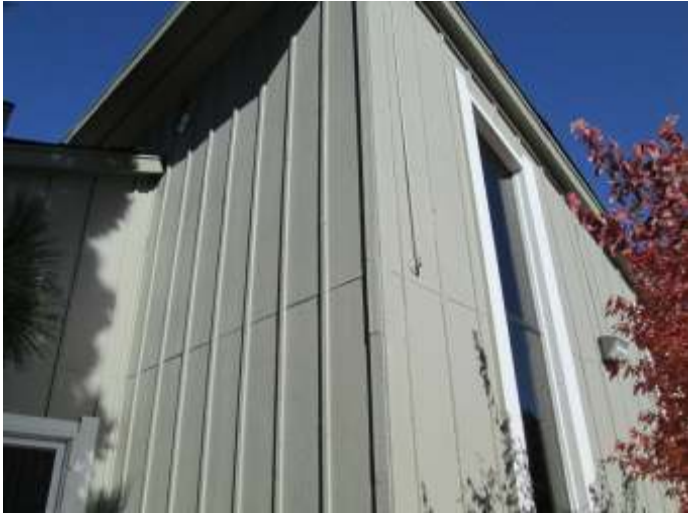
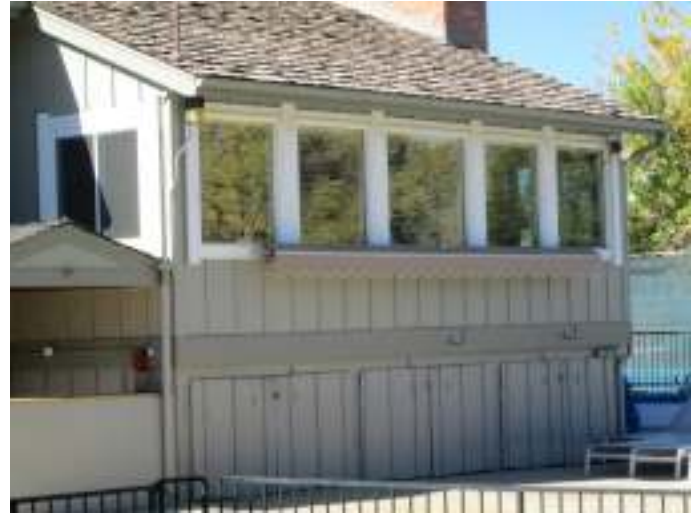
Comp #: 202 Clubhouse Exterior - Repaint

Location: Clubhouse

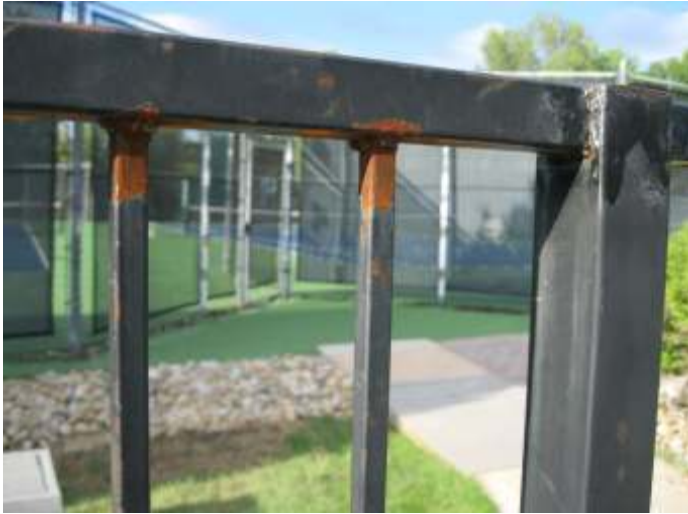
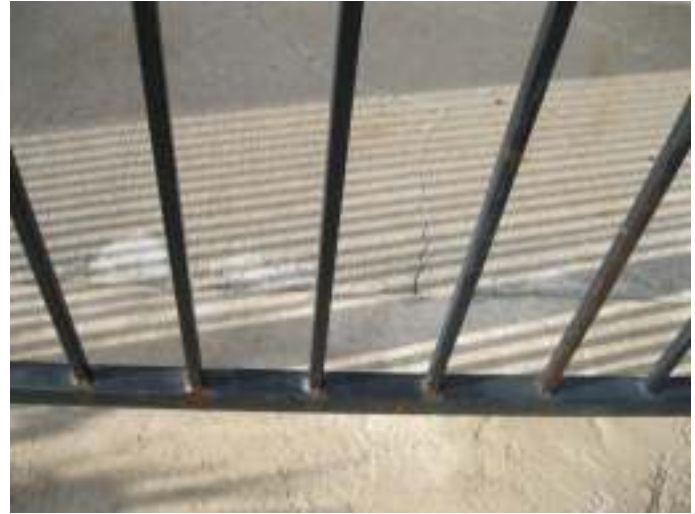
Comp #: 207 Iron Fencing - Repaint

Location: Pool area, clubhouse

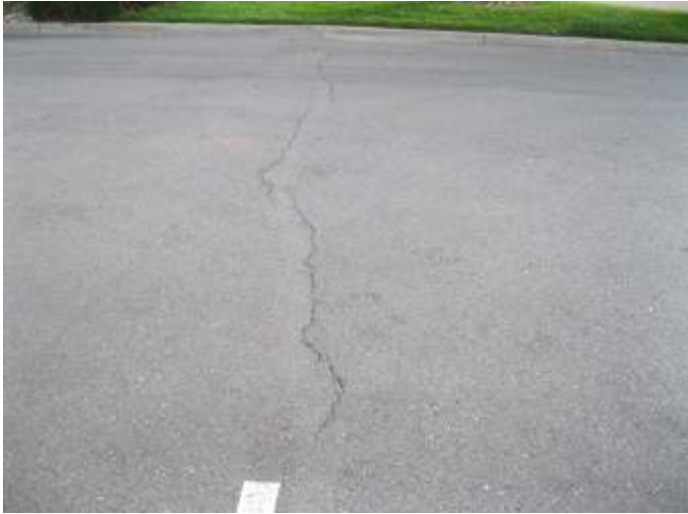
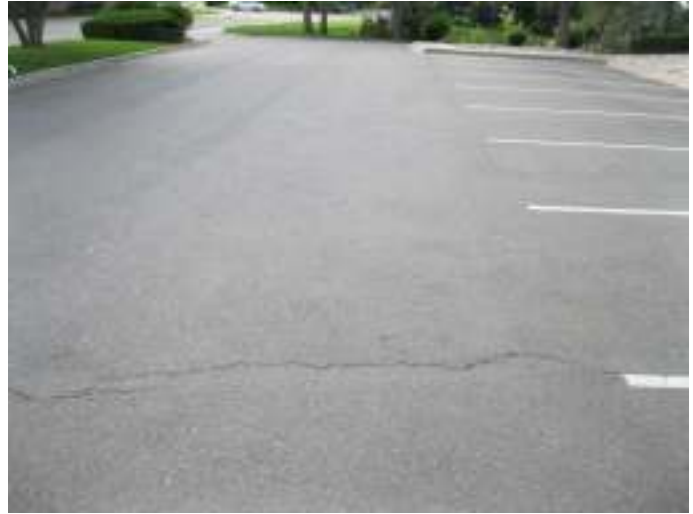
Comp #: 401 Asphalt - Overlay

Location: Clubhouse parking lot

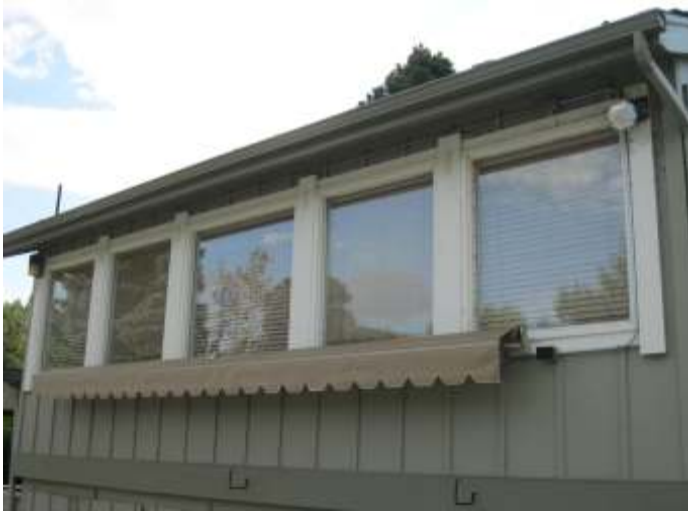
Comp #: 506 Doors/Windows - Replace

2009 - \$800 (replace doors at clubhouse), 2009 - \$830.75 (doors), 2011 - \$2500 (windows). Based on the expense history, it does not appear that all windows and doors were replaced. Therefore, due to varying ages, we have revised the philosophy to include an allowance for partial replacement of windows (about 1/3rd) every 10 years. One of the middle windows on the pool side of the building was broken.

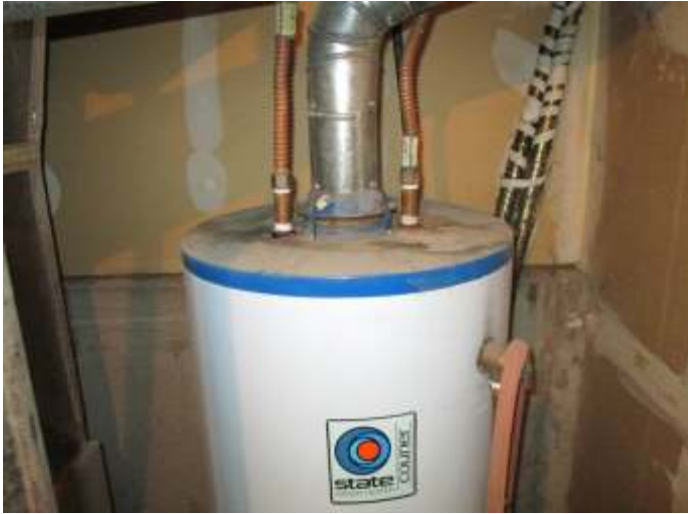
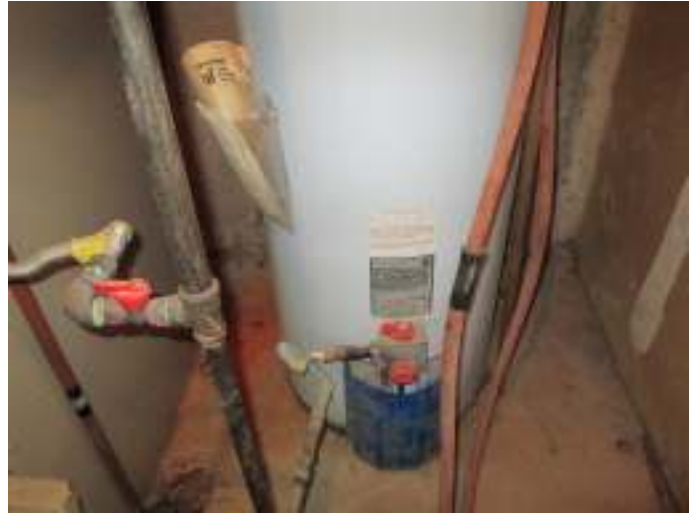
Comp #: 703 Hot Water Heater Tank - Replace

Operating expense if purchased and installed proactively. If this needs to be replaced in an emergency situation, then expect to spend almost twice the normal price.

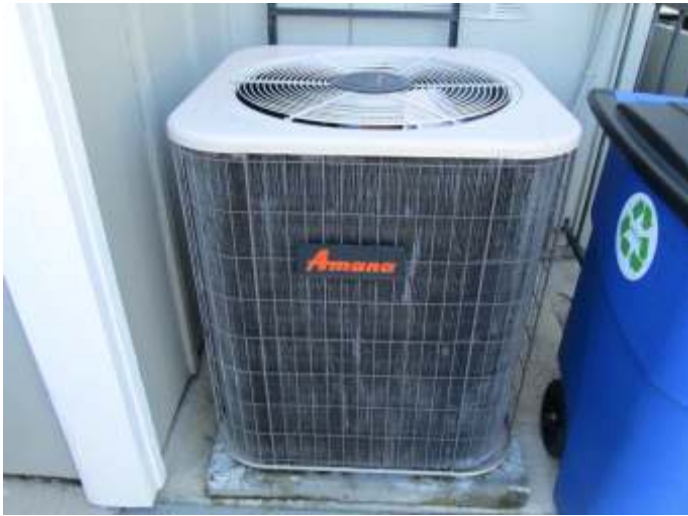
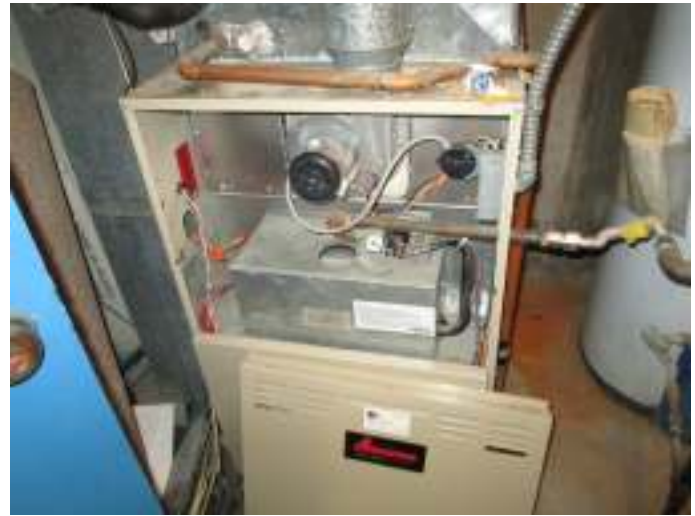
Comp #: 705 HVAC System - Replace

Location: Clubhouse

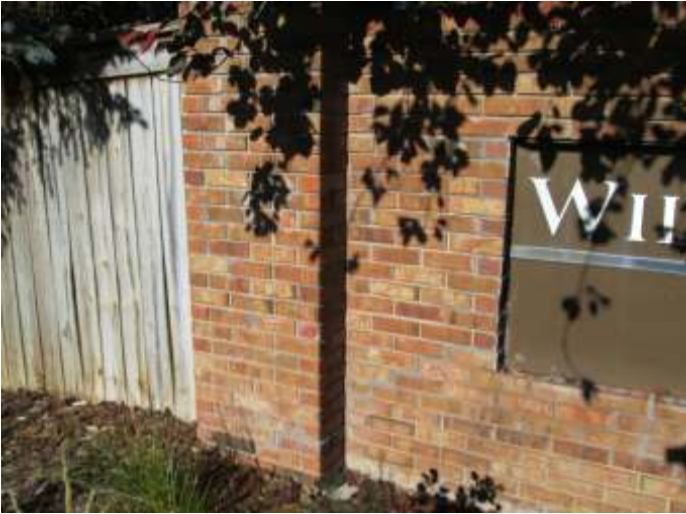
Comp #: 801 Monument - Rebuild

The crack that was noted in the brick wall below the signage has been filled. Monument is structurally stable and in good condition with no deterioration noted.

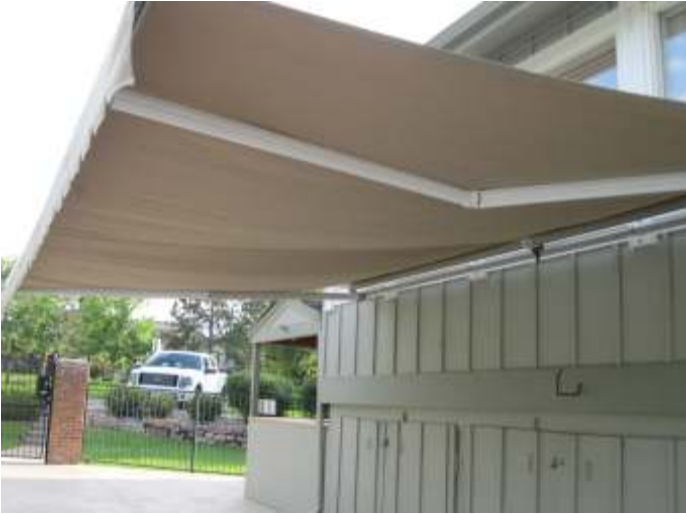
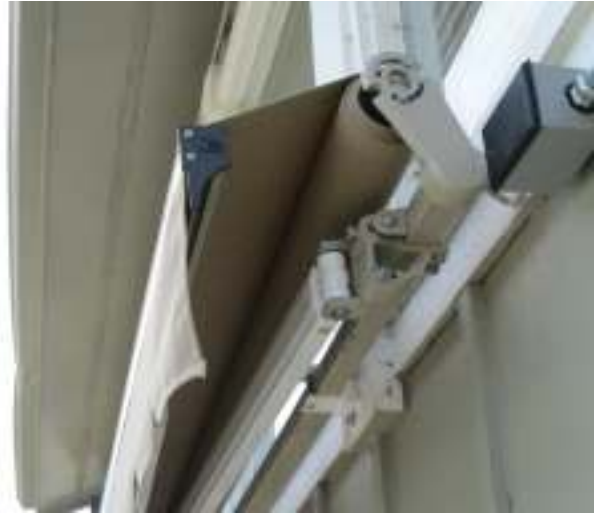
Comp #: 804 Awnings - Replace

Replaced recently. Good operating condition with no problems observed or reported.

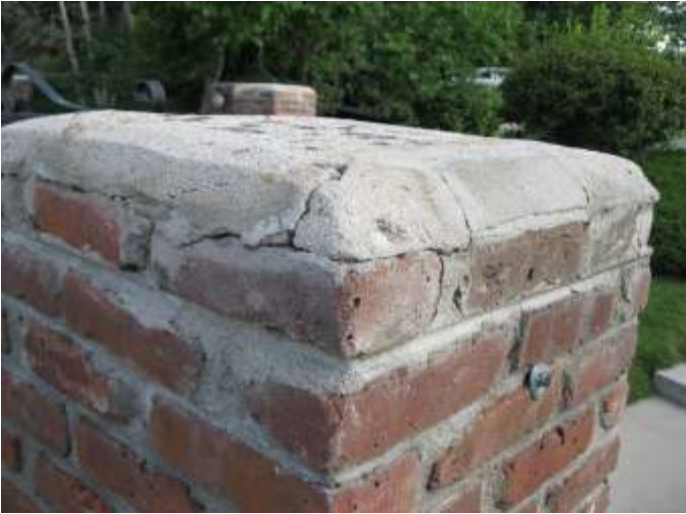
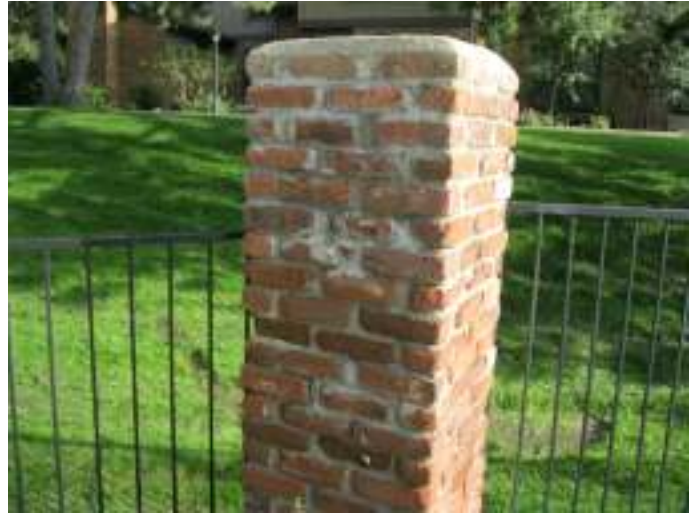
Comp #: 1005 Brick Columns - Major Repairs

Location: Pool and community perimeter

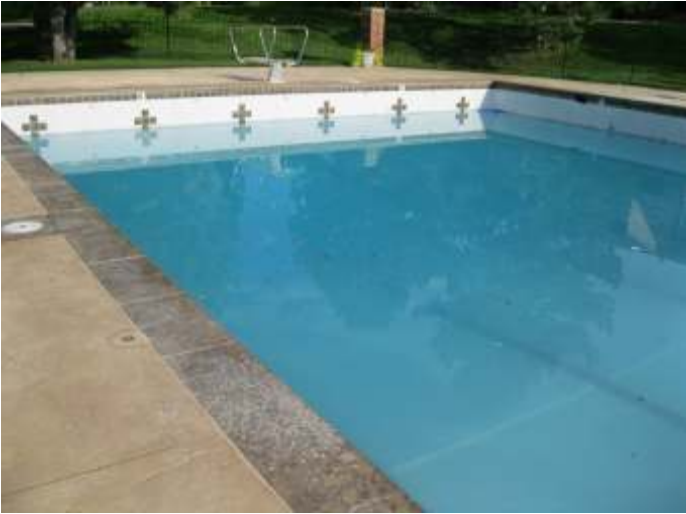
Comp #: 1101 Pool - Resurface

resurfaced in 2005 with the Diamond Brite plaster material. According to several maintenance companies, this coating should last 2-3 times longer than white marble plaster because aggregate is much more durable than marble dust. There has not been any reports of having to replace the pool due to using this type of surface. This type of material typically costs 50% more than the typical surface of marble dust.

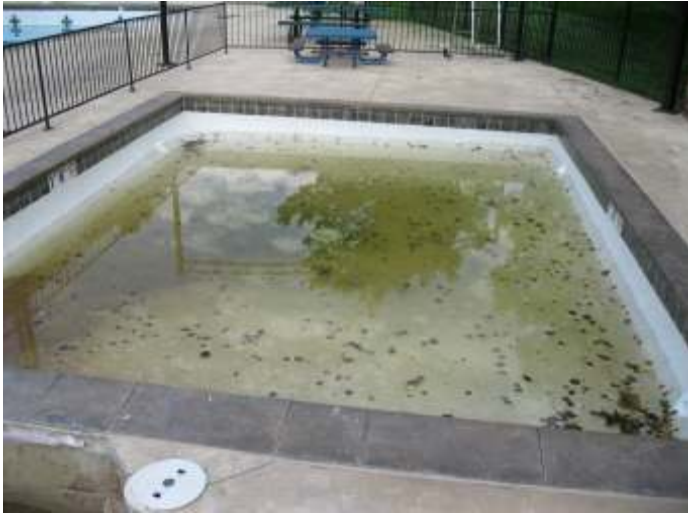
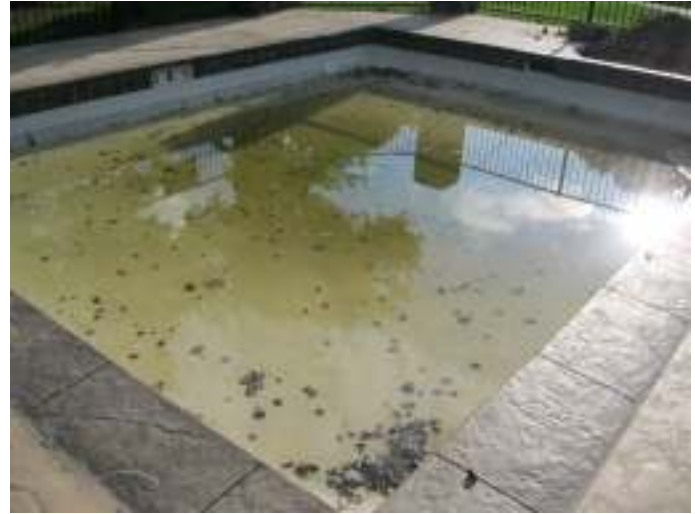
Comp #: 1103 Wader - Resurface

resurfaced in 2005 with the Diamond Brite plaster material. According to several maintenance companies, this coating should last 2-3 times longer than white marble plaster because aggregate is much more durable than marble dust. There has not been any reports of having to replace the pool due to using this type of surface. This type of material typically costs 50% more than the typical surface of marble dust.

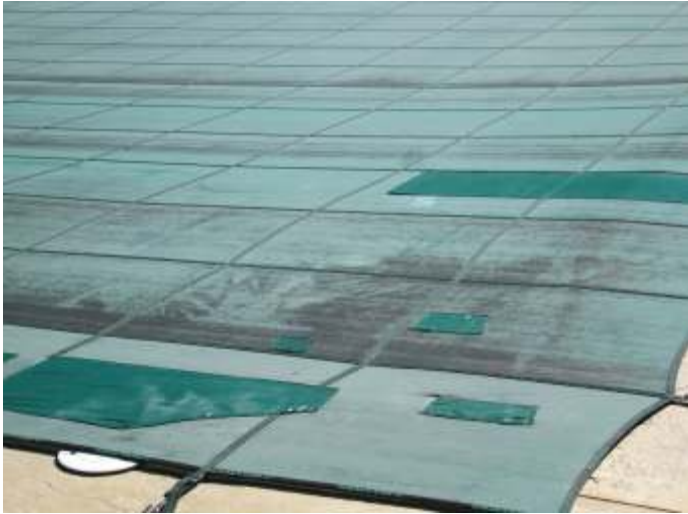
Comp #: 1112 Pool Cover - Replace

Material is very thin and does not currently serve as a safety cover. If someone were to walk on the cover, the material would not hold the weight of an average person. Also, the thin material is not protecting the plaster from exposure to sunlight during winter months when the water level is lowered. Based on observed conditions, we recommend replacing the covers immediately.

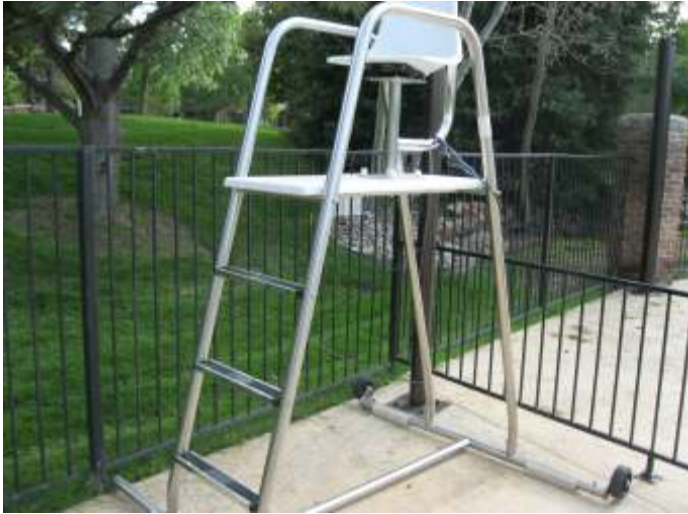
Comp #: 1117 Lifeguard Stand - Replace

Lifeguard stand was new and in good condition. Minor rusting is expected around the base due to exposure to chemicals and moisture from the pool. Replacement cycle for lifeguard stands range from 8 - 10 years, depending on quality of materials used for stand.

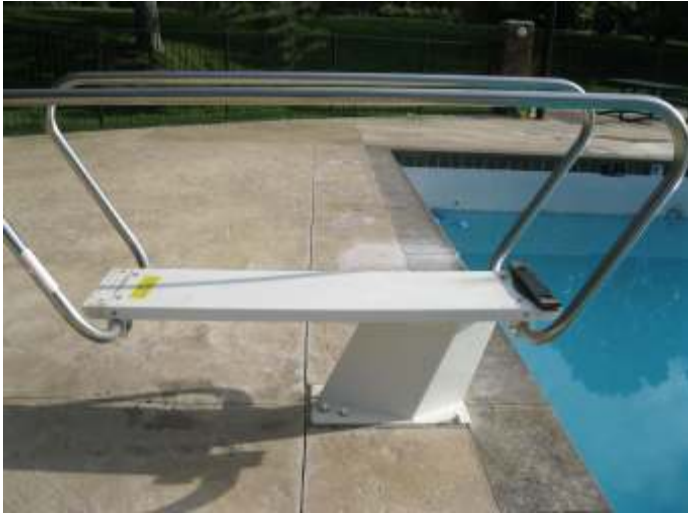
Comp #: 1118 Diving Board - Replace

New diving board was installed at the same time as the pool renovation project in 2013. The estimated cost includes replacement of the hand bars and platform.

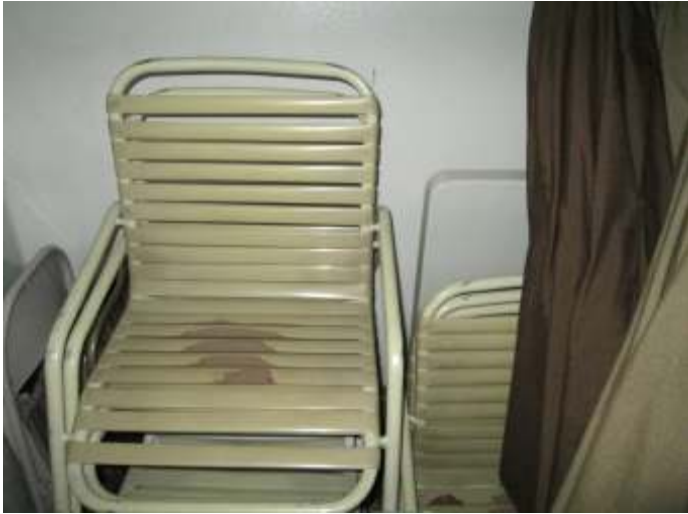
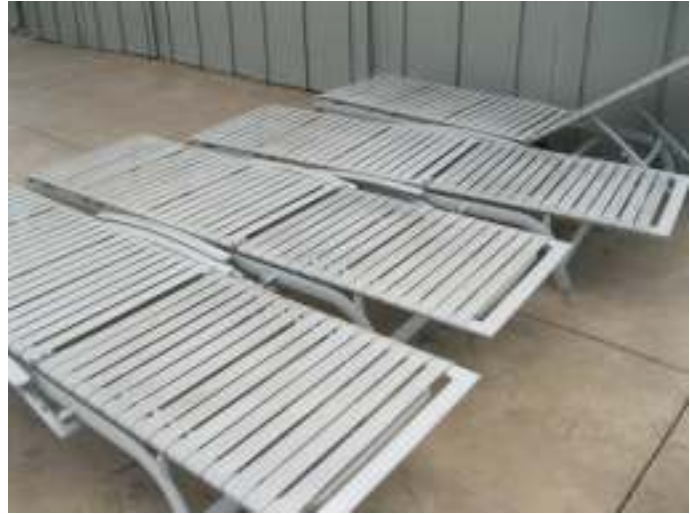
Comp #: 1120 Pool Furniture - Replace

furniture in storage, so it was difficult to evaluate the condition and exact quantity.

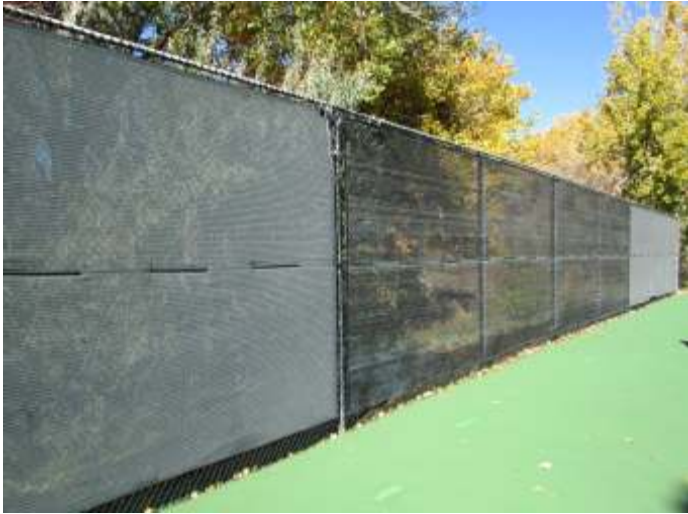
Comp #: 1202 Tennis Court Windscreen - Replace

A few panels had been replaced many years ago, but even the newer panels are thin and worn. In general, the majority of the windscreen is in poor condition and will need to be replaced in the near future.

Best Cost: **\$7,000**
\$0.85/GSF; Estimate to replace

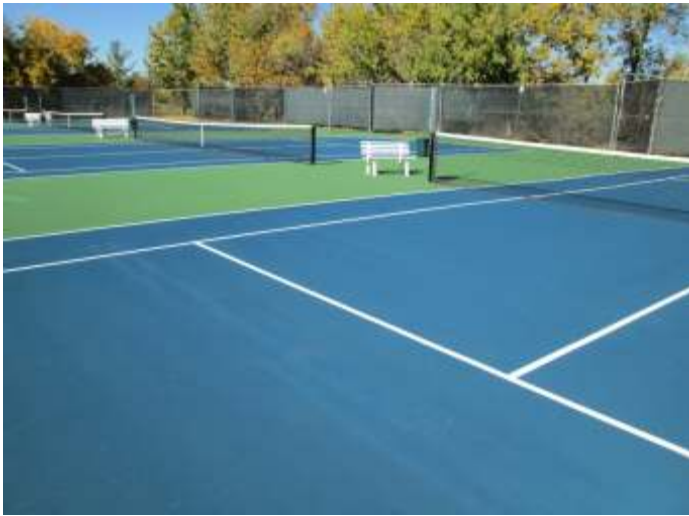
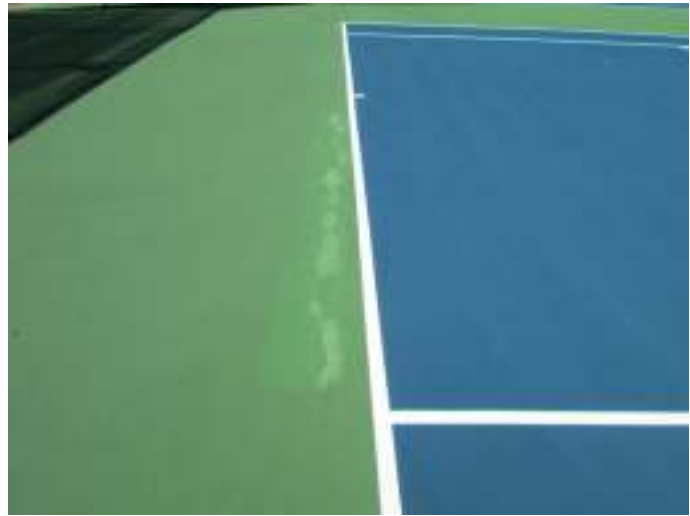
Comp #: 1203 Tennis Court Asphalt - Resurface

Court was overlaid with a 2" cap in 2007, then again in 2012?

\$9000/court; Estimate to remove and replace

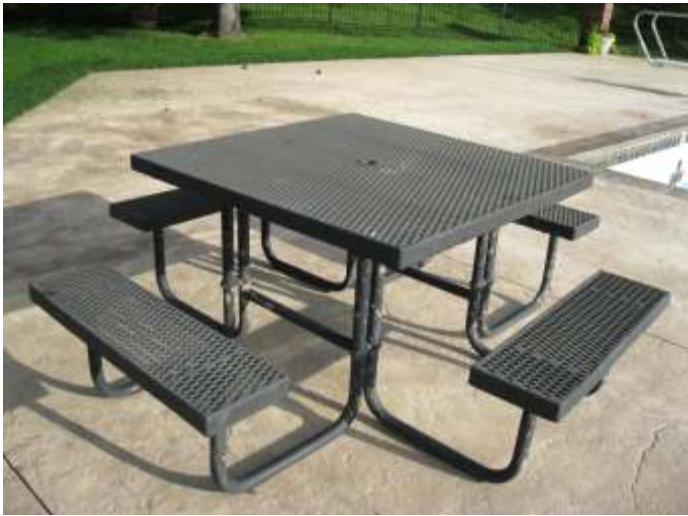
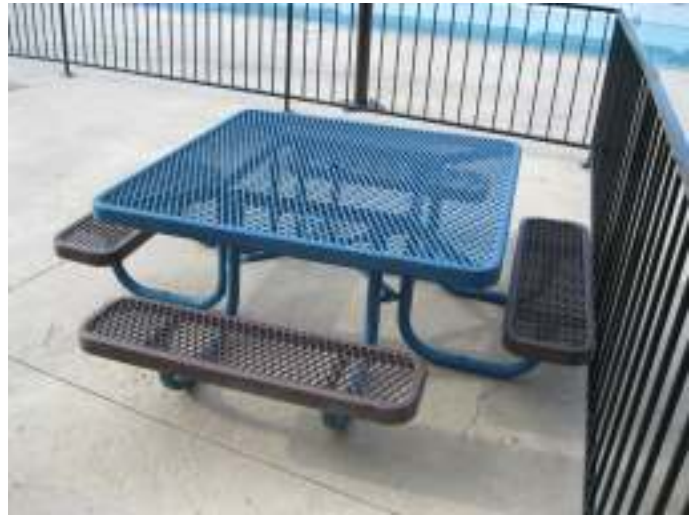
Comp #: 1306 Park Furnishings - Replace

Location: Clubhouse & Tennis Court Common Area

Allowance for partial replacement

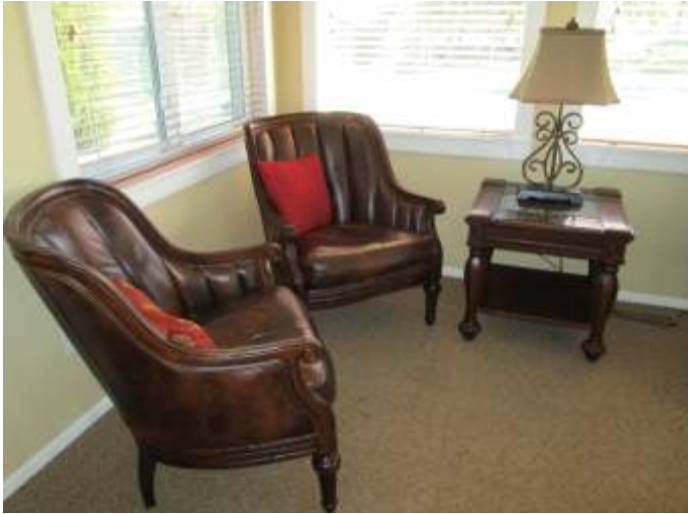
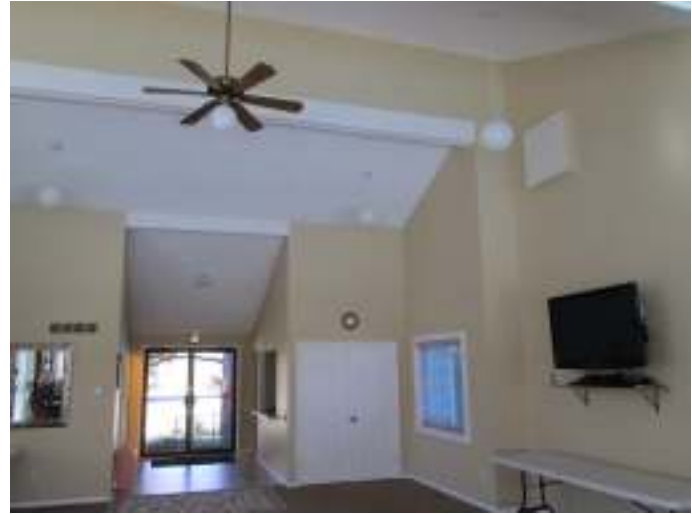
Comp #: 1414 Clubhouse - Remodel

Association spent approximately \$3,125 on six new chairs in May, 2005. New refrigerator purchased in 2007 (\$510), new clubhouse furniture purchased in 2009 (\$4729), 2009 - fireplace - \$3228.60, 2009 - "improvements" - \$1671.34, 2010 - countertops - \$2970, carpet and 3 bath lights - \$2985.17,

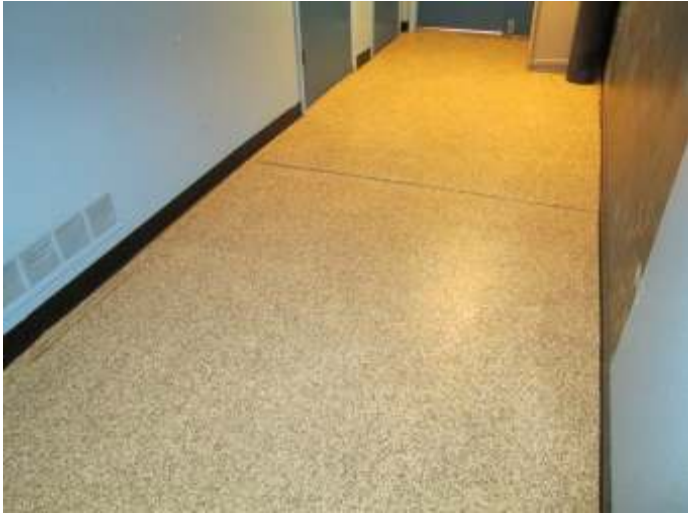
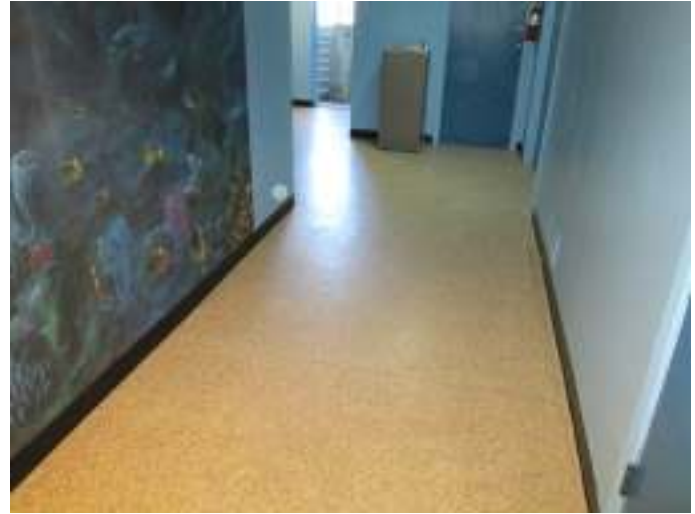
Comp #: 1506 Clubhouse Flooring - Recoat

Location: Lower level of clubhouse

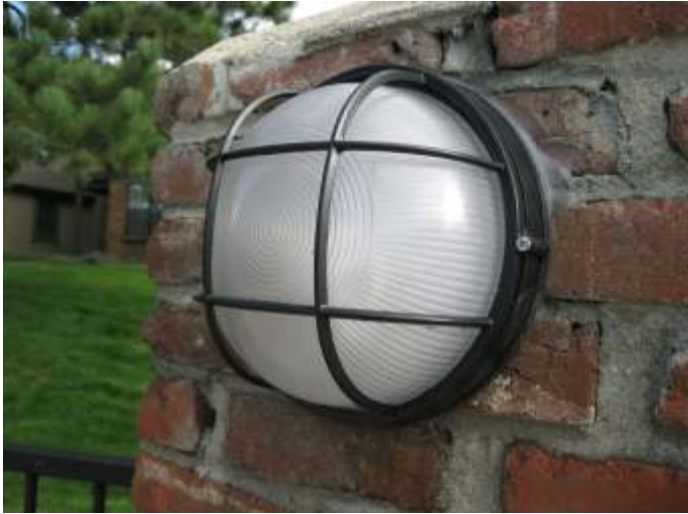
Comp #: 1602 Exterior Wall Mount - Replace

Observations:
Operating issue.

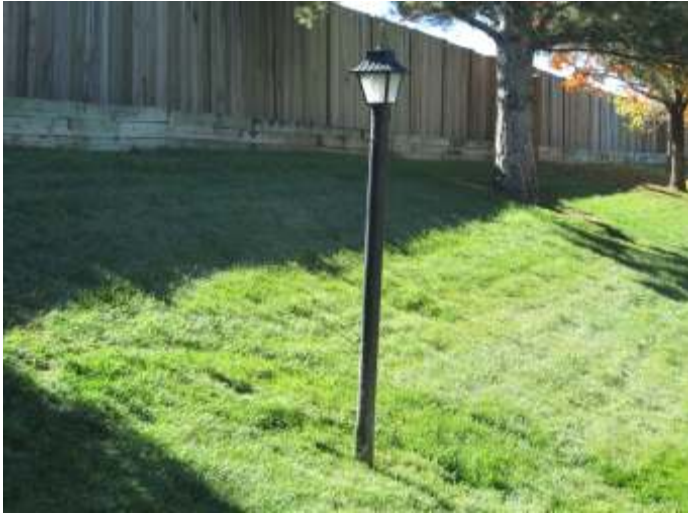
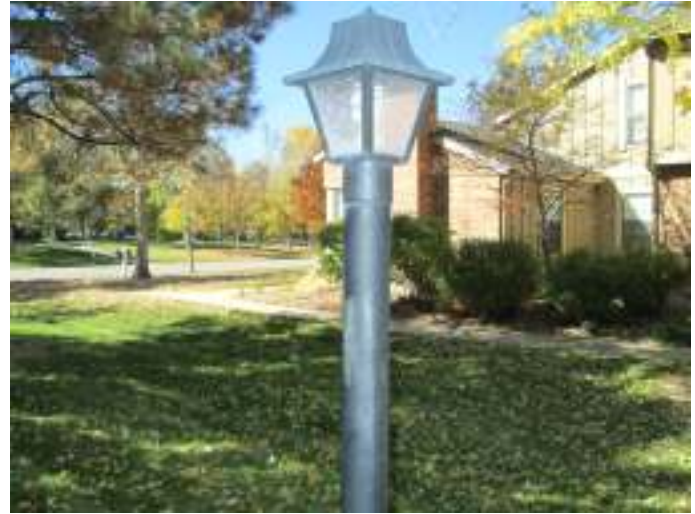
Comp #: 1604 Pole Lights - Replace

It was reported by the association in the last Reserve Study that these lights will be replaced on an as needed basis with general operating funds. Therefore, Reserve funding is not required for this component.

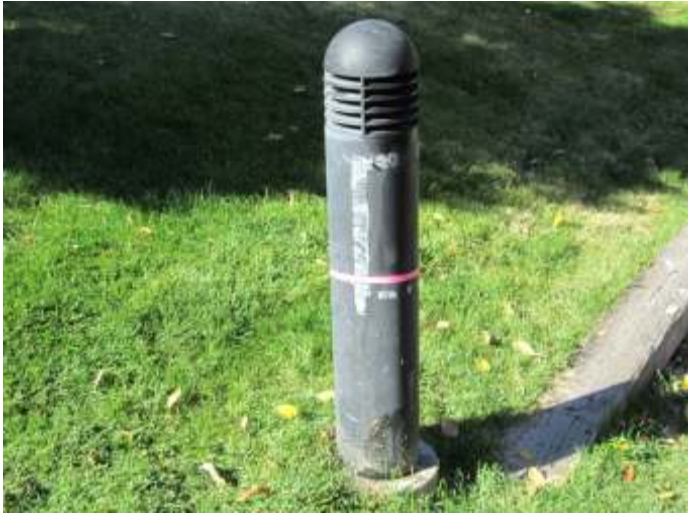
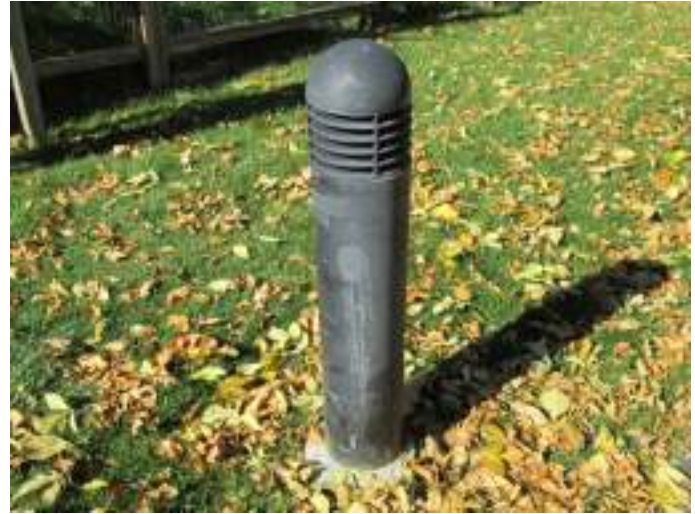
Comp #: 1605 Bollard Lights - Replace

It was reported by the association in the last Reserve Study that these lights will be replaced on an as needed basis with general operating funds. Therefore, Reserve funding is not required for this component.

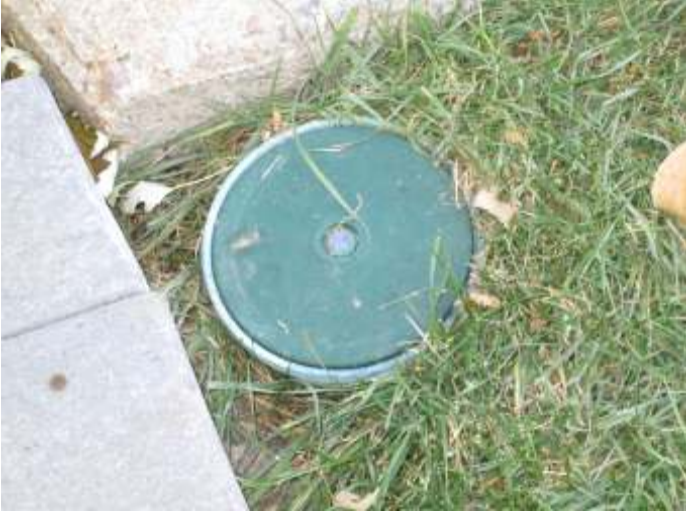
Comp #: 1701 Irrigation System - Rebuild

No reports of major problems with the irrigation system was noted at time of inspection or preparing this report. This system is less than 10 years old, however, systems that reach 15 - 20 years old start to see the need for major renovations and repairs. Therefore, we suggest the association establish a Reserve allowance for major repairs every 5 years. The remaining life is based on the age of the system and when it will reach the age that major repairs will be required.

Estimate for major repairs and renovating system

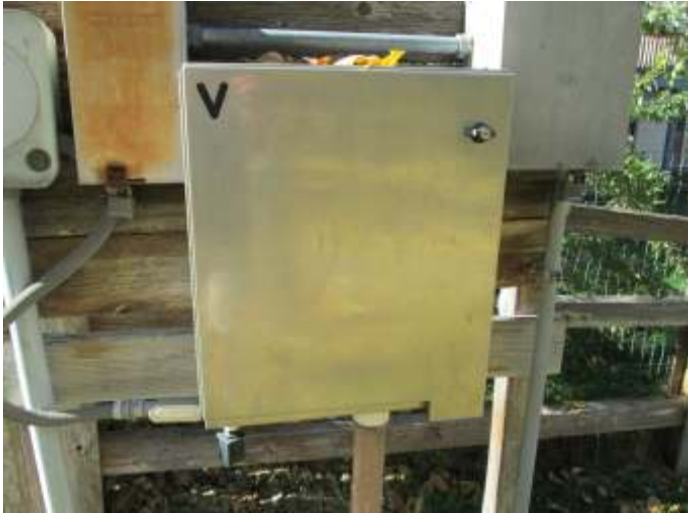
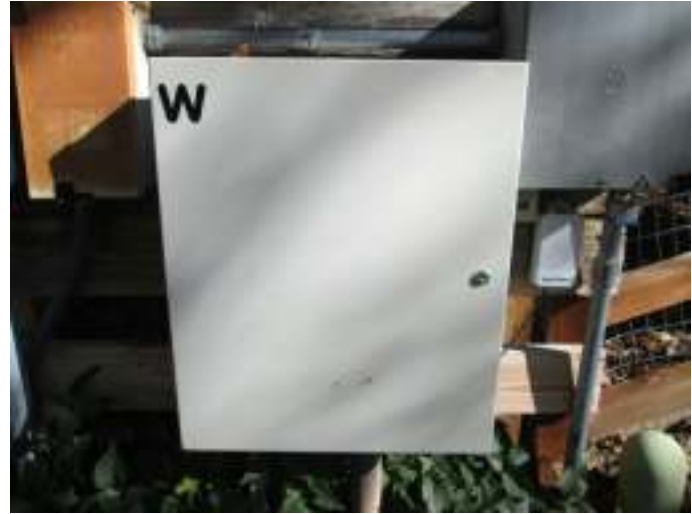
Comp #: 1703 Irrigation Timeclocks - Replace

2007 - \$4357.47, 2009 - \$20584, 2011 - \$6950,

Estimate to partially replace every other year

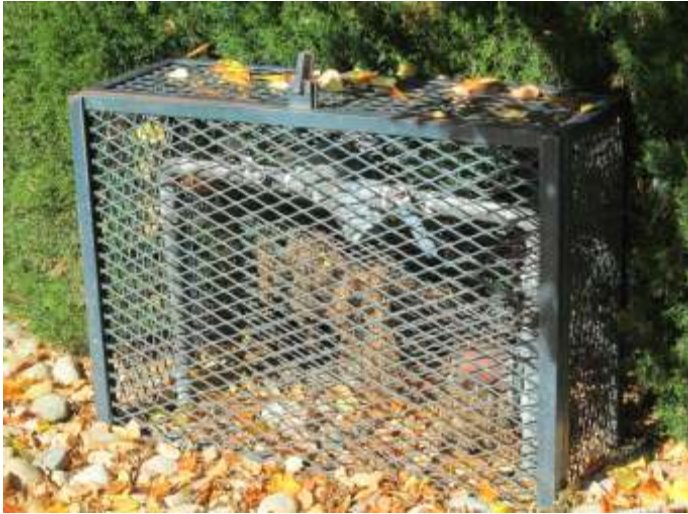
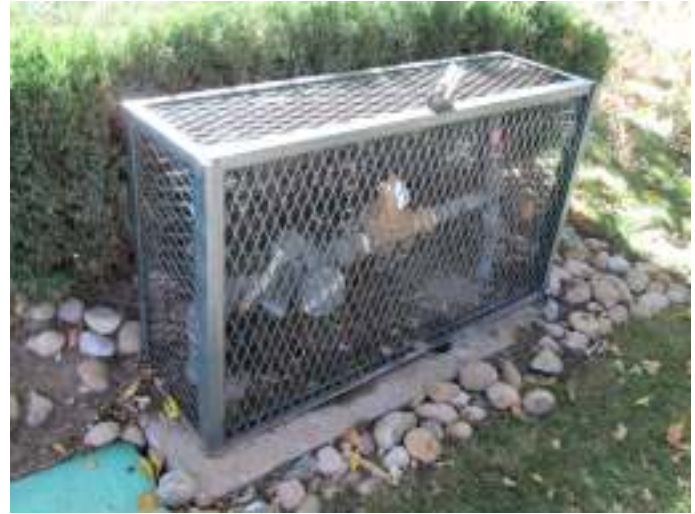
Comp #: 1706 Backflow Devices - Replace

No problems noted at the time of inspection. Due to the minimal replacement cost (\$500 - \$800 each) and unpredictable useful life associated with this component, reserve funding is not appropriate. Make repairs and replacements as necessary as an operating expense.

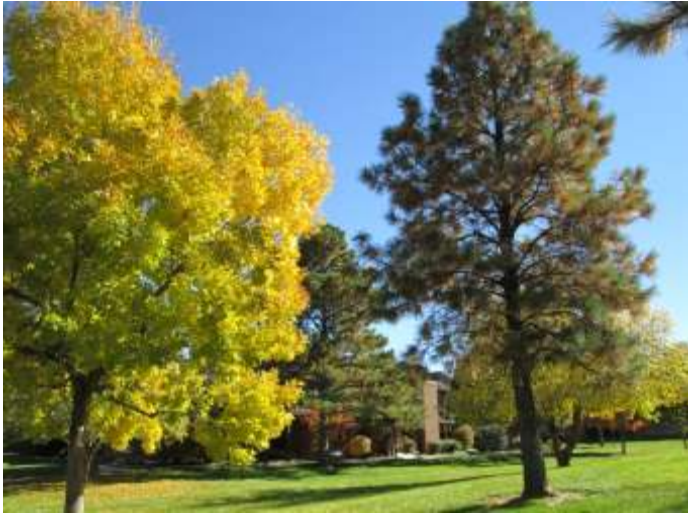
Comp #: 1804 Tree - Replacement

Trees appeared to be healthy and in good condition at time of inspection. It is very difficult to predict a replacement cycle for trees as there are several factors that will contribute to a tree dying. Factors such as disease, infestation of insects, heavy snow storms, etc. can all attribute to eventual tree replacement. Since it is difficult to predict when the replacement will be necessary, Reserve funding is typically not a factor. Therefore, unless requested by the association, Reserve funding will not be included as part of the study for this component.

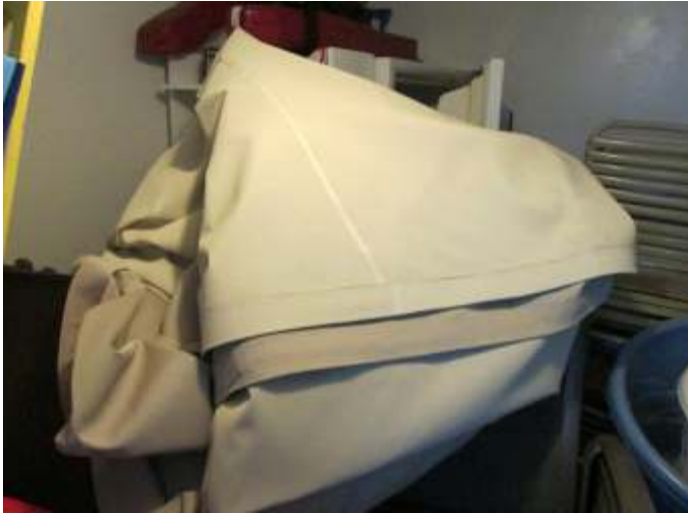
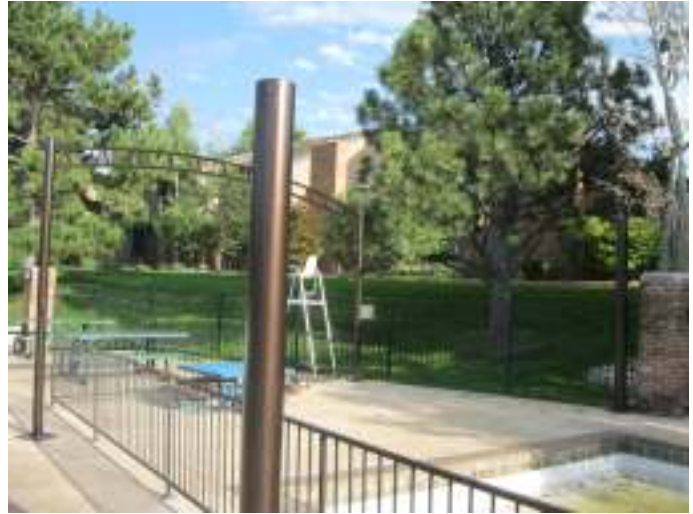
Comp #: 2001 Shade Structure - Replace

Location: Wader pool area
Quantity: Approx. 300 GSF
Life Expectancy: 16 Remaining Life: 15
Best Cost: \$7,500
\$25/GSF; Estimate to replace with same material
Worst Cost: \$9,000
\$30/GSF: Higher estimate for upgraded material
Source of Information: Cost Database
