**Willow Creek III HOA  
8091 E. Phillips Cir.  
Centennial, CO. 80112**

**Level 2, Platinum Reserve Analysis  
Report Period – 01/01/19 – 12/31/19**

**FINAL  
Version**

**Report was prepared on - Wednesday, August 29, 2018**

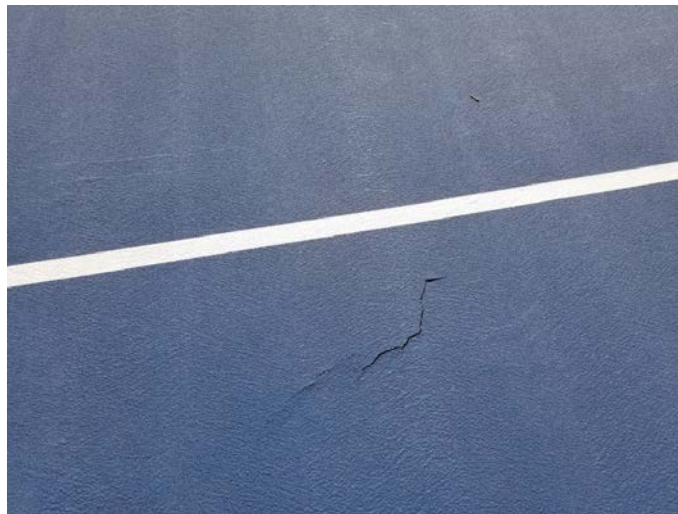
Comp #: 1202 Tennis Court - Recoat/Paint

- The association is planning on replacing these courts with post-tension concrete in 2022.
- Post-tention concrete will also need to be repainted every 5 - 7 years. Some repairs may be necessary as well at this time.
- Remaining life is based on the timing of the court installation.

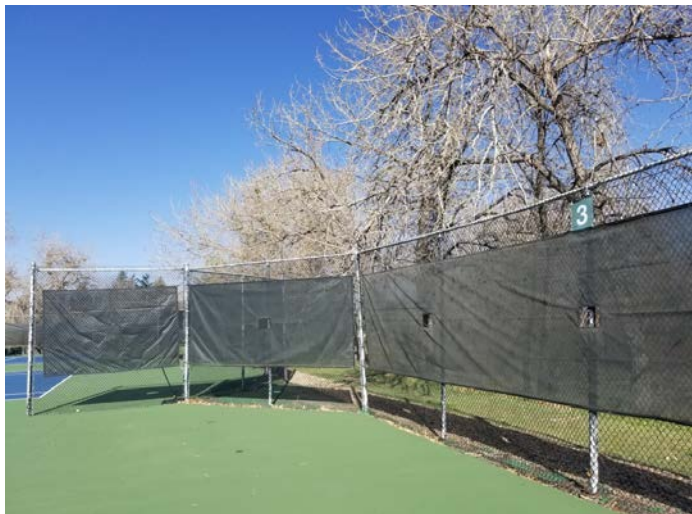
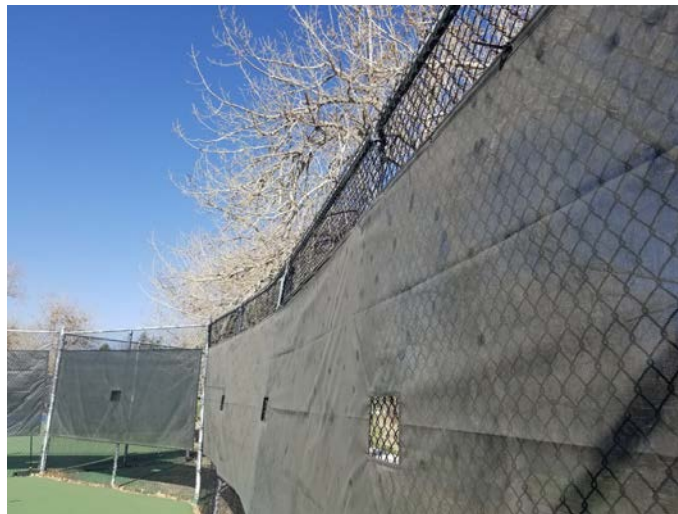
Comp #: 1203 Tennis Court Windscreen - Replace

- Expect a useful life of approximately 4 to 8 years from this component.

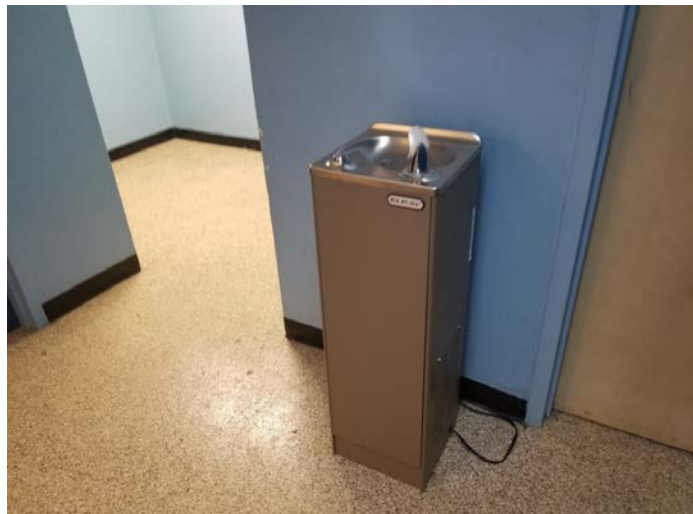
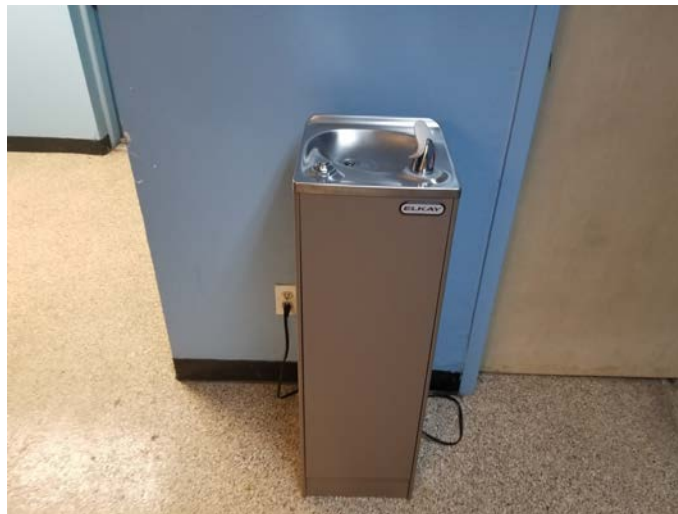
Comp #: 1304 Drinking Fountain - Replace

- Most communities are replacing these units with a bottle filling station, in addition to the standard drinking fountain to the side.
- These units usually last 10 - 15 years depending on level of use and exposure to elements.

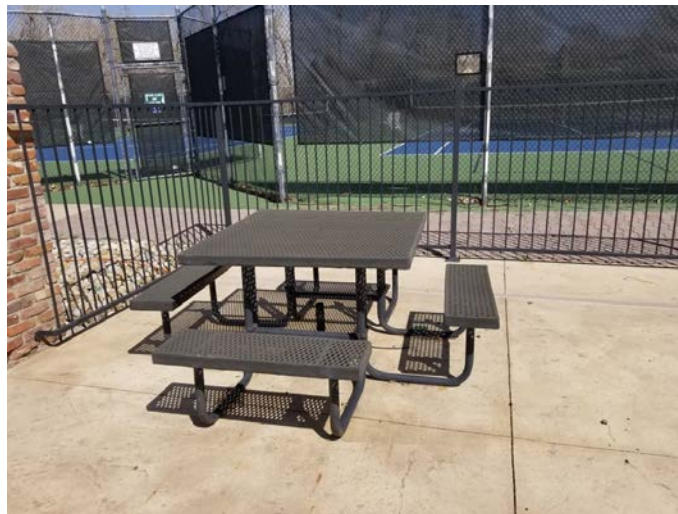
Comp #: 1306 Park Furnishings - Replace

- Expect to replace park equipment approximately every 16 years to maintain appearance.
- Remaining life based on assumed age and observed conditions.

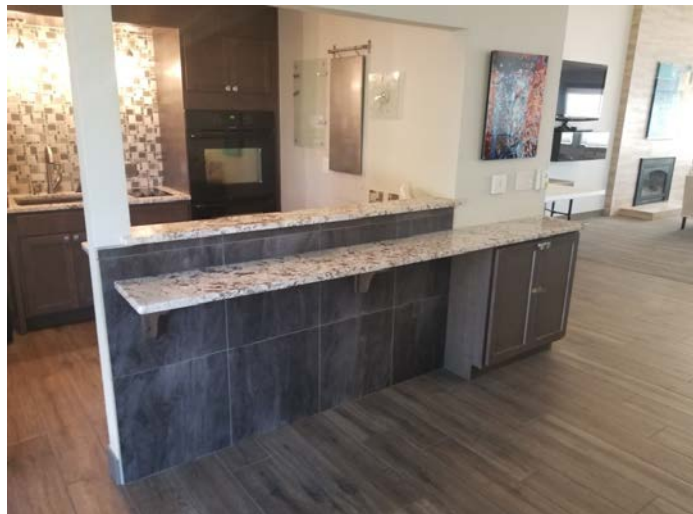
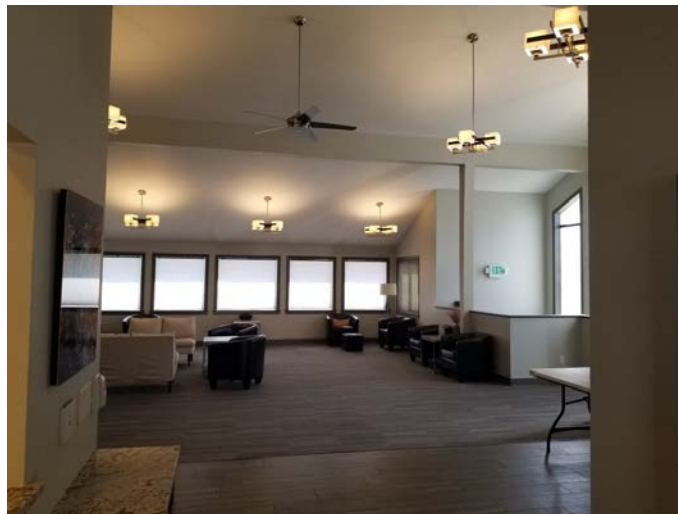
Comp #: 1413 Clubhouse - Remodel (Upper Level)

- Most associations perform a general remodel of the clubhouse interiors every 15 - 20 years to maintain appearance and keep up with current decorative trends.
- The final decision is up to the community members in deciding when to spend the money to perform this project since it is considered cosmetic.

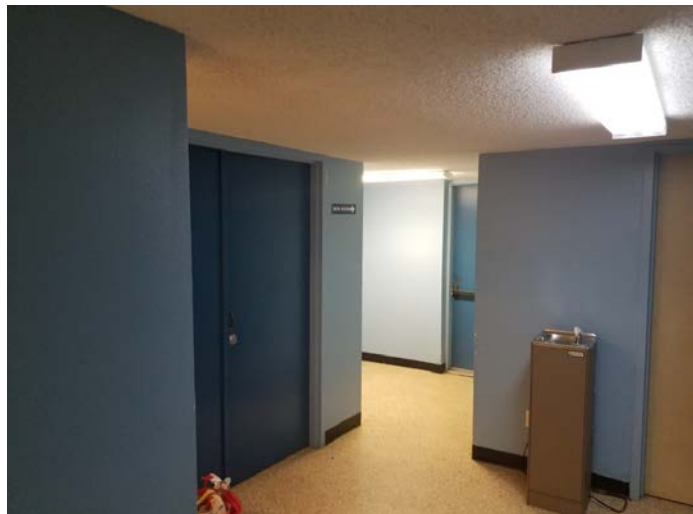
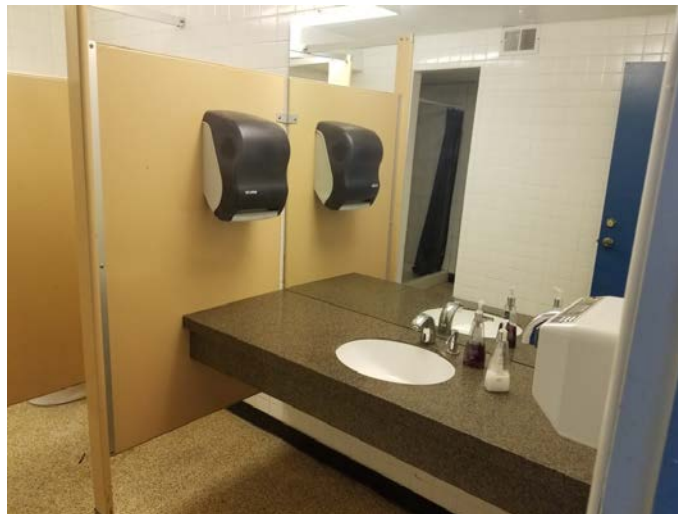
Comp #: 1414 Clubhouse - Remodel (Lower Level)

- Most associations perform a general remodel of the clubhouse interiors every 15 - 20 years to maintain appearance and keep up with current decorative trends.
- Based on the age of the community, we suggest planning a remodel of the interiors within the next couple years.
- The final decision is up to the community members in deciding when to spend the money to perform this project since it is considered cosmetic.

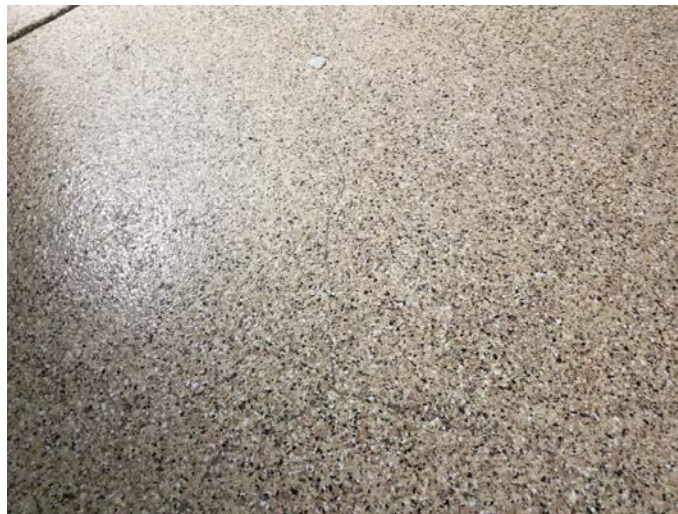
Comp #: 1506 Lower Level Flooring - Recoat

- There were some cracks noted in the floor of the lower level at the clubhouse.
- We recommend recoating this type of flooring every 10 years.
- Remaining life is based on the observed conditions and age.

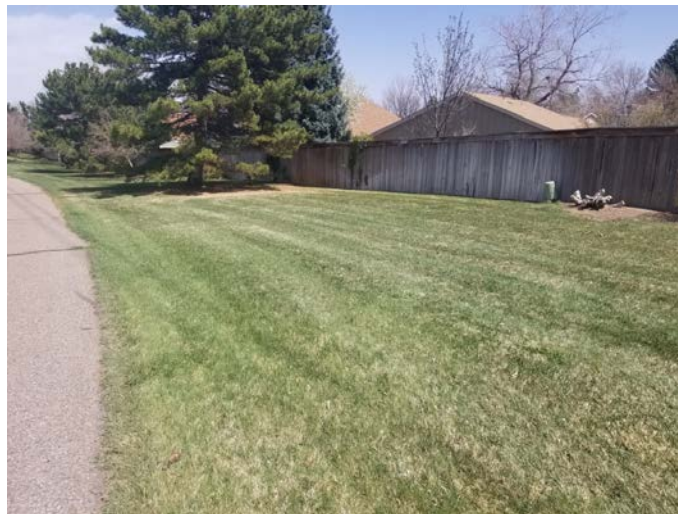
Comp #: 1701 Irrigation System - Rebuild

- This line item is for repairs and replacement that lies outside the scope of routine maintenance: bulk sprinkler head replacement, bulk valve replacement, rerouting lateral lines, rewiring, etc.
- In order to ensure the funds are available for major repairs, we recommend reserving funds for these projects every 4 - 5 years.
- The funding on this line item is for major repairs and is not to be interpreted as complete irrigation system replacement.

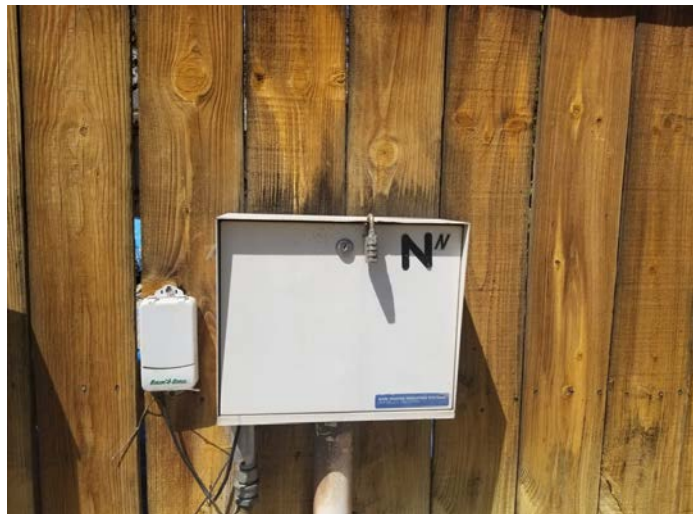
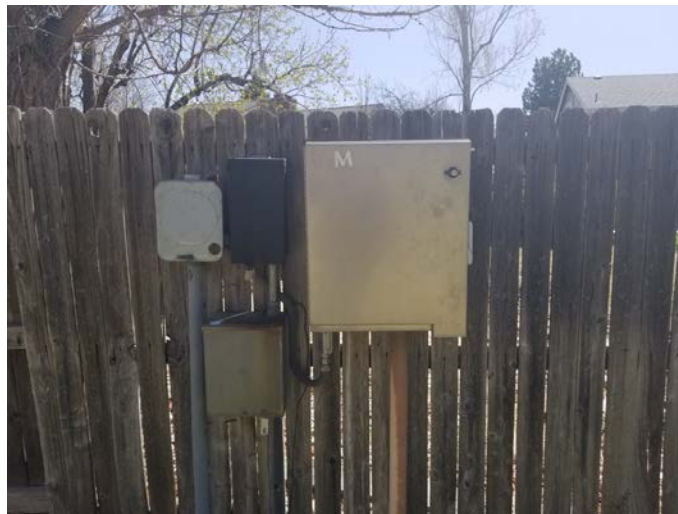
Comp #: 1703 Irrigation Timeclocks - Replace

- The overall life expectancy of irrigation controllers typically ranges between 10 - 12 years if properly maintained and under normal conditions.
- Due to the varying types and ages of controllers, we have established a Reserve allowance for partial replacement of controllers every 2 years.
- This line item should not be intended to be interpreted as complete replacement.

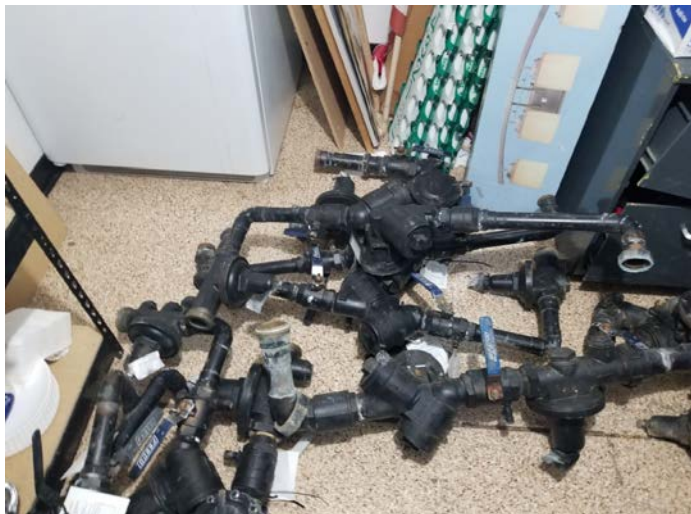
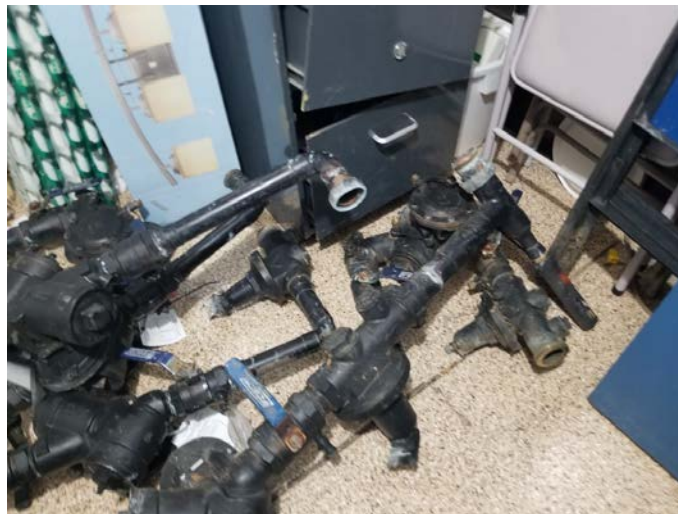
Comp #: 1706 Backflow Devices - Replace

- Devices can be rebuilt and repaired when needed as a maintenance issue.
- It is very seldom that a complete system would need to be replaced due to normal wear and tear.
- Replacement would be as a result of freezing conditions if system is not winterized properly or in a timely manner.
- No Reserve funding is required due to difficulty of predicting a life expectancy and the fact that systems can be rebuilt at a minimal cost, as opposed to being replaced.

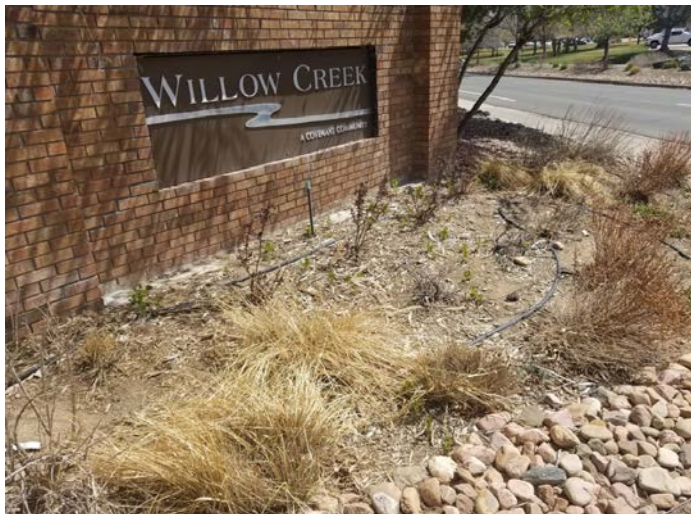
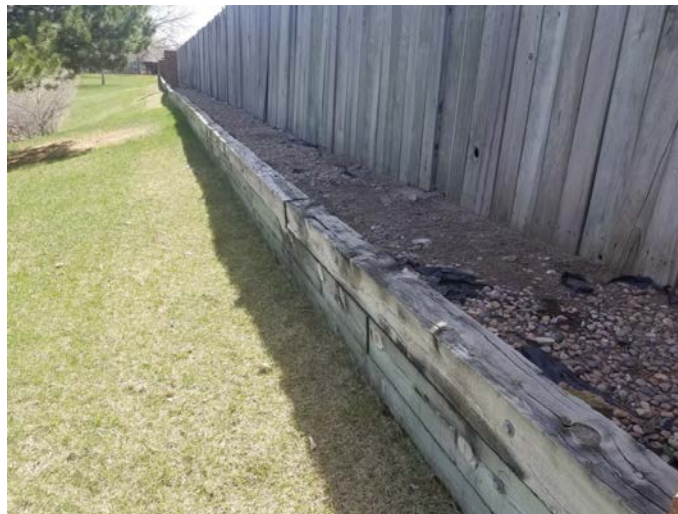
Comp #: 1801 Groundcover - Replenish

- This line item, similar to irrigation repairs, is for projects that lie outside the scope of routine maintenance.
- In order to preserve an attractive curb appeal and to maintain the health of the plants and shrubs, we recommend reserving for refurbishment projects every 2 - 3 years.
- This line item is for cyclical refurbishment and should not be considered as complete landscaping replacement.

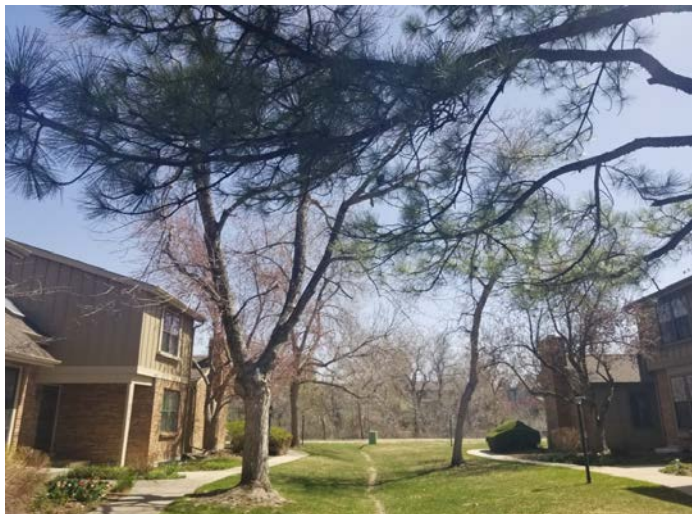
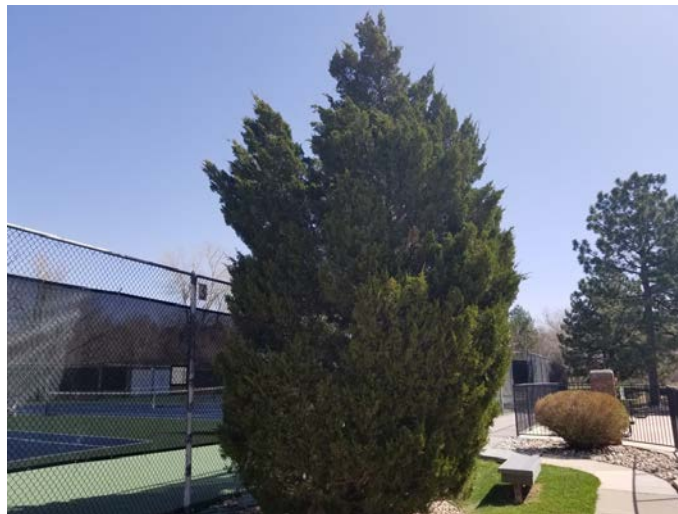
Comp #: 1804 Tree - Replacement/Major Maintenance

- It is very difficult to predict a replacement cycle for trees as there are several factors such as disease, infestation of insects, heavy snow storms, etc. can all attribute to eventual tree replacement.
- Since it is difficult to predict when the replacement will be necessary, Reserve funding is typically not a factor.
- Therefore, unless requested by the association, Reserve funding will not be included as part of the study for this component.

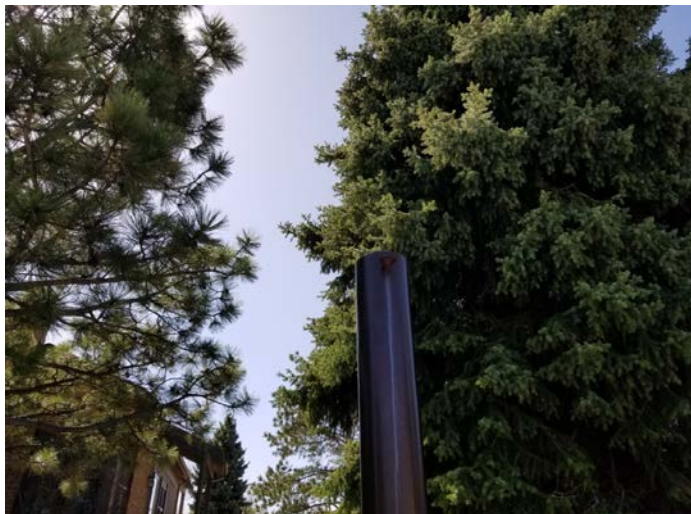
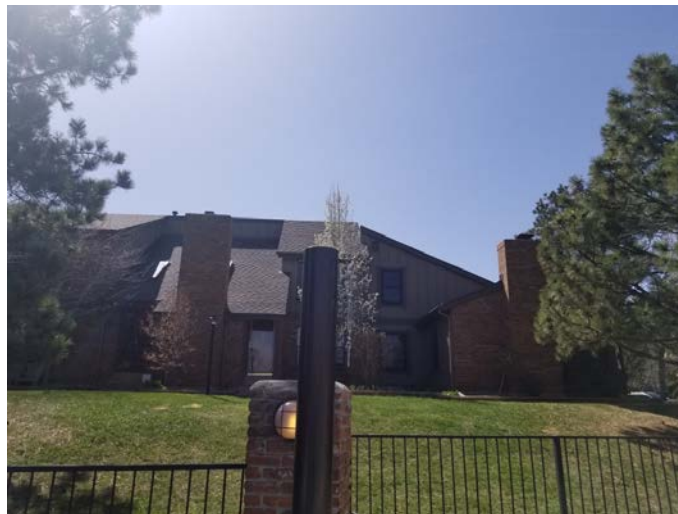
Comp #: 2001 Shade Structure - Replace

- We could not locate the fabric of the shade structure at the time of the site observation.
- There were no reported issues with the structures.
- Remaining life is based on the age of the structures.
