Level 2, Platinum Reserve Analysis

Willow Creek III HOA
8091 E. Phillips Cir.
Centennial, CO. 80112

FINAL VERSION

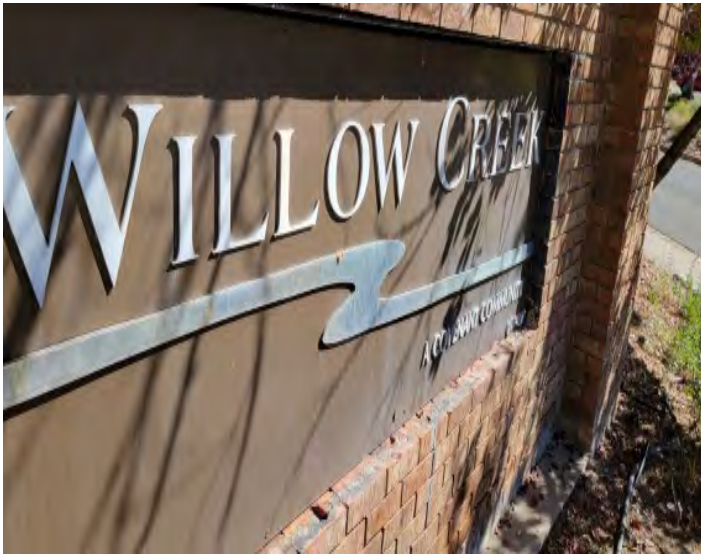
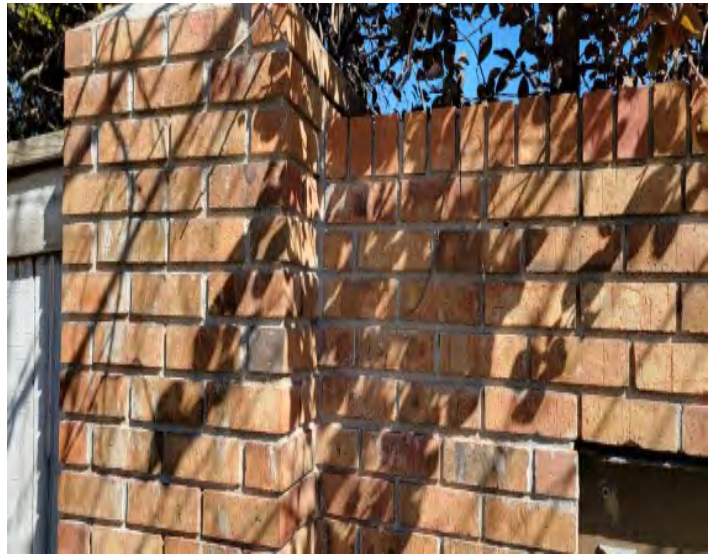
Comp #: 801 Monument - Rebuild

- While the materials used should have an indefinite life expectancy, we recommend planning on renovating monument every 20 - 25 years to maintain current trends and an appropriate appearance.
- It was reported in past Reserve Studies that any maintenance associated with the entry monument would be handled with general operating funds.
- Therefore, unless requested by current client, Reserve funds are not included in this report

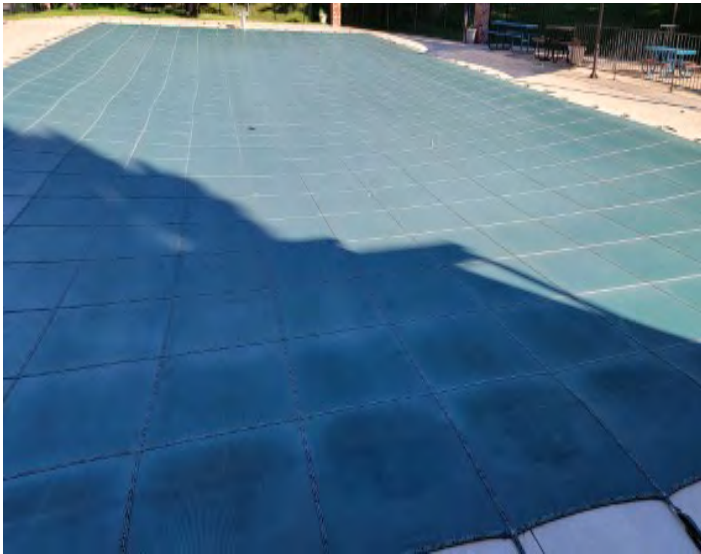
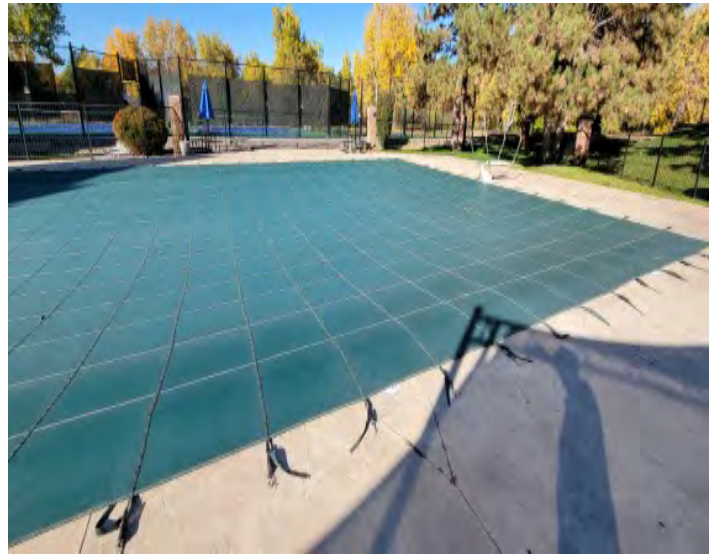
Comp #: 1101 Pool - Resurface

- Pool was winterized and covered at time of inspection, so we were unable to evaluate the entire surface.
- The average resurfacing cycle for pool surfaces ranges from 10 - 15 years, depending on the quality of the water and the chemical levels in the water.
- The remaining life is based on when the pools were last resurfaced in 2013.

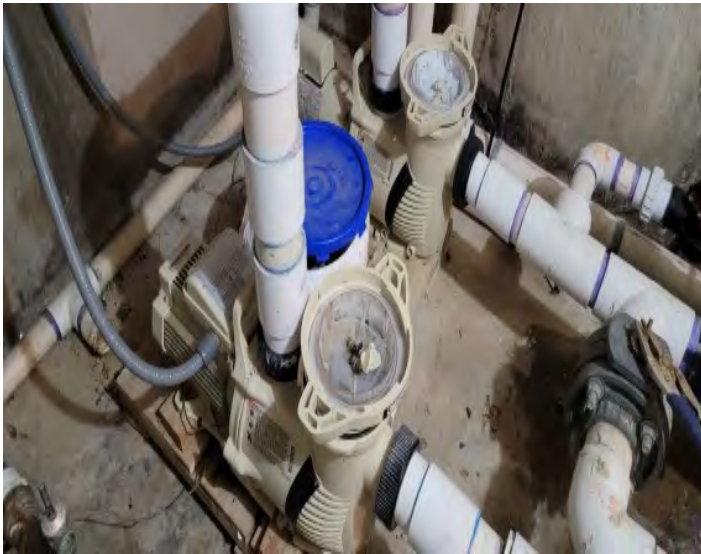
Comp #: 1111 Pool/Wader Pumps - Replace

- Two of the pumps have been replaced since our last site visit in 2018. No reports of when the pumps were replaced.
- The life expectancy for this equipment can differ depending on the level of use and maintenance, as well as the quality of the equipment.
- Therefore, we suggest establishing an allowance for periodic replacement of the equipment.
- Meaning, this is just an allowance to provide the association some funds to replace equipment when required and should not be interpreted as complete replacement of all pumps every 5 years

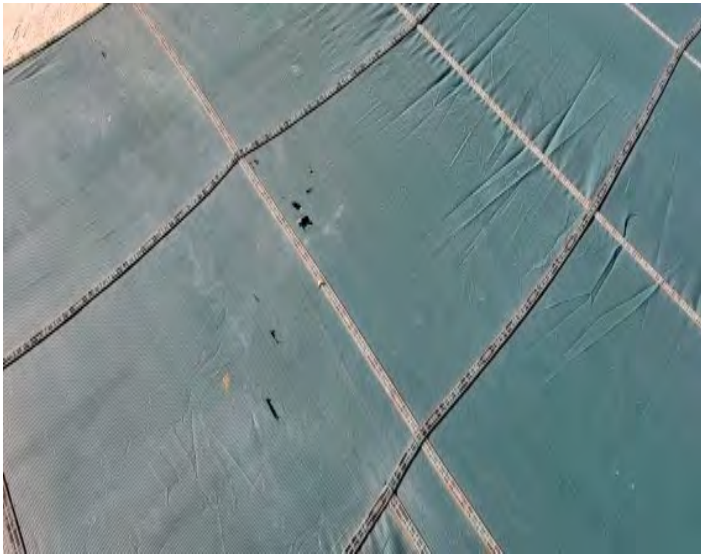
Comp #: 1113 Pool Cover - Replace

- Some small holes were observed in several sections of the cover. Also, the fabric appears to be thinning, which is defeating the purpose of being a safety cover, as it may not hold the weight of a person.
- Most pool covers come with a 10 year manufacturers warranty as long as the cover is being stored according to their specific guidelines; check with your pool manufacturer to ensure you are properly storing your pool cover.
- If properly stored and properly maintained, we recommend reserving to replace the pool cover every 10 - 12 years.
- It is noted at time of site observation, there are small holes in the pool cover.

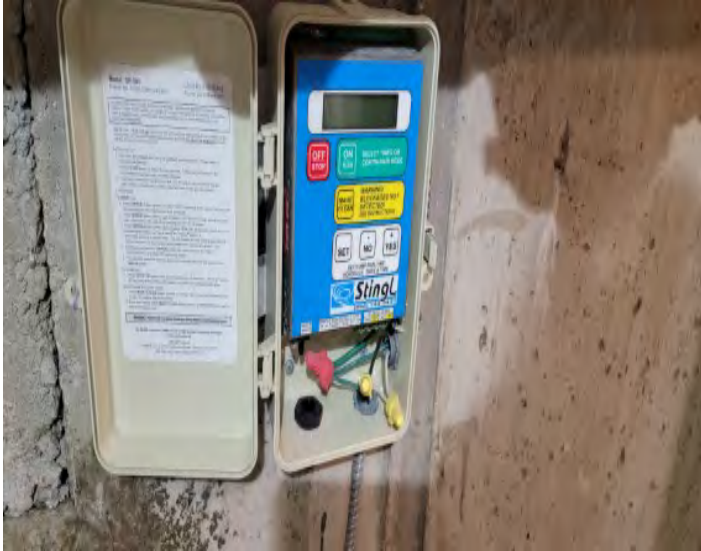
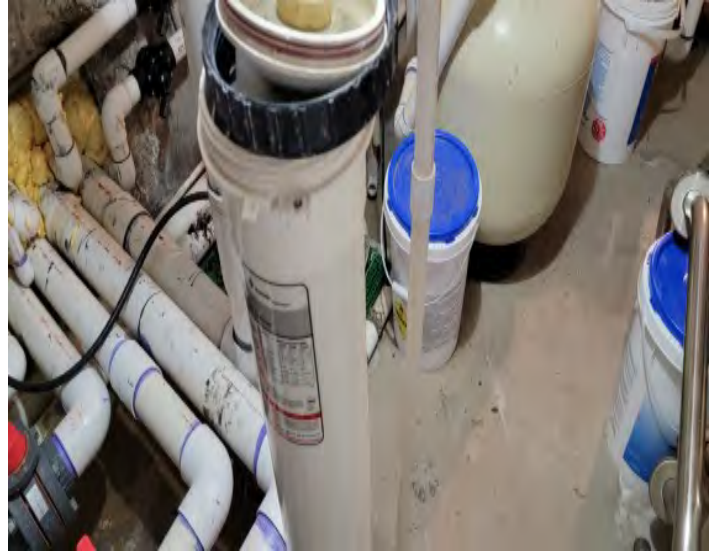
Comp #: 1117 Miscellaneous Pool Equipment - Replace

- Due to low replacement cost of individual pieces of equipment, we recommend replacing these on an as needed basis with general operating funds.
- Therefore, Reserve funding is not required for this component

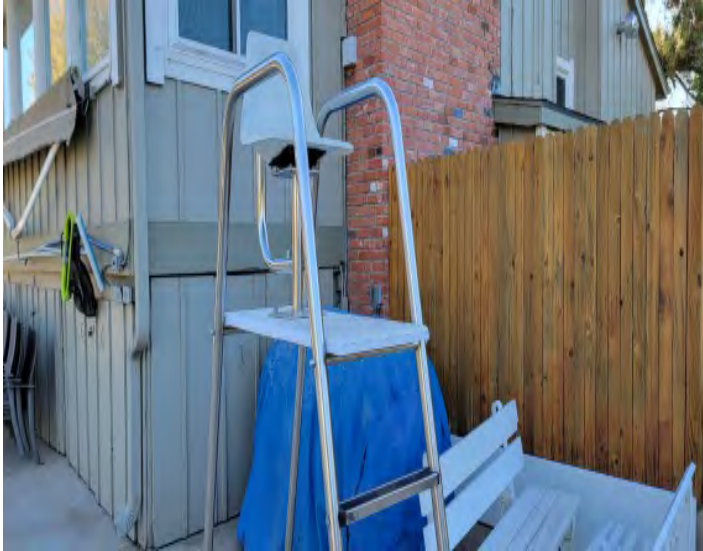
Comp #: 1118 Lifeguard Stand - Replace

- The lifeguard stand was stable and in fair condition with typical signs of wear and tear noted
- The average replacement cycle for lifeguard stands ranges from 12 - 15 years.
- However, based on the observed condition, we extended the replacement cycle a couple years.

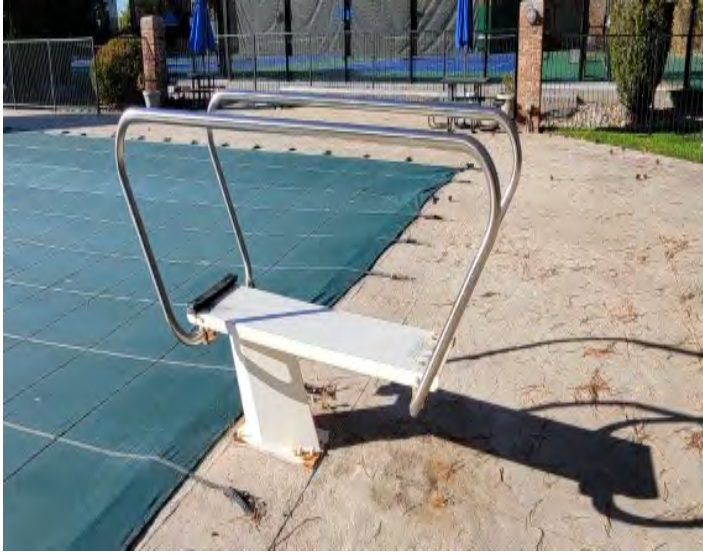
Comp #: 1119 Diving Board - Replace

- No unusual conditions were noted during site visit. There was some minor rusting noted on the base
- On average, these last 15 - 20 years under normal conditions
- The estimated cost includes replacement of the hand bars and platform.

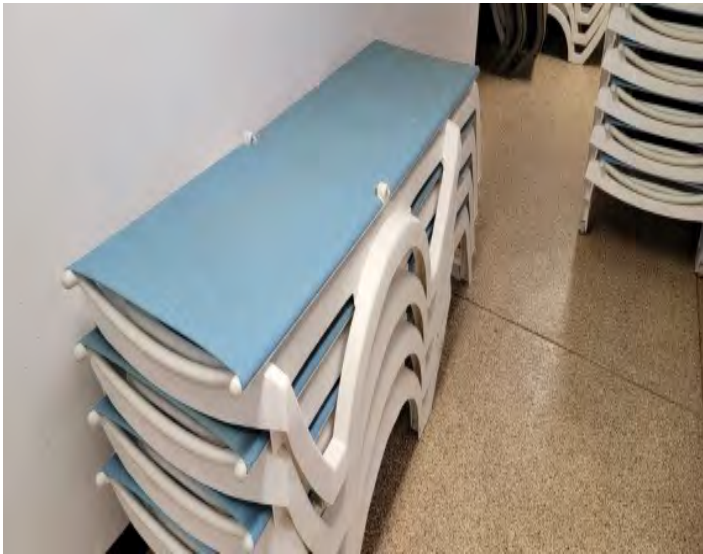
Comp #: 1121 Pool Furniture - Partial Replacement

- It was difficult to observe all pieces because they were still stacked upon each other.
- From what we were able to observe, the furniture is in fair condition with no major signs of broken slings or significant sun damage noted at the time of evaluation.
- Due to varying types of furniture and different levels of use each piece receives, we recommend establishing funds for partial replacement every 4 years.
- This line item is an allowance for partial replacement and should not be misinterpreted as complete replacement of all pieces every 4 years

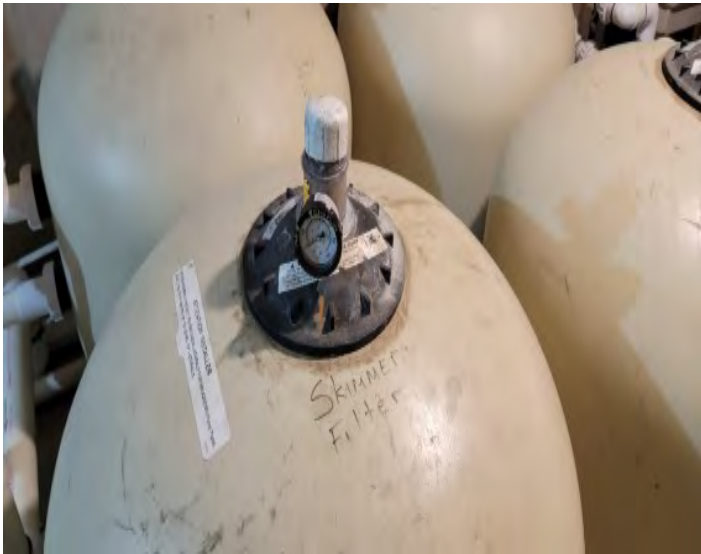
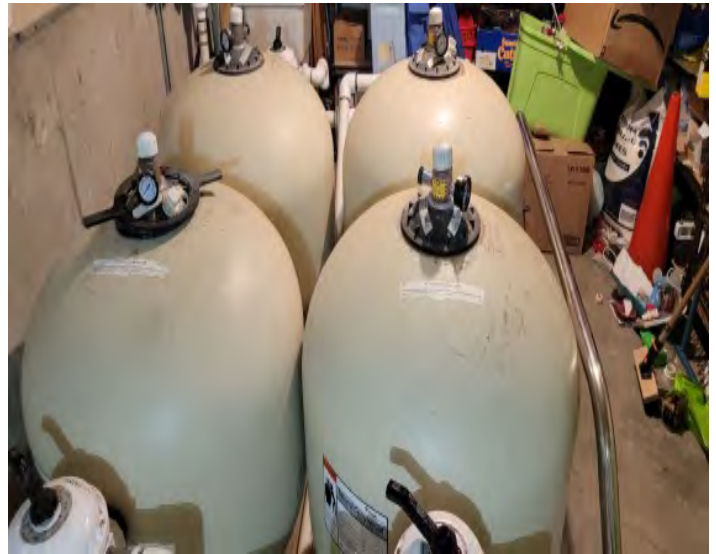
Comp #: 1124 Filter Media - Replace

- It has been suggested to replace filter media on suggested cycle depending on the level of use and quality of water.
- For this pool, which receives heavy use, we recommend planning on replacing the media (sand) every 4 years.

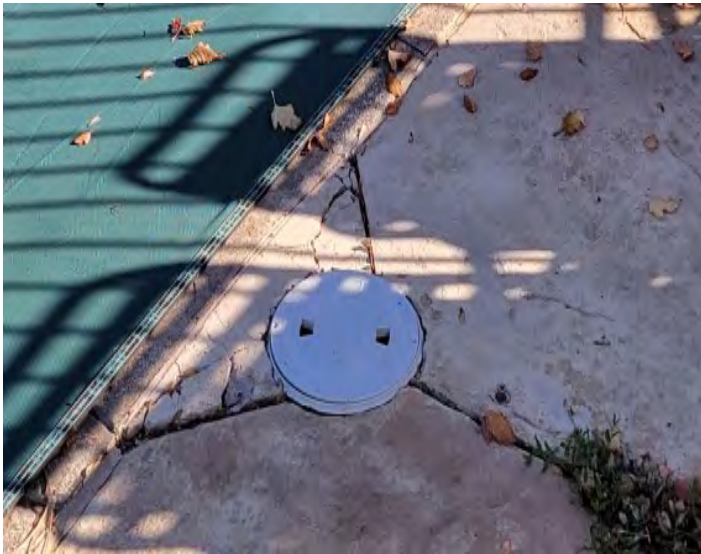
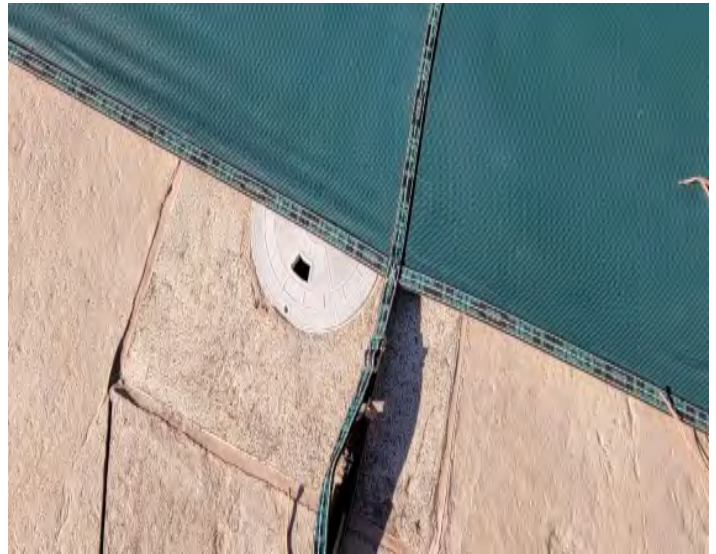
Comp #: 1126 Skimmers - Replace

- In our experience, we have seen the need to replace skimmers every 20 - 30years.
- It is typical to replace every other pool plaster cycle, or at the same time as coping stones and tile is being replaced.
- Therefore, we suggest setting aside Reserve funding for replacement every 32 years at this time.

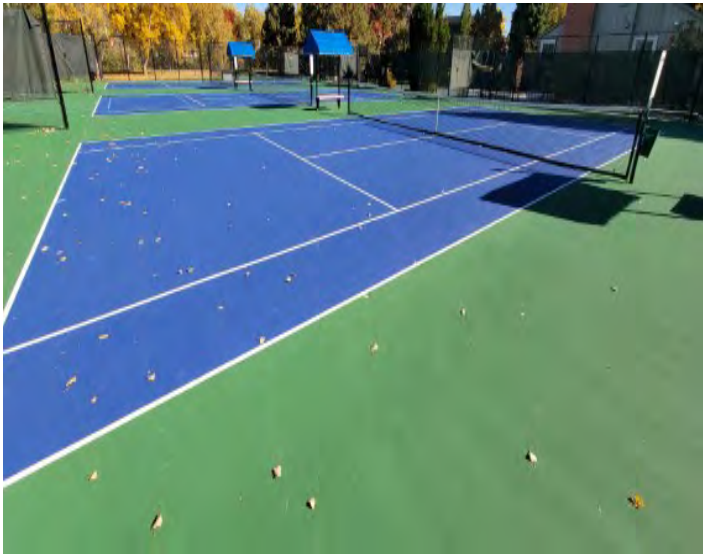
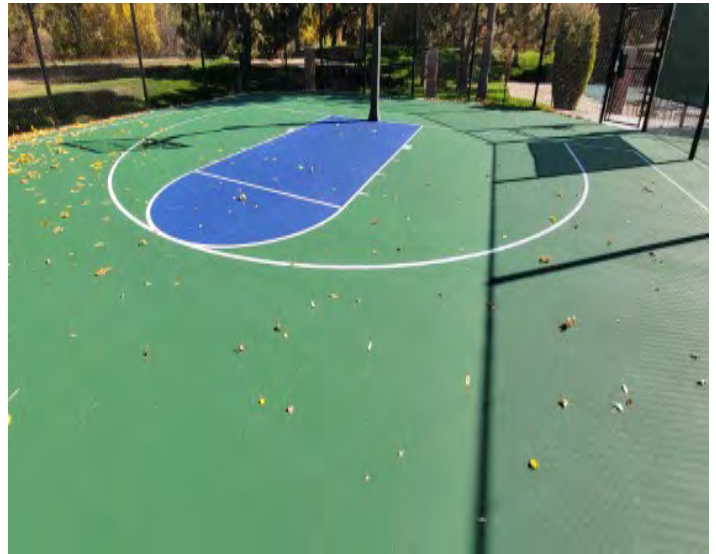
Comp #: 1201 Tennis Court/Basketball - Replace

- Courts were replaced in 2022 with a post tension concrete system
- According to several local contractors, these courts have a realistic life expectancy of 30 - 40 years under normal conditions.
- Periodic maintenance includes recoating every 6 - 8 years depending on level of use and care.

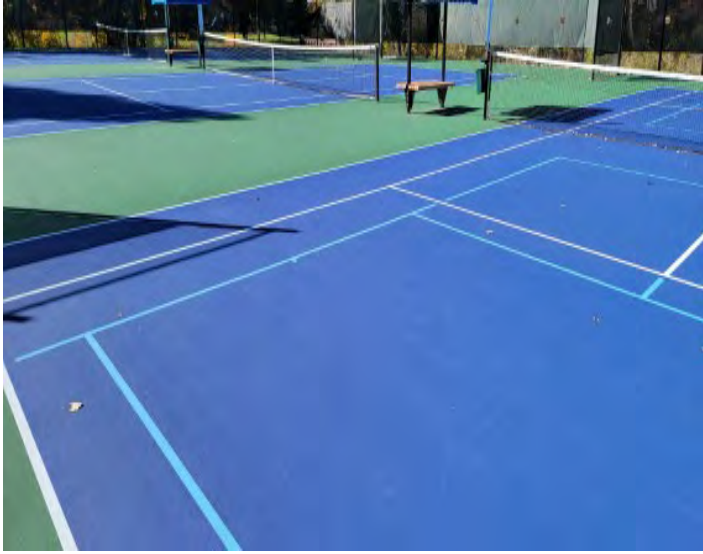
Comp #: 1202 Tennis Court/Basketball - Recoat/Paint

- All courts are new in 2022 and in very good condition
- Depending on the level of use and care, we recommend recoating (also known as resurfacing) the court every 5 - 7 years.
- In between recoating cycles, minor crack fill should be performed as needed with operating funds to prevent the cracks from worsening.

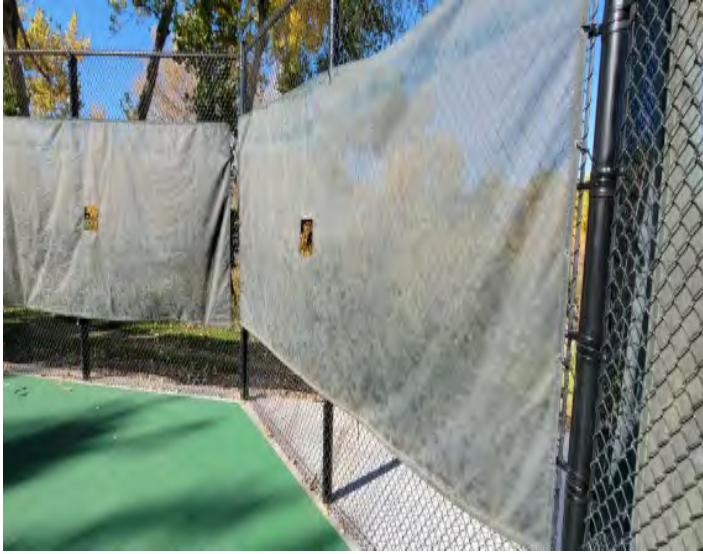
Comp #: 1203 Tennis Court Windscreen - Replace

- The older windscreens were reused when the new courts and fencing was replaced. No tears or holes were observed, but the fabric was dirty and thin in a few areas.
- Expect a useful life of approximately 4 to 8 years from this component.

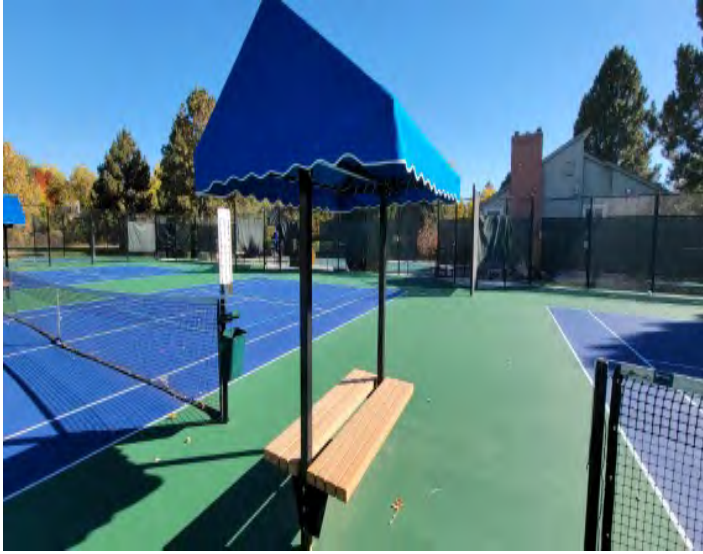
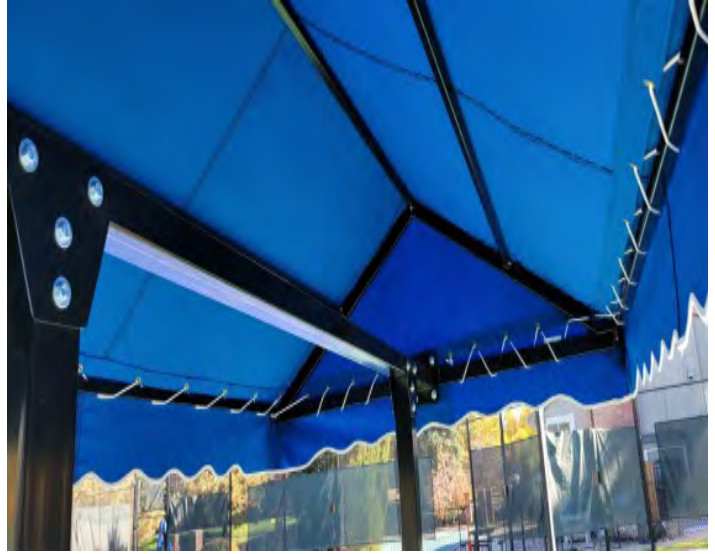
Comp #: 1204 Shade Shelters - Replace

- New shade shelters were installed along with the new courts
- The overall life expectancy of the entire structure should range between 20 - 30 years
- We recommend replacing the fabric as needed with operating funds
- Reserve to replace the entire structure every 27 years and adjust the life expectancy in future updates if necessary

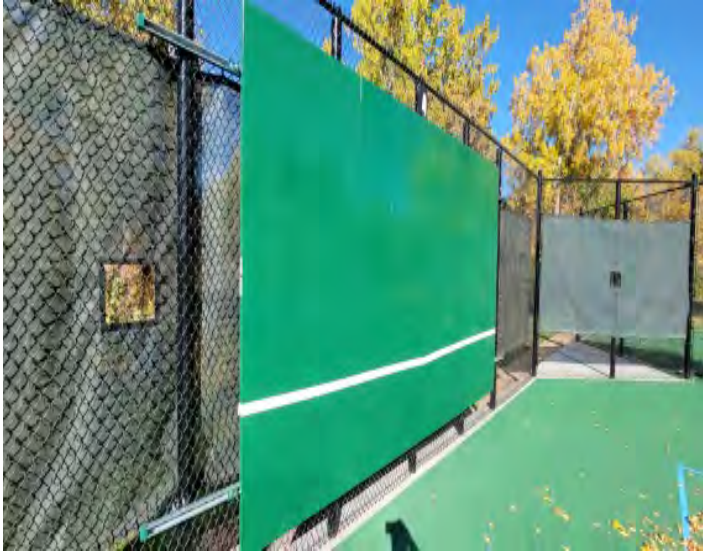
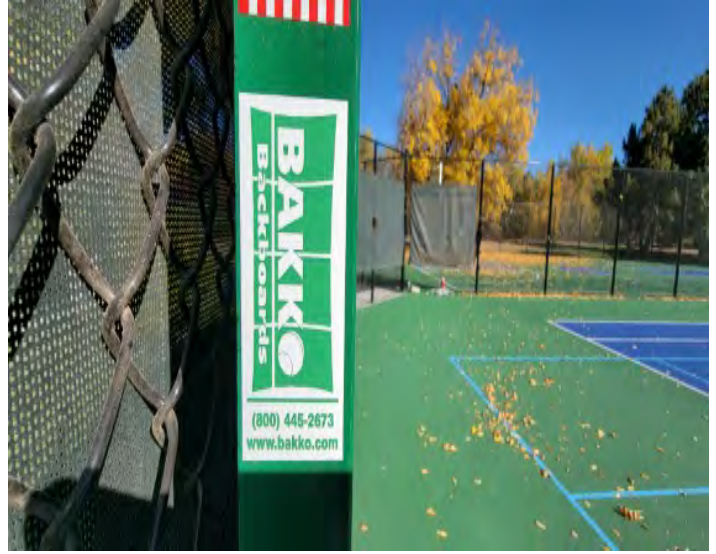
Comp #: 1205 Playback Board - Replace

- This is a fiberglass board that should have a long life expectancy.
- However, in this climate, the sun is harsh on fiberglass material
- At this time, plan on replacement every 25 years and adjust the life expectancy in future updates based on how the playback board is aging in this climate

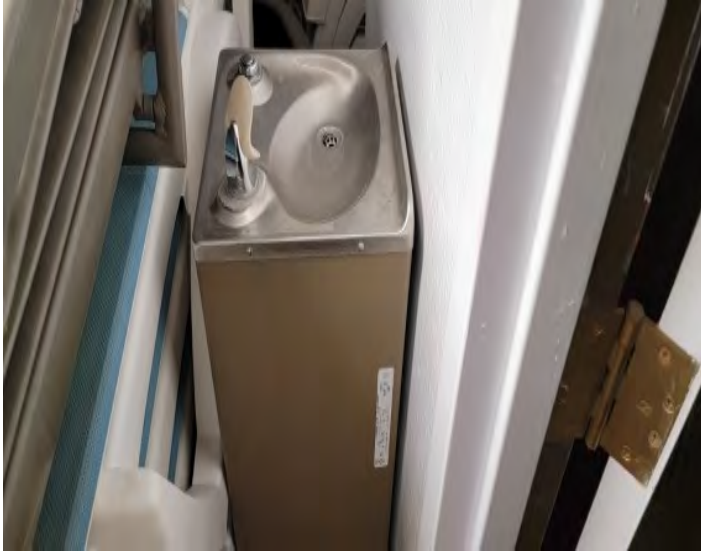
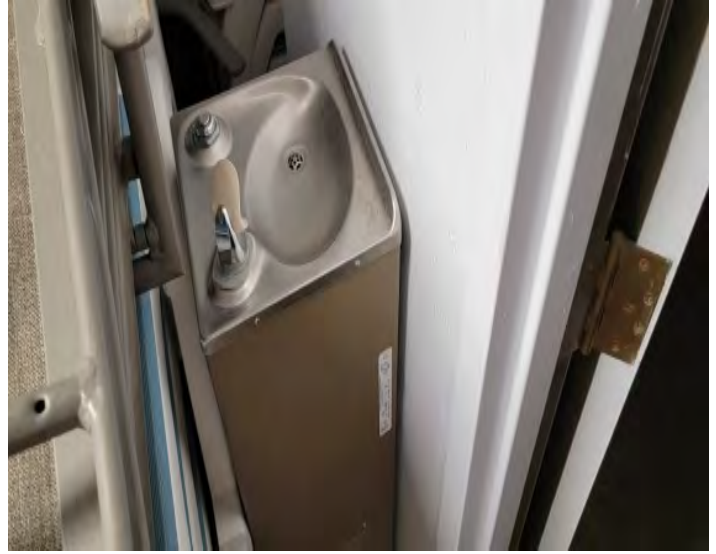
Comp #: 1304 Drinking Fountain - Replace

- Most communities are replacing these units with a bottle filling station, in addition to the standard drinking fountain to the side.
- These units usually last 10 - 15 years depending on level of use and exposure to elements.

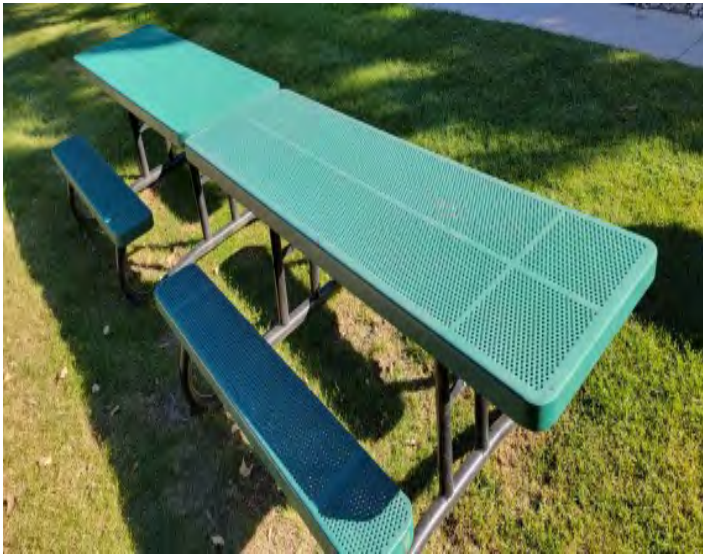
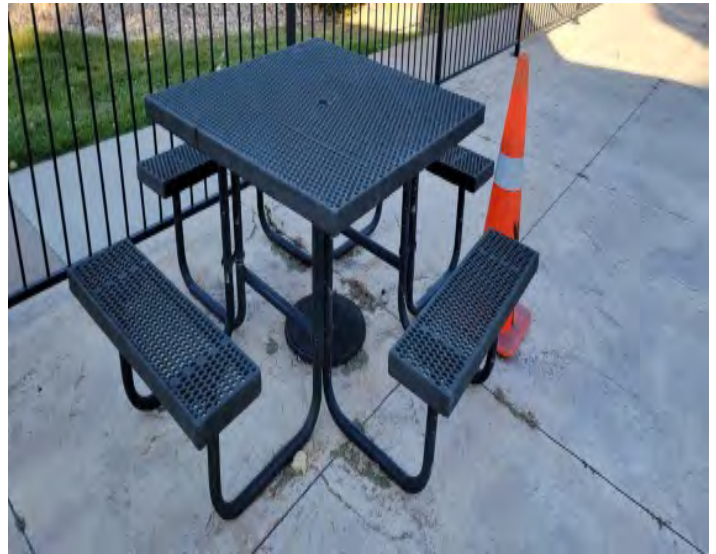
Comp #: 1306 Park Furnishings - Partial Replacement

- Conditions and ages of furnishings vary, as some are older and close to needing replacement, while others are new and in very good condition.
- Expect to replace park equipment approximately every 12 - 18 years on average to maintain appearance.
- Due to varying ages, we recommend establishing a Reserve allowance for periodic partial replacement of needed furnishings every 6 years.

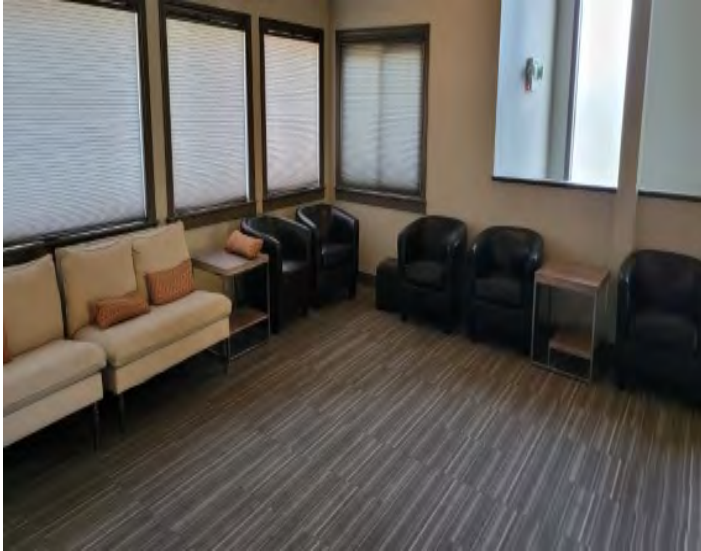
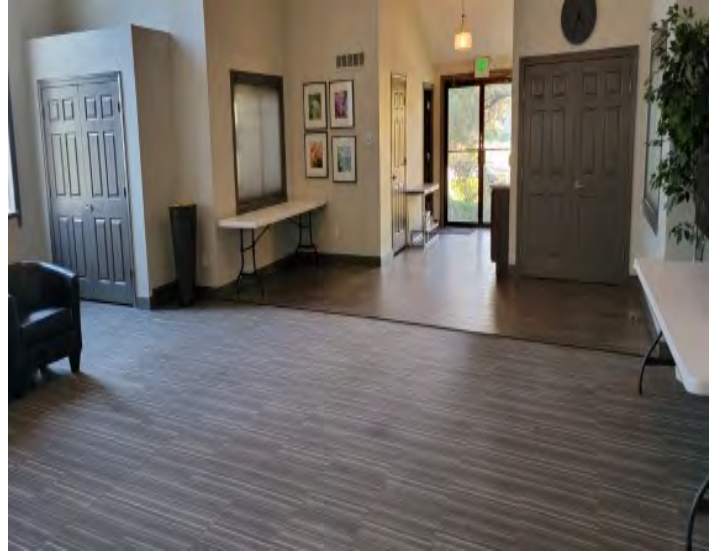
Comp #: 1413 Clubhouse - Remodel (Upper Level)

- Most associations perform a general remodel of the clubhouse interiors every 15 - 20 years to maintain appearance and keep up with current decorative trends.
- The final decision is up to the community members in deciding when to spend the money to perform this project since it is considered cosmetic.

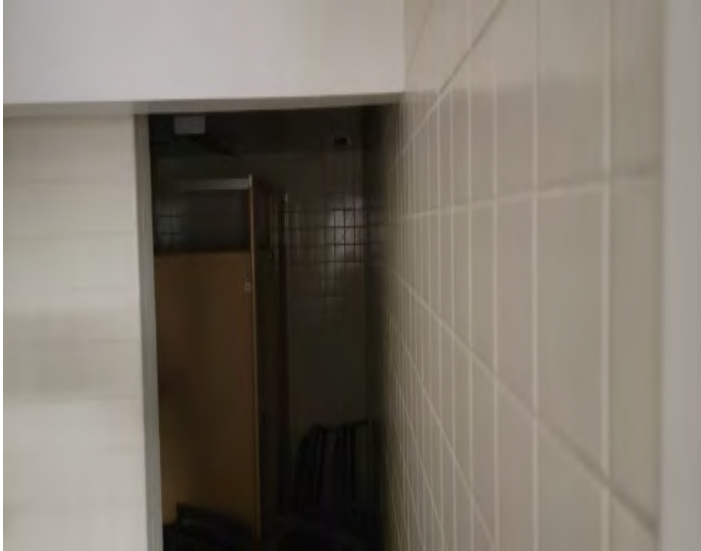
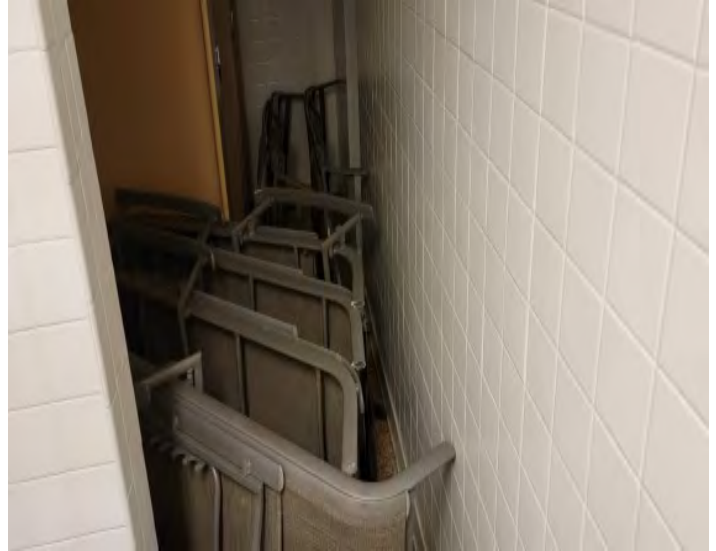
Comp #: 1414 Clubhouse - Remodel (Lower Level)

- Most associations perform a general remodel of the clubhouse interiors every 15 - 20 years to maintain appearance and keep up with current decorative trends.
- Based on the age of the community, we suggest planning a remodel of the interiors within the next couple years.
- The final decision is up to the community members in deciding when to spend the money to perform this project since it is considered cosmetic.
- At the time of site observation, restrooms were full of furniture and difficult to enter.

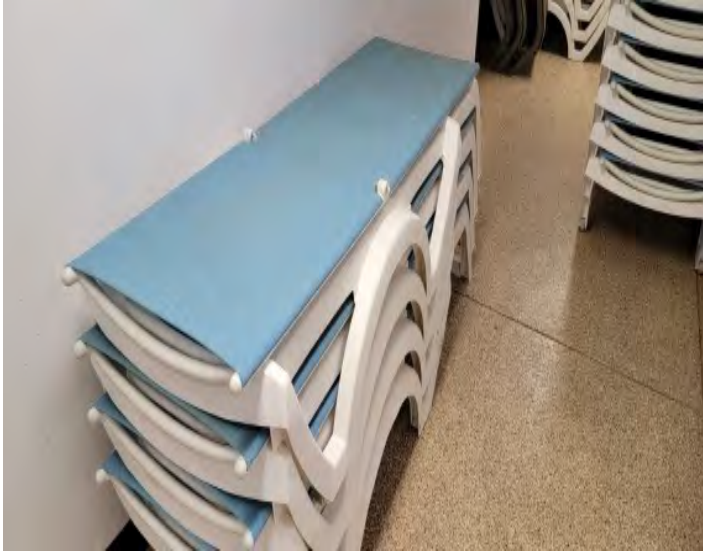
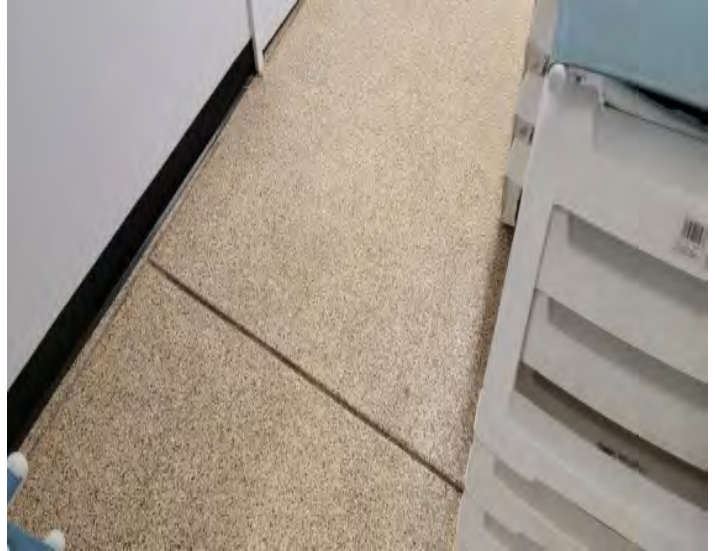
Comp #: 1506 Lower Level Flooring - Recoat

- Most of the area was covered with furniture, so it was difficult to observe all of the flooring
- We recommend recoating this type of flooring every 8 - 10 years, depending on the level of use and care.
- Remaining life is based on the observed conditions and age.
- We recommend coordinating resurfacing with lower level remodel project for best cost and to match decor trends.

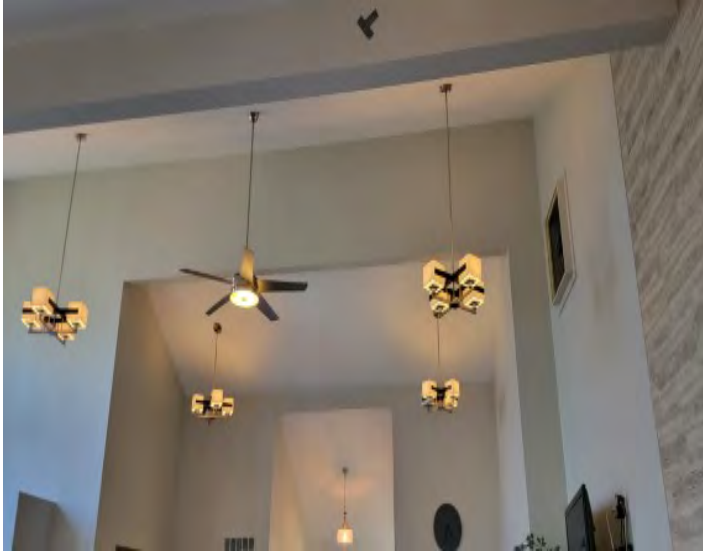
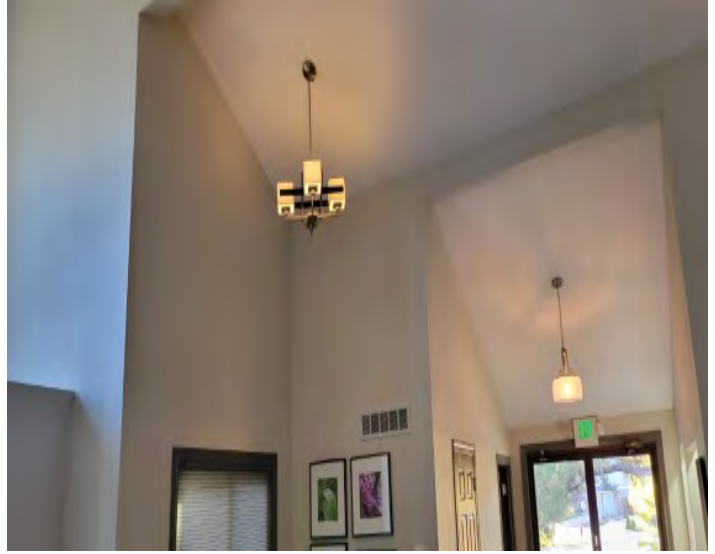
Comp #: 1601 Interior Hallway - Replace

- Inspect these fixtures frequently to ensure proper function.
- Funding for replacement is included with the remodel line item
- No additional funding is required for this component

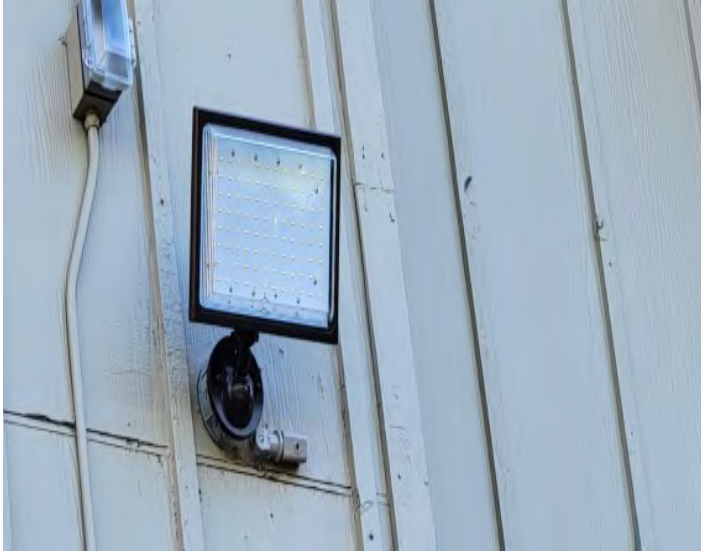
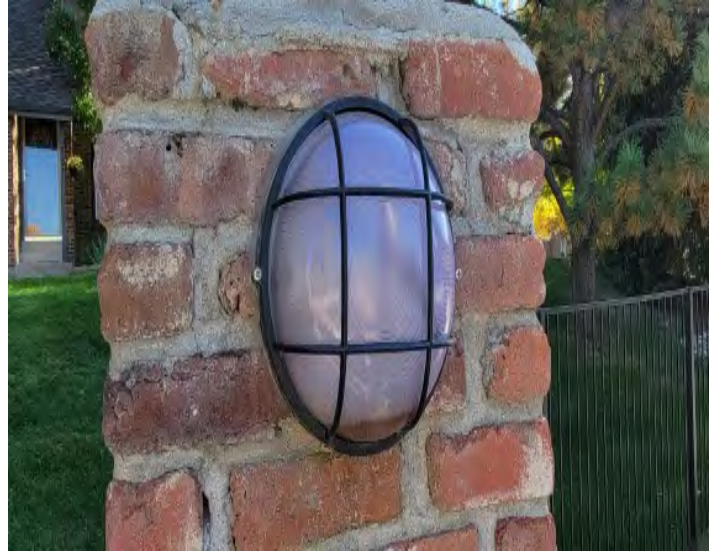
Comp #: 1602 Exterior Wall Mount - Replace

- Due to the minimal cost to replace these lights, Reserve funding is not appropriate.
- Repair and replace as necessary as an operating expense.

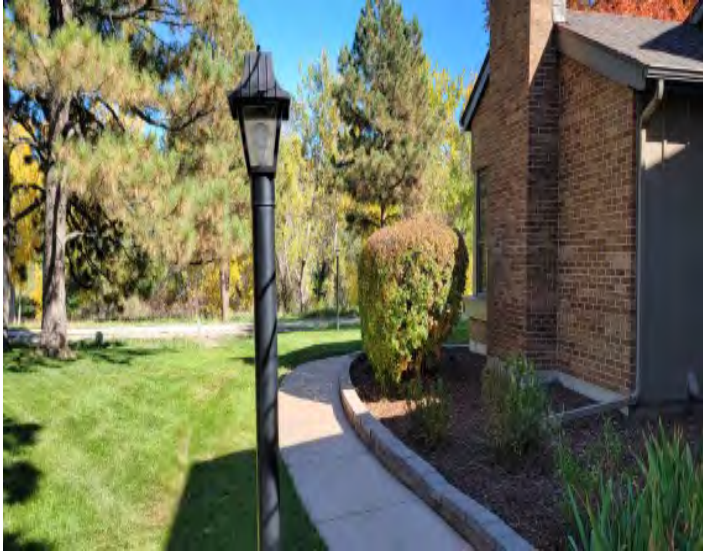
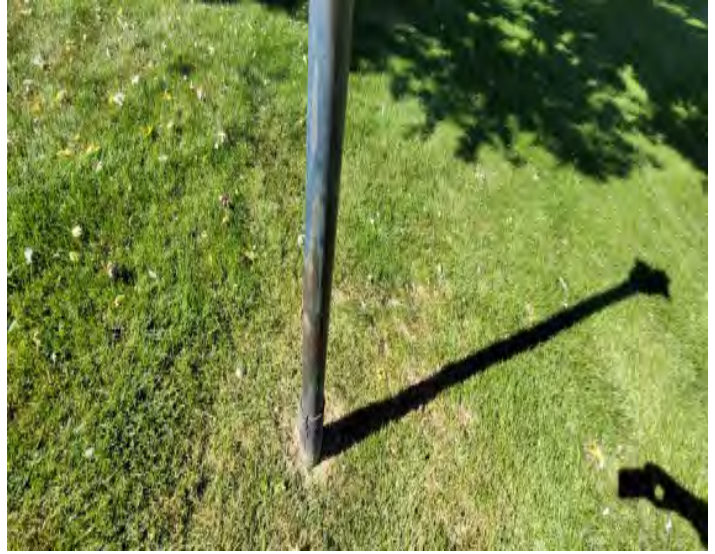
Comp #: 1604 Pole Lights - Replace

- Many poles are rusted and corroded at the base and heads are older, but assume to be functional.
- It has been reported by the association in past Reserve Studies that these lights will be replaced on an as needed basis with general operating funds.
- Therefore, Reserve funding is not required for this component.
- If the association decides to replace as a whole, expect to spend approximately \$40,000 - \$50,000 depending on type of fixture chosen, if any poles need to be replaced, and the condition of wiring.

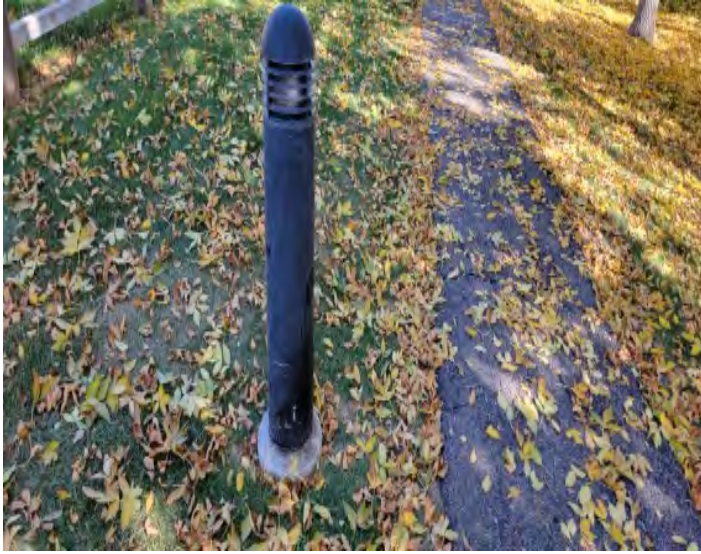
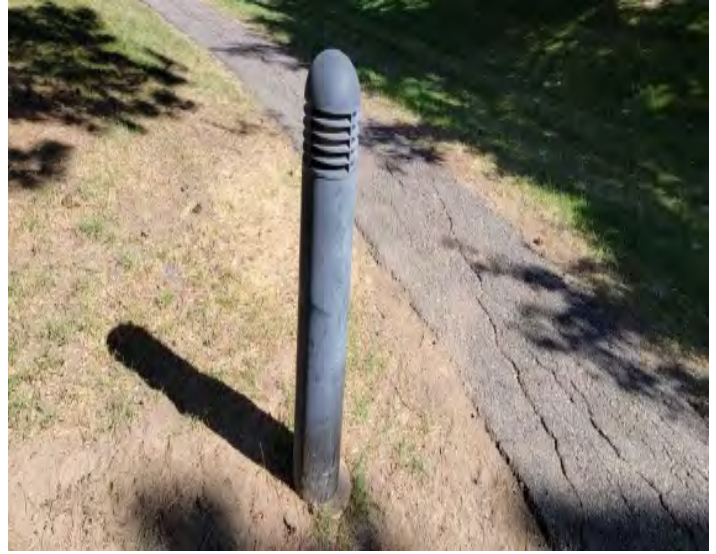
Comp #: 1605 Bollard Lights - Replace

- It has been reported by the association in past Reserve Studies that these lights will be replaced on an as needed basis with general operating funds.
- Therefore, Reserve funding is not required for this component.
- If the association decides to replace as a whole, expect to spend approximately \$30,000 - \$35,000 depending on type of fixture chosen, if any poles need to be replaced, and the condition of wiring.

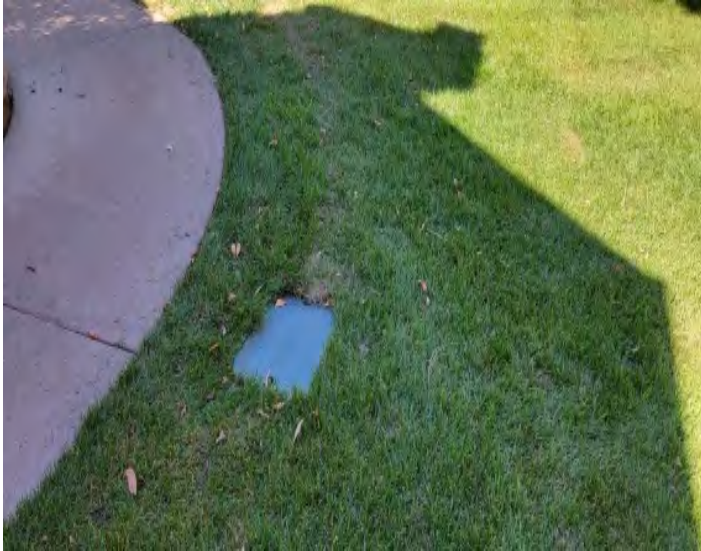
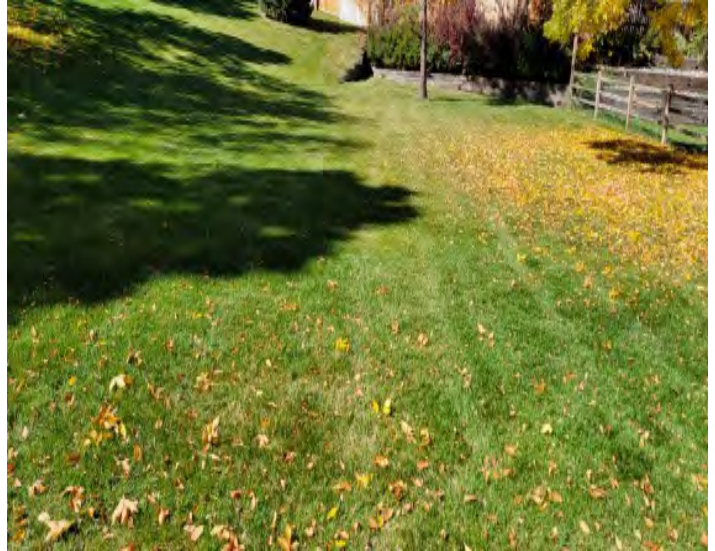
Comp #: 1701 Irrigation System - Rebuild

- This line item is for repairs and replacement that lies outside the scope of routine maintenance: bulk sprinkler head replacement, bulk valve replacement, rerouting lateral lines, rewiring, etc.
- In order to ensure the funds are available for major repairs, we recommend reserving funds for these projects every 4 - 5 years.
- The funding on this line item is for major repairs and is not to be interpreted as complete irrigation system replacement.

Best Cost: **\$17,500**
 Estimate for major repairs and renovating system

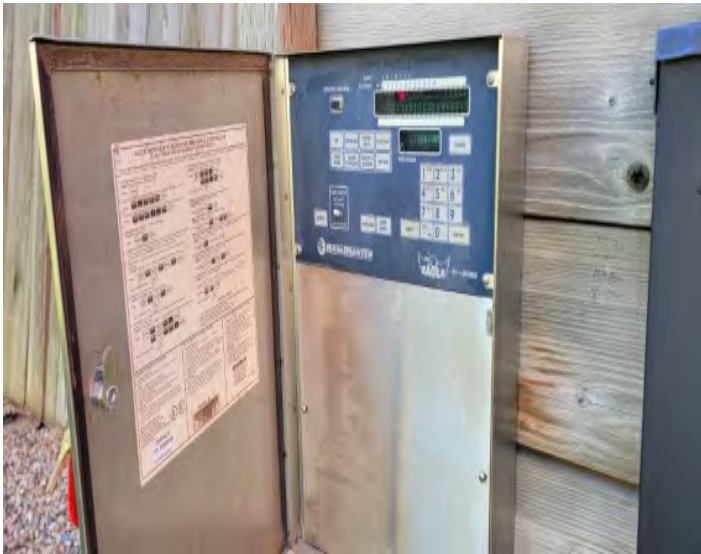
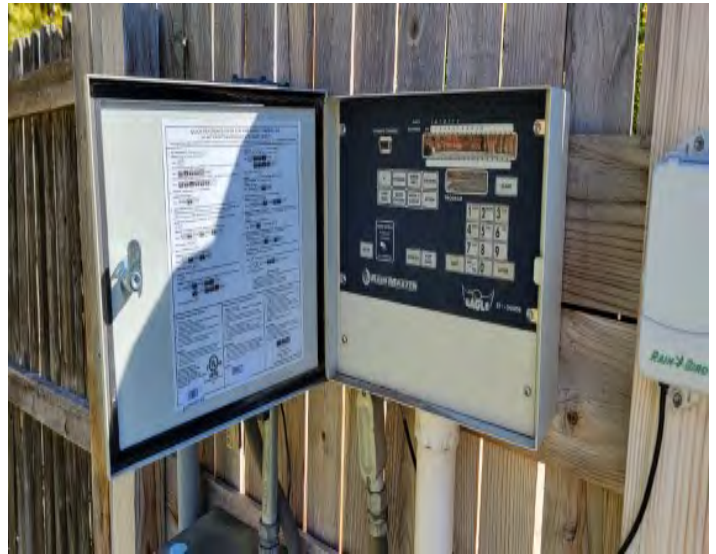
Comp #: 1703 Irrigation Timeclocks - Replace

- Controllers are older and most have exceeded the typical replacement cycle.
- Most are padlocked and we did not have access to the panel during site visit
- Expect to replace irrigation controllers every 10 - 15 years if properly maintained and under normal conditions.
- Funding is for replacement with a similar controller

Best Cost: **\$66,500**
 \$3500/controller; Estimate to replace

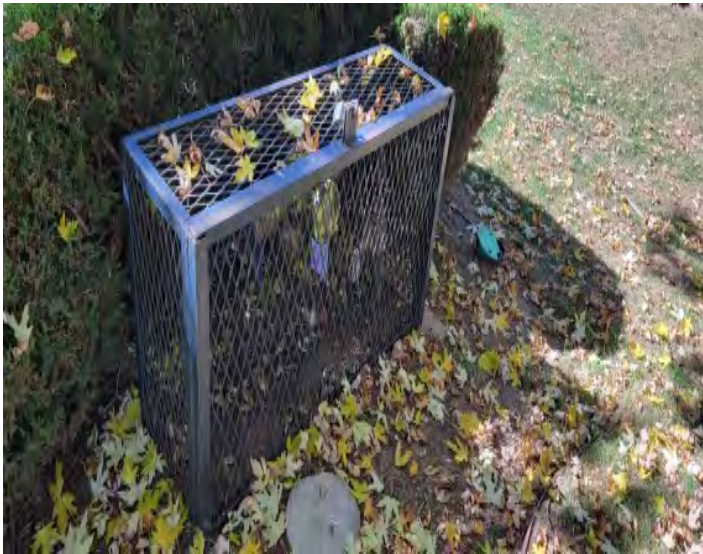
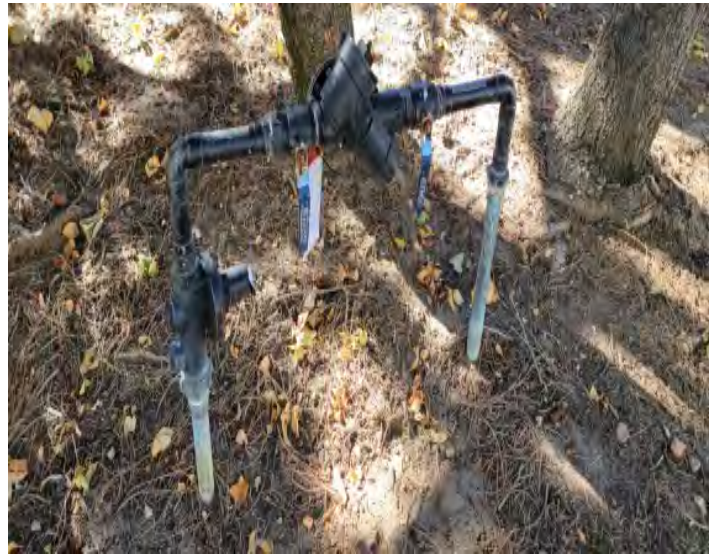
Comp #: 1706 Backflow Devices - Replace

- Devices can be rebuilt and repaired when needed as a maintenance issue.
- It is very seldom that a complete system would need to be replaced due to normal wear and tear.
- Replacement would be as a result of freezing conditions if system is not winterized properly or in a timely manner.
- No Reserve funding is required due to difficulty of predicting a life expectancy and the fact that systems can be rebuilt at a minimal cost, as opposed to being replaced.

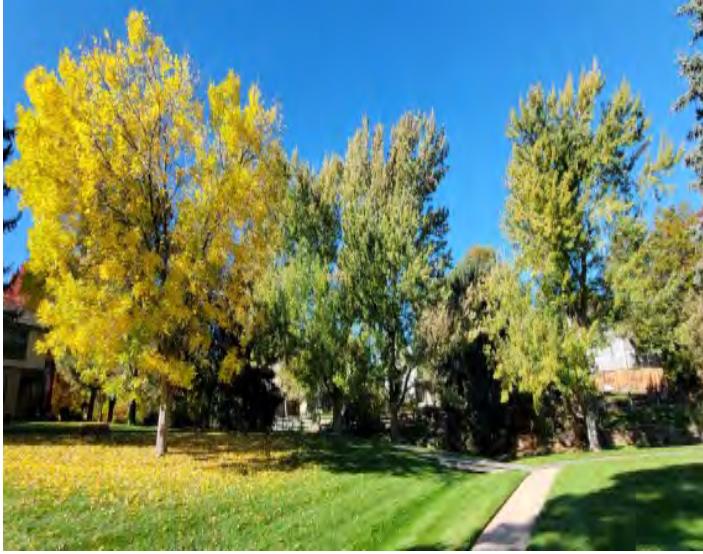
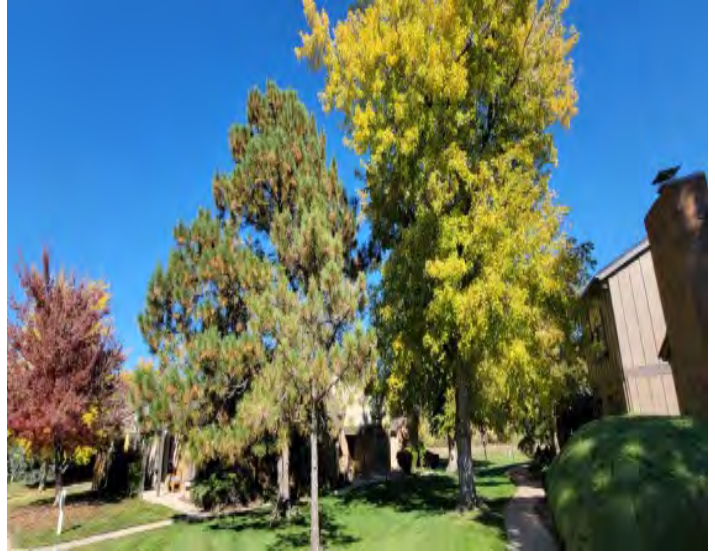
Comp #: 1804 Tree - Replacement/Major Maintenance

- It is very difficult to predict a replacement cycle for trees as there are several factors such as disease, infestation of insects, heavy snow storms, etc. can all attribute to eventual tree replacement.
- Since it is difficult to predict when the replacement will be necessary, Reserve funding is typically not a factor.
- Therefore, unless requested by the association, Reserve funding will not be included as part of the study for this component.
