Level 2, Platinum Reserve Analysis

Willow Creek III HOA
8091 E. Phillips Cir.
Centennial, CO. 80112

FINAL VERSION

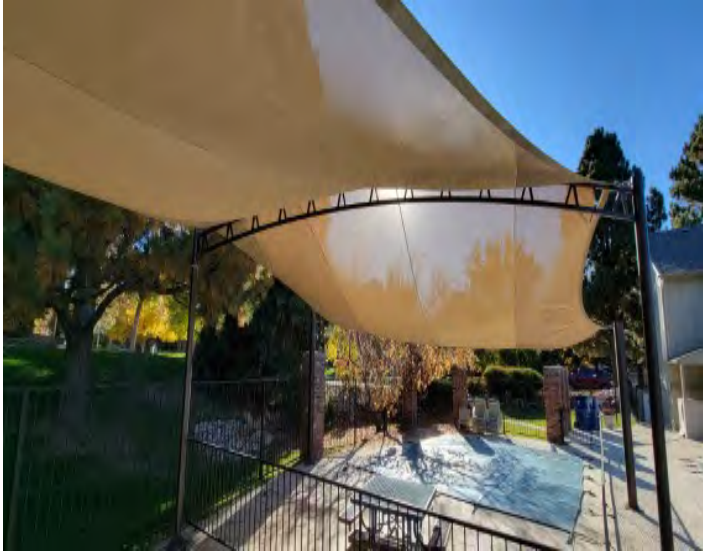
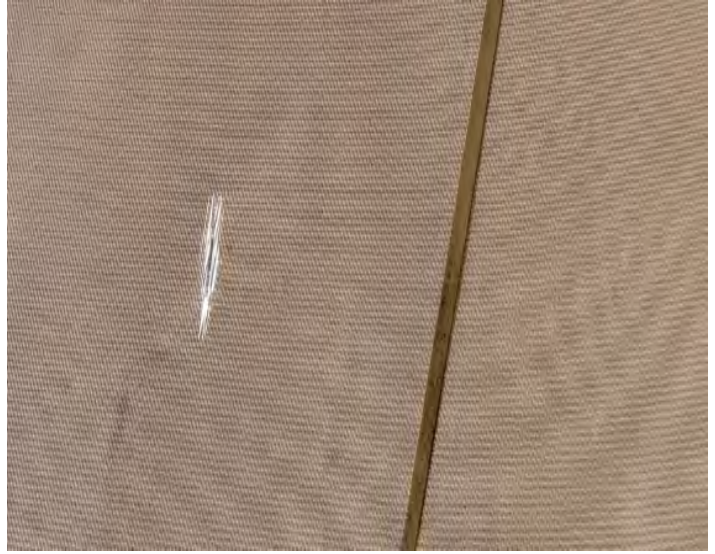
Comp #: 2001 Shade Structure - Replace

- At time of site observation, there is one sail that had a tear in the fabric.
- There were no reported issues with the structures.
- Reserve to replace the fabric only, as the poles should have an indefinite life expectancy
- The only reason to replace the poles is because the association wants a different configuration.

Best Cost: **\$3,900**
Estimate to replace with same quality material
